# Assessment of High-Temperature Hydrogen Attack Using Advanced Ultrasonic Array Techniques

by M.G. Lozev<sup>\*††</sup>, G.A. Neau<sup>†</sup>, L. Yu<sup>‡</sup>, T.J. Eason<sup>‡</sup>, S.E. Orwig<sup>††</sup>, R.C. Collins<sup>‡</sup>, P.K. Mammen<sup>††</sup>, F. Reverdy<sup>†</sup>, S. Lonne<sup>§</sup>, C. Wassink<sup>†</sup>, H. Cence<sup>¶</sup>, and J. Chew<sup>‡</sup>

## ABSTRACT

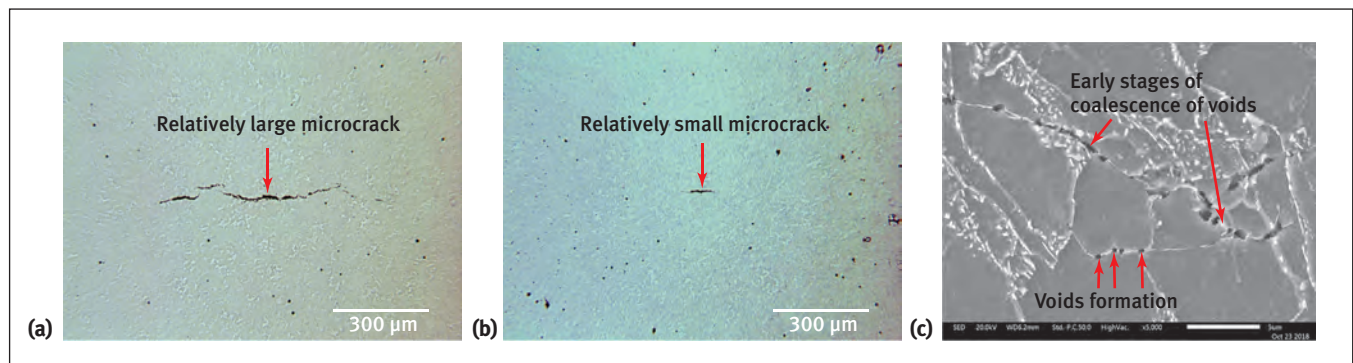
**Figure 5. Optical microscopy and SEM imaging of synthetic HTHA damage: (a) fissures forming relatively large microcrack indicative of HTHA damage (~100 $\times$ , as polished); (b) fissures forming small microcrack indicative of HTHA damage (~100 $\times$ , as polished); (c) damage feature showing severe dissolution of grain boundaries, grain boundary single void formation, and early stages of coalescence of voids in the periphery of the main feature, indicative of HTHA volumetric damage (~5000 $\times$ , as polished).**

The presence and the length of a ~0.7 mm (~700  $\mu$ m) indication was validated at low magnification using optical microscopy (Figure 5a). Optical microscopy at a lower magnification (shown in Figure 5b) displayed a smaller ~0.1 mm (~100  $\mu$ m) fissure-forming isolated microcrack below the larger microcrack. The separation between these microcracks is larger than the pixel size, and microcracks can be visualized as isolated indications. Scanning electron microscopy (SEM) at a higher magnification revealed damage features ~0.01 mm (~10  $\mu$ m) showing severe dissolution of grain boundaries, some early stages of single submicron void formation, and some early stages of coalescence of voids in the periphery of the main feature (Figure 5c). Submicron void formations are not detectable by any of the techniques evaluated in this study. No evidence was obtained to verify that any of the investigated techniques were capable of detecting linking voids at one grain boundary or clustered linking voids in a small volume. If limited fissures start forming small microcracks in the clustered linking voids along 5 to 10 damaged grain boundaries, the detectability probably is enhanced. This type of early-stage volumetric damage is possibly visualized as a blue haze and cloudy area around internal large microcracks and macrocracks or adjacent to the bar surface exposed to the hydrogen (Figure 4d, right). This surface of the bar is acting as a backwall for ultrasound and is represented by the solid red line in the front and side view images.

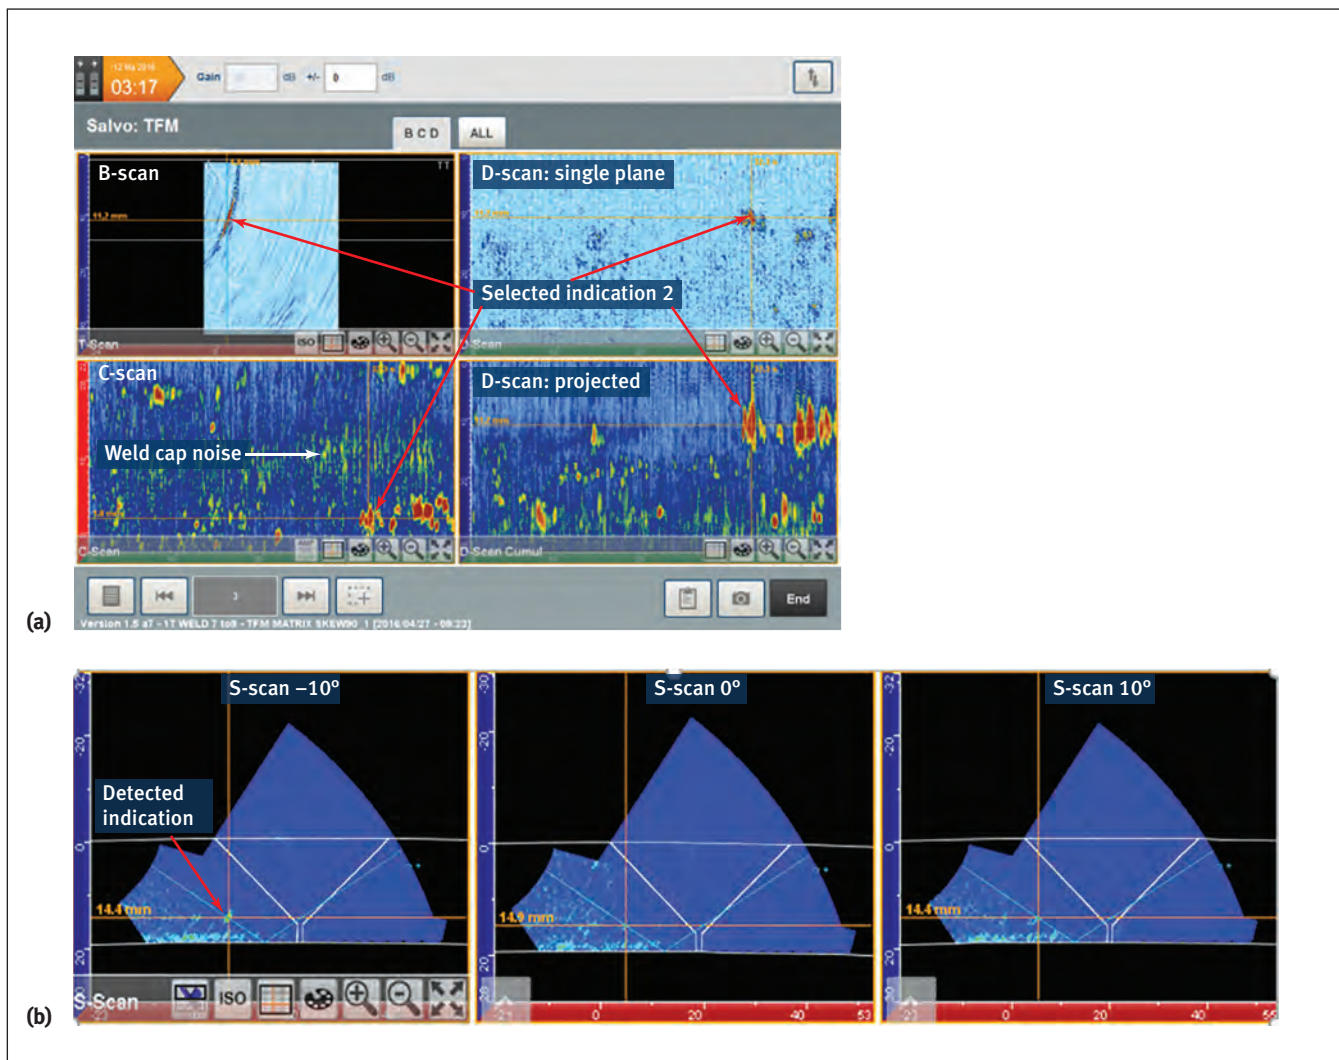
**Channel welds:** Potential HTHA blistering, micro-, and macrocracking indications were detected in the channel welds using a 10 MHz linear probe with the FMC/TFM TT technique. Multiple indications were detected in the HAZ of the most susceptible section of the shell-to-head circumferential weld. The ROI width was extended to cover the HAZ of the weld at the head side. Similar micro and macro indications were observed on the head side, but the severity was lower compared to the shell side. The analysis results for indication 2 are shown in the split screen views of Figure 6a. The B-scan image (Figure 6a, top left) analysis displays a root crack 5 mm high representing 34% wall thickness damage. The intersections of the vertical and horizontal cursors on the C-scan (Figure 6a, bottom left), cumulative D-scan (Figure 6a, bottom right), and D-scan single plane (Figure 6a, top right) show the location of the same crack-like indication. The elongated red areas on the right side of the C-scan and D-scans represent potentially breaking macrocracking at the root. The clusters of blue dots in the single-plane D-scan represent an early stage of HTHA damage. Indications of potential facets of HTHA damage were detected at skew  $-10^\circ$  in the breaking areas using the matrix probe and S-scan (Figure 6b). The matrix probe results in the second focalization plane indicate that the root crack is potentially continuous.

The metallographic investigation verified the presence of root cracking, stepwise cracking, and blistering with cracking edges. A cross-sectional image of the root crack is shown in Figure 7a. Optical metallography confirmed the matrix probe findings, showing that the crack in the HAZ is a continuous macrocrack along the weld starting from indication 2 and

Figure 6. Imaging of HTHA weld damage using 10 MHz TT FMC/TFM and PAUT techniques: (a) linear probe split screen views of indication 2; (b) indication of potential HTHA damage detected in the breaking areas using matrix probe and S-scan at skew  $-10^{\circ}$ .

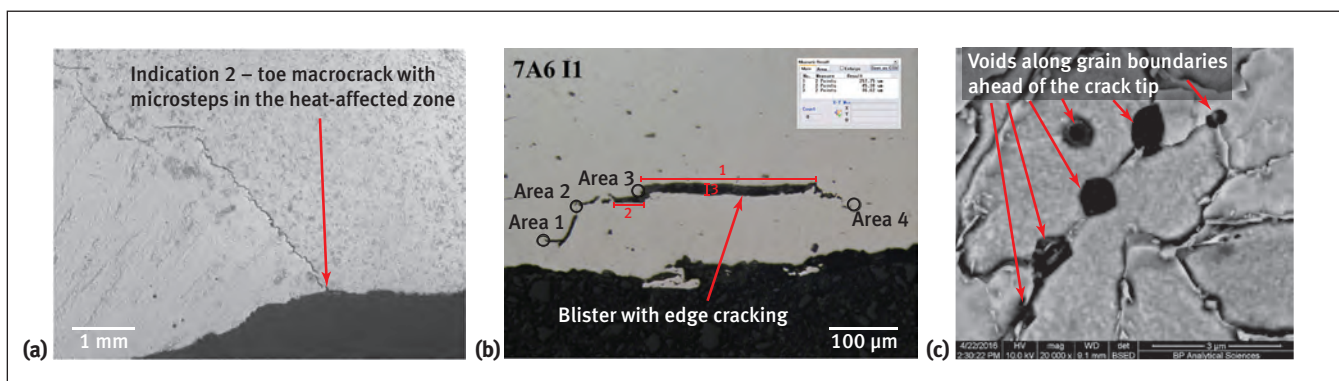
Figure 7. Weld damage validation using optical metallography and SEM: (a) root cracking in the heat-affected zone indicative of HTHA damage ( $\sim 20\times$ , nital etched); (b) blister with edge cracking ( $\sim 40\times$ , nital etched); (c) voids along grain boundaries ahead of the crack tip ( $\sim 20\,000\times$ , nital etched).

finishing at the end of the scan. Macro stepwise cracking was observed in the base material adjacent to the root crack. Microscopic and macro blistering with cracking edges was documented near the ID (Figure 7b). Voids and linked voids, an indication of volumetric HTHA damage, were observed at the tips of the cracks and blisters at a higher magnification (Figure 7c). Single submicron voids and submicron linking voids were not detected with any array techniques. Stress-related microcracks were observed at the same magnification, but it was not possible to distinguish HTHA crack-like damage from stress-related microcracking with ultrasonic techniques.

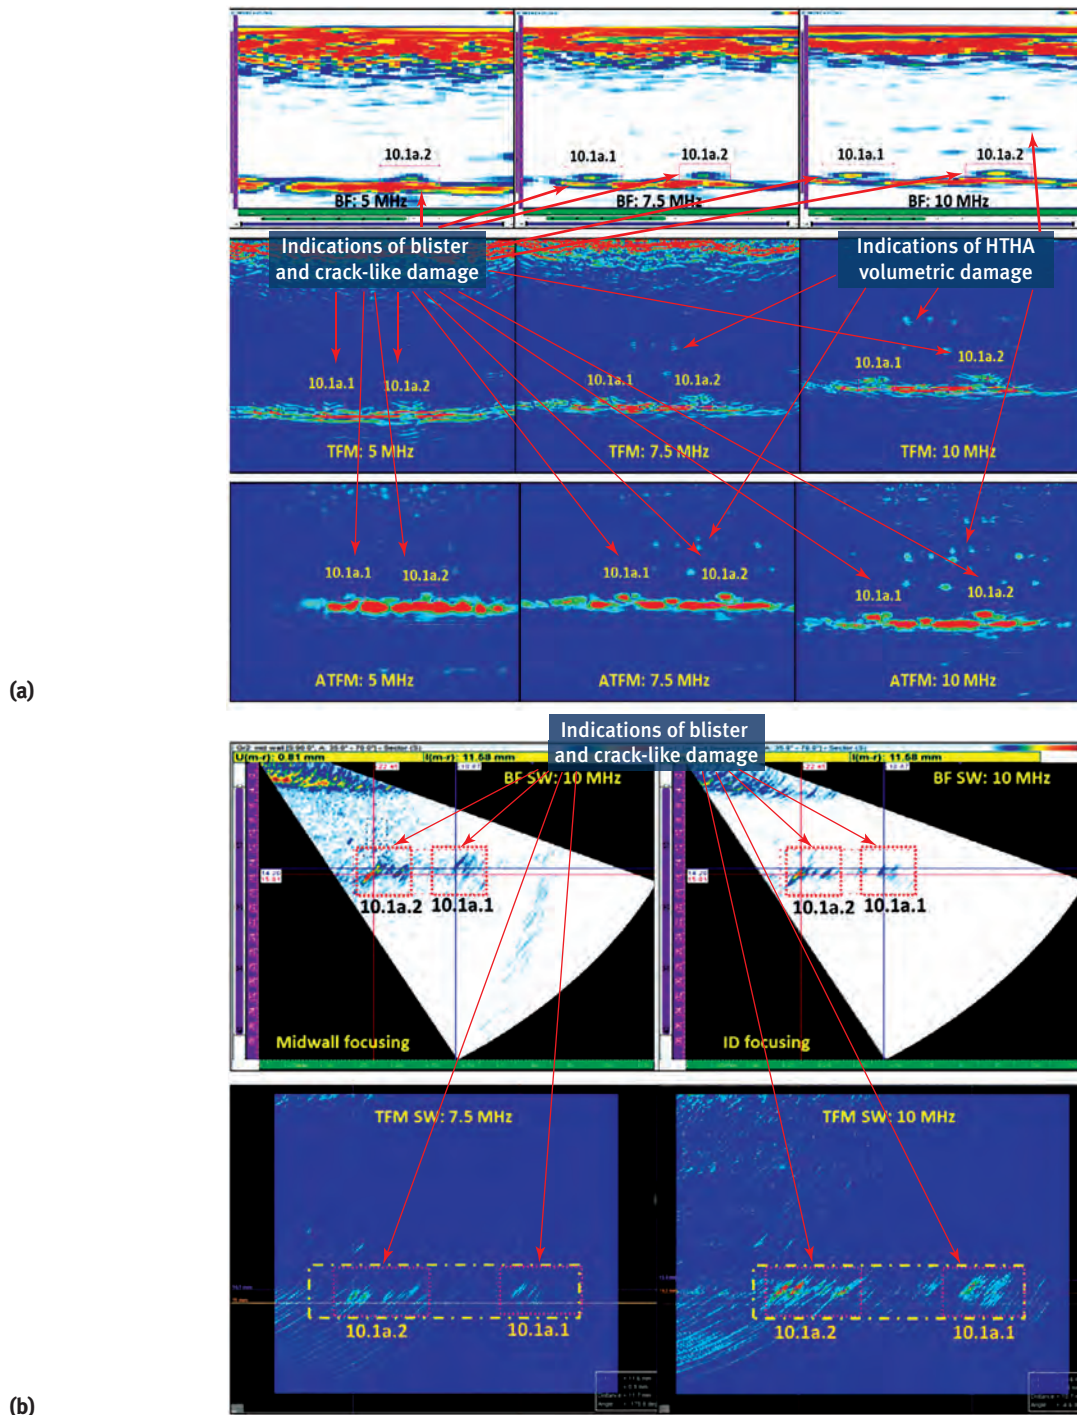
Figure 8. Imaging of indication 10.1a.1 and 10.1a.2: (a) PAUT straight-beam and FMC/TFM/ATFM LL B-scans comparison; (b) comparison of PAUT S-scans and FMC/TFM TT B-scans using shear wave techniques.

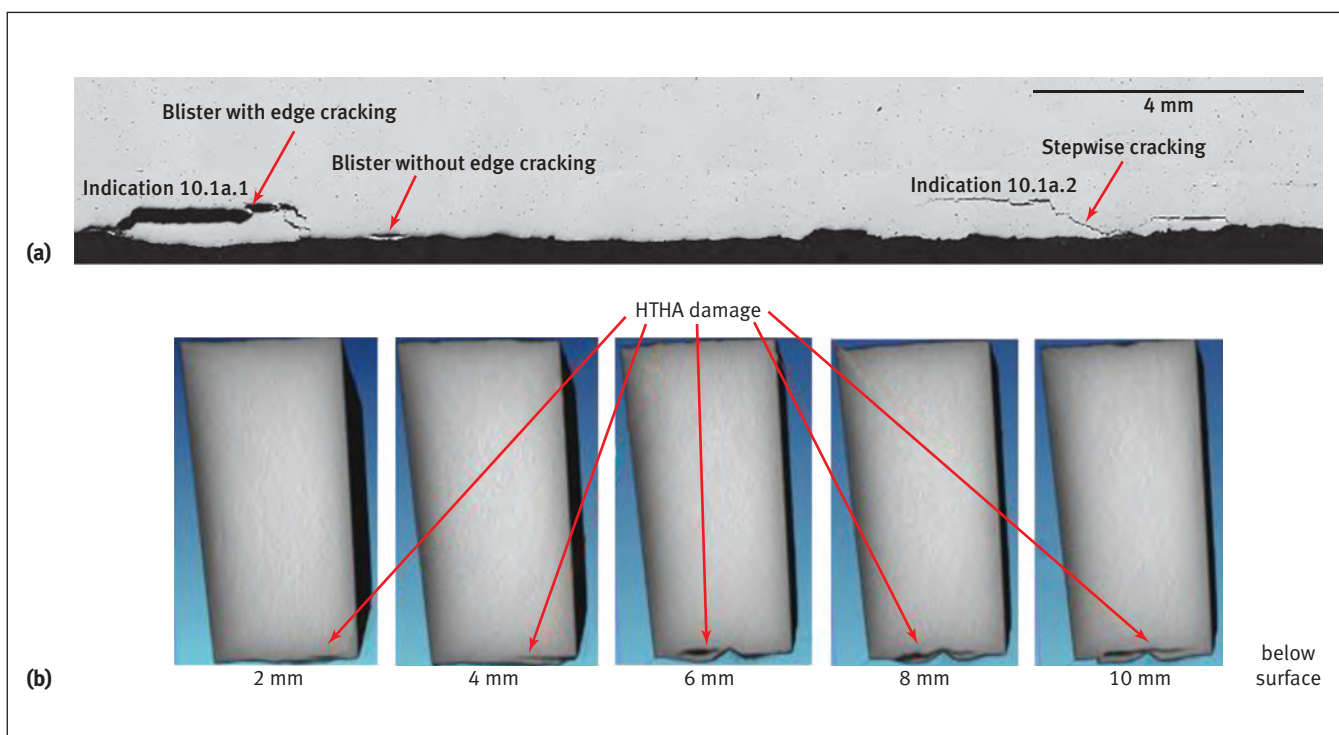
**Figure 9. Metallographic and CT images: (a) indications 10.1a.1 and 10.1a.2, ~10 $\times$ , as polished; (b) CT images of indication 10.1a.2 from 2 to 10 mm below the polished surface of the mount.**

The metallographic images for both indications are shown in Figure 9a. The enhanced detection and visualization capabilities of FMC/TFM and ATFM techniques at a higher frequency were validated metallographically. Indication 10.1a.1 was classified as two microblisters and 10.1a.2 as a stepwise microcrack. The complexity of the blistering and crack-wise morphology in the mount remnants was validated using CT. CT images of indication 10.1a.2 from 2 to 10 mm below the front polished surface of the mount are shown in Figure 9b.

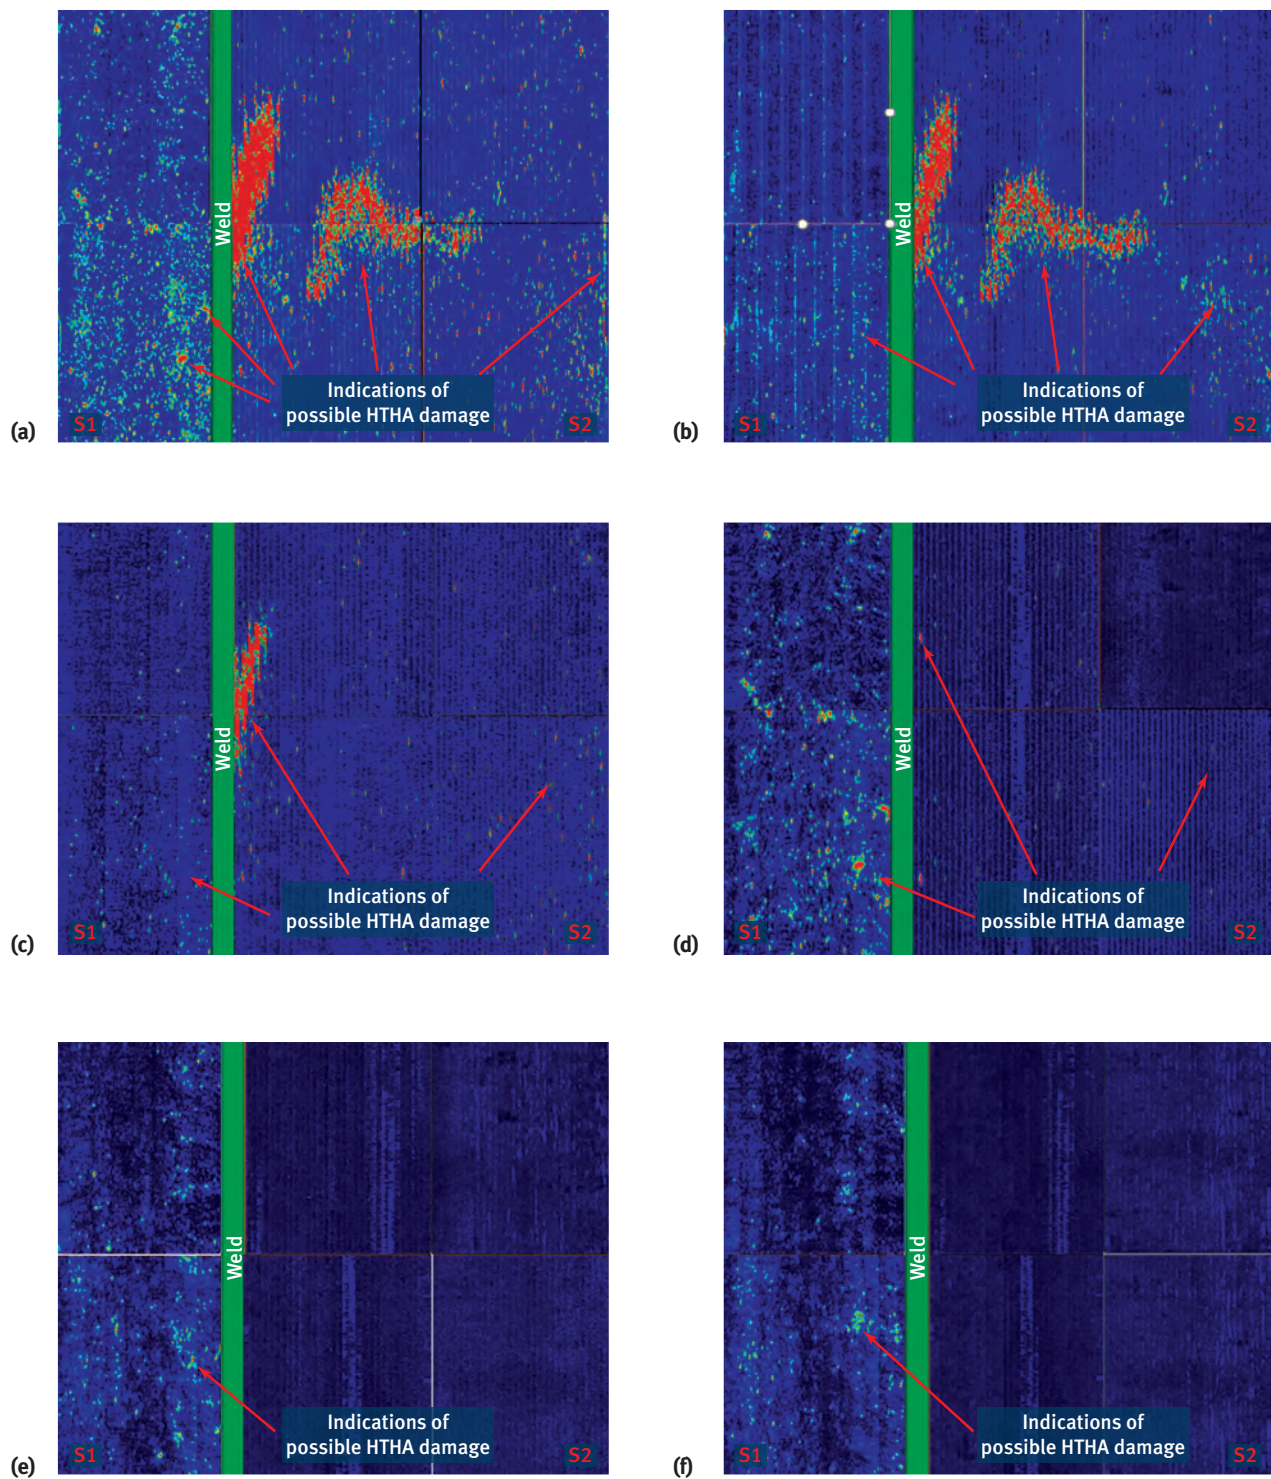
The 10 MHz FMC/TFM LL C-scan data analysis revealed widely spread, multiple indications of HTHA damage in the base material. In the south section of the drum, the localized blister-like damage had occurred in the base material and HAZ on both sides of the welds. The localized nature of the HTHA damage in one area of the south section and through-wall distribution is shown in Figure 10. FMC/TFM raster C-scans, through-wall thickness imaging, and the analysis determined that predominantly HTHA

damage in plate S1 is confined in less than 50% wall thickness, and plate S2 is limited in less than 20% wall thickness. A 3D TFM visualization of the expected blister-like damage is shown in Figure 11. An example of optical metallographic verification of micro- and macroblistering is shown in Figure 12a. Figure 12b shows a SEM image of voids formation and coalescence along grain boundaries at an early stage.

Figure 10. FMC/TFM imaging and HTHA validation of localized and through-wall distribution for the south section of drum: (a) 0% to 88% wall thickness (34 to 5 mm); (b) 0% to 5% wall thickness (34 to 32.3 mm); (c) 5% to 10% wall thickness (32.3 to 30.6 mm); (d) 10% to 20% wall thickness (30.6 to 27.2 mm); (e) 20% to 30% wall thickness (27.2 to 23.2 mm); (f) 30% to 50% wall thickness (23.2 to 17 mm).

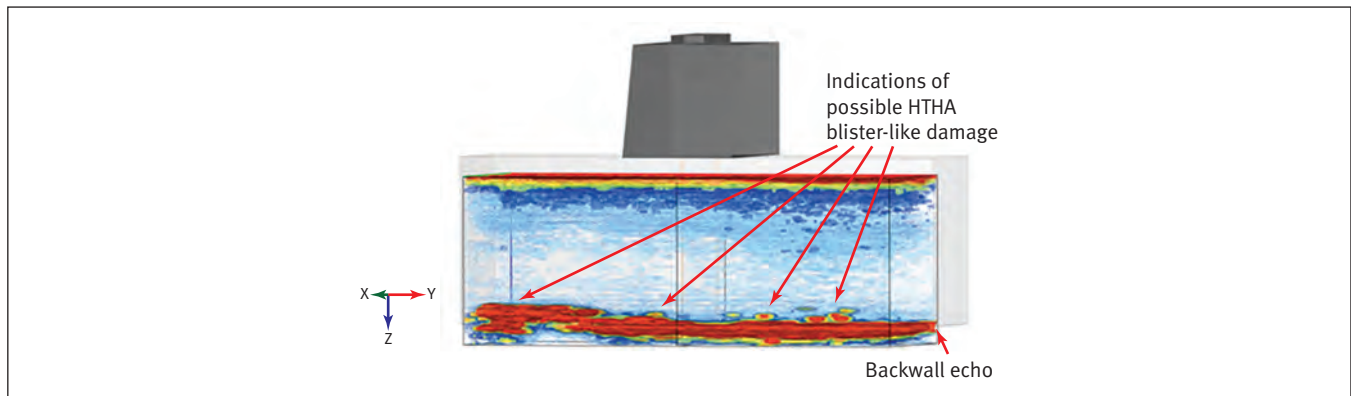
Figure 11. 3D imaging of possible blister-like damage.

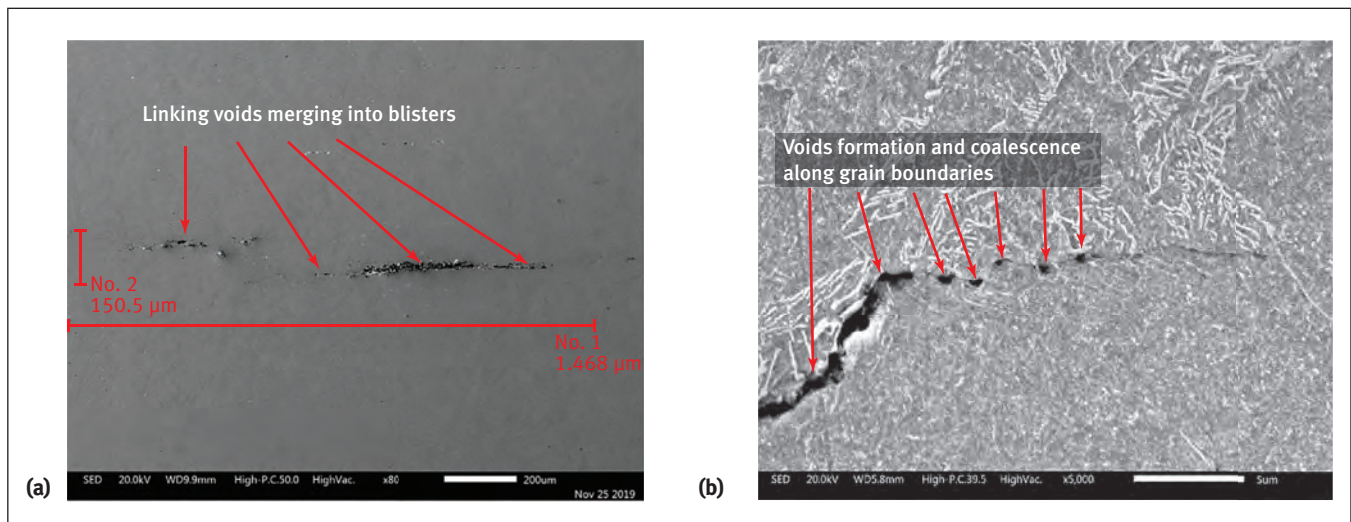
Figure 12. Optical metallography: (a) linking voids merging into blisters, ~80 $\times$ , as polished; (b) SEM validation of early-stage HTHA volumetric damage, ~5000 $\times$ , nital etched.

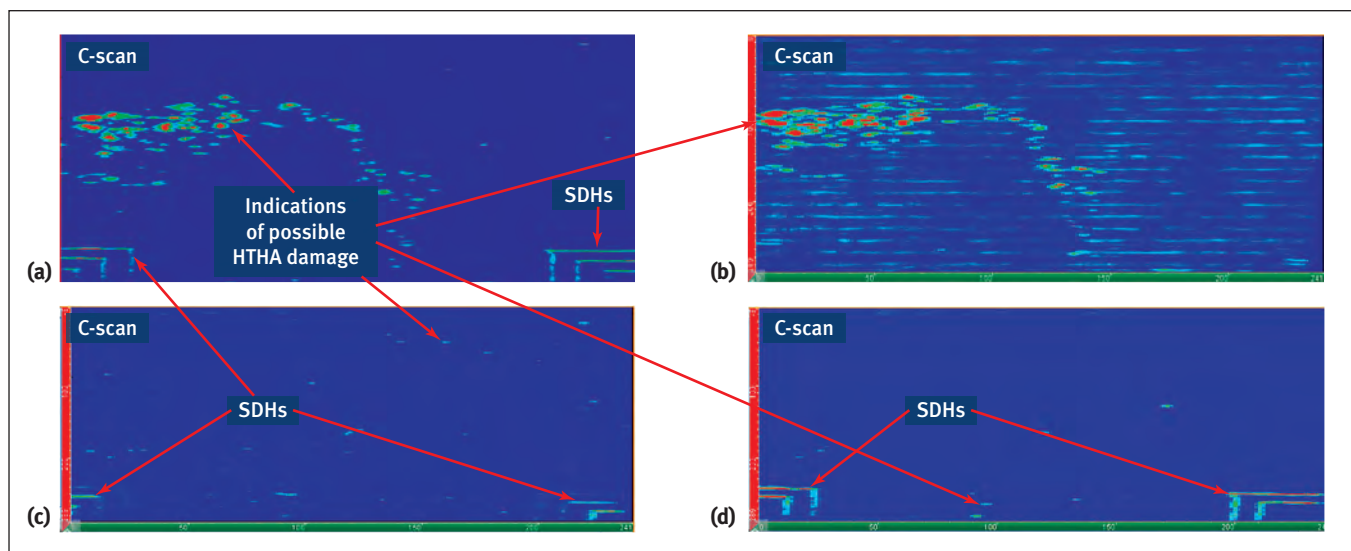
A less severe level of HTHA damage detected only in the base material of the north drum section is shown in Figure 13. The damage appeared as a “hockey stick” on the FMC/TFM raster C-scan image. Ninety-five percent of the indications were very shallow and compacted in 5% through-wall thickness. No indications were observed in a depth larger than 20% wall thickness. Six sets of reference SDHs that were manufactured in the front side of the plate were visualized at the bottom of the TFM images. The TFM line scan imaging (B- and D-scans) of the damage and a blister-like indication (N2-7.1.2; depth of 5.4 mm and length of 33.5 mm) are shown in Figure 14. Blister sizing based on 2D TFM multiview imaging suggested 10% to 20% larger dimensions compared to measurements using a digital caliper. A picture of visually observed scattered blistering (depth 1 to 3 mm and length 2 to 12 mm) is shown in Figure 15a. Reported larger TFM dimensions are due to bulging complexity and sharp blistering edges that were not contributing to the bulge’s visual appearance but subsidizing TFM imaging. An example of blister manifestation with sharp crack-like edges is shown in Figure 15b.

Figure 13. FMC/TFM imaging and HTHA validation raster C-scan imaging of possible HTHA damage localized and through-wall distribution for the north section of drum: (a) 0% to 70% wall thickness (34 to 10 mm); (b) 0% to 5% wall thickness (34 to 32.3 mm); (c) 5% to 10% wall thickness (32.3 to 30.6 mm); (d) 10% to 20% wall thickness (30.6 to 17 mm).

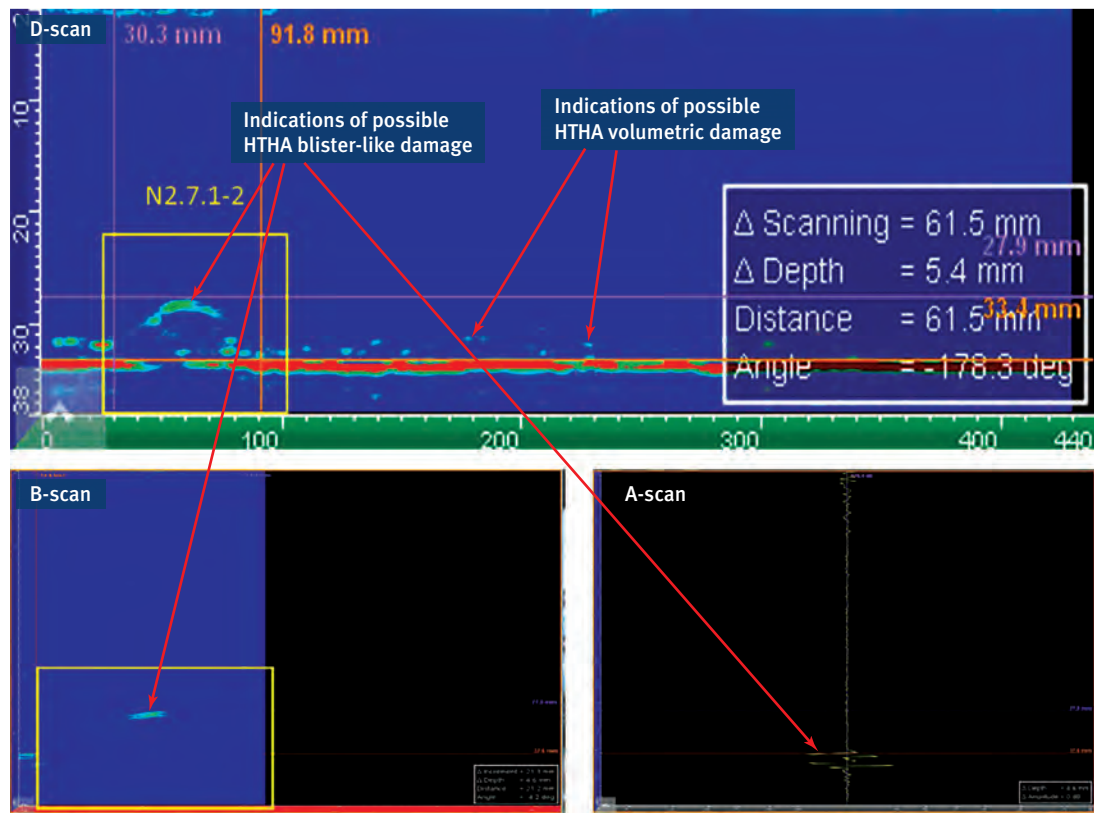
Figure 14. Line scan imaging of possible blistering with sharp crack-like edges.

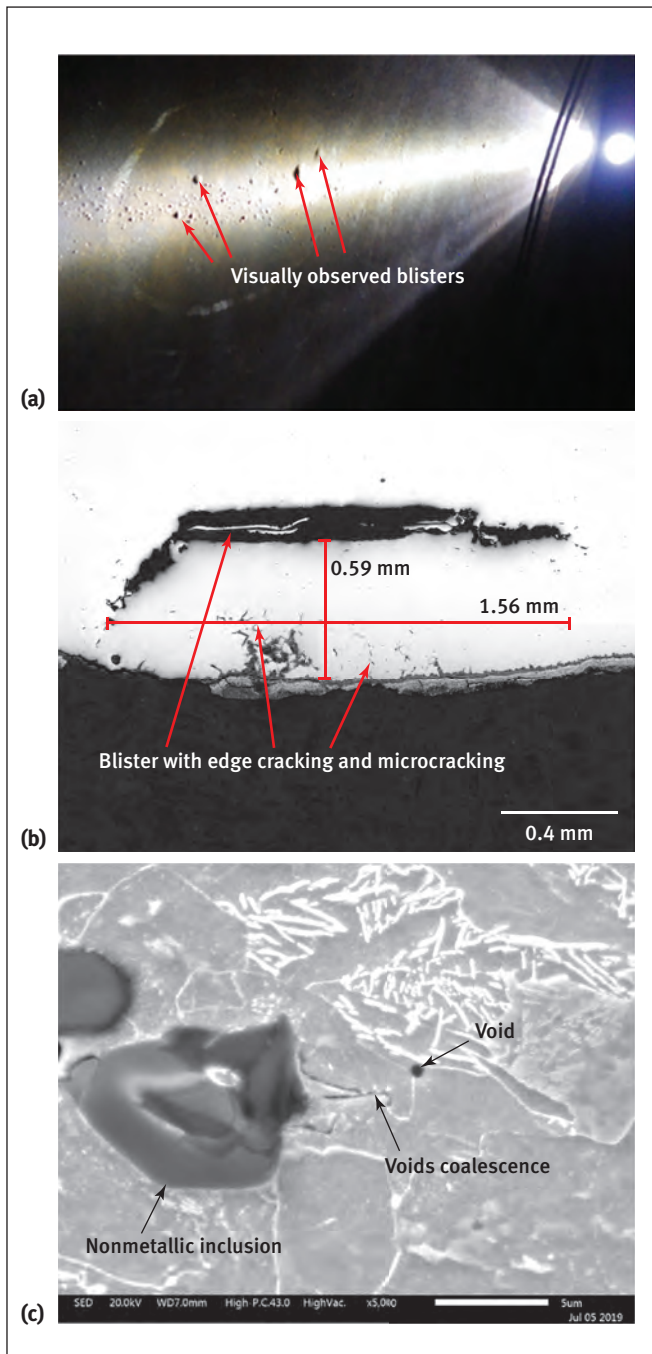
The SEM photograph revealing the presence of nonmetallic inclusions and evidence of early-stage HTHA damage of void formation and voids coalescence associated with the inclusion location ahead of the blister edges is shown in Figure 15c.

**Figure 15. Potential indications of HTHA: (a) visual validation of typical blister bulging; (b) optical metallography of blistering with sharp crack-like edges, ~50 $\times$ , as polished; (c) SEM of nonmetallic inclusions and evidence of early-stage HTHA damage of void formation and voids coalescence, ~5000 $\times$ , nital etched.**
