Vertical ridge augmentation with simultaneous implant placement in the central incisor area of the upper jaw

Dr. Norbert Hassfurth, Germany

Treatment plan: Vertical ridge augmentation with NeoGen® Ti-Reinforced Membrane - Medium Interproximal and simultaneous implant placement of Neoss ProActive® Straight implant.

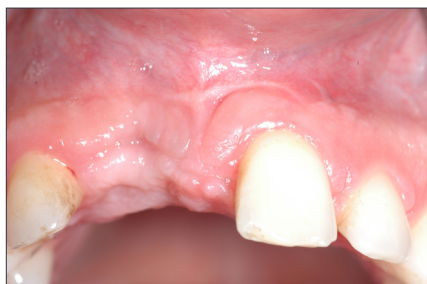
Figure 1

A 40 year old patient presented with a missing central incisor and a resorbed ridge (Figure 1). A full thickness flap with releasing incisions was opened, revealing a large vertical defect (Figure 2).

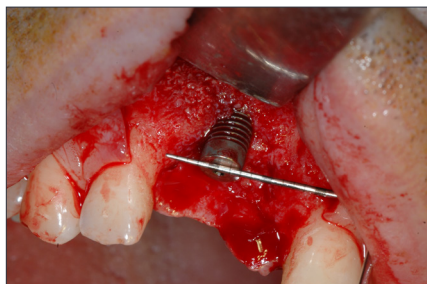
Figure 3

A Neoss ProActive® Straight implant was placed on an 8 mm vertical defect (Figure 3). Autogenous bone cylinders (3.4 x 4-5 mm) were harvested from the oblique line of the mandible in the molar region and placed around the implant to accelerate regeneration and to act as space fillers (Figure 4).

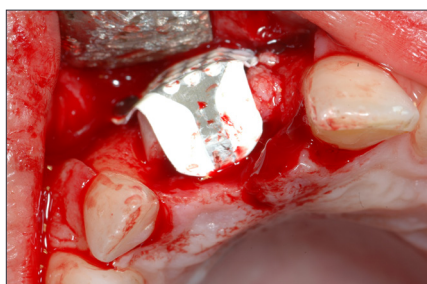
Figure 5

A Neogen® Ti-Reinforced Membrane Medium Interproximal was trimmed, shaped, and fitted at the surgical site and secured buccally with two tacks (Figure 5). Stress free flap closure was achieved by releasing the periosteum on the buccal side (Figure 6).

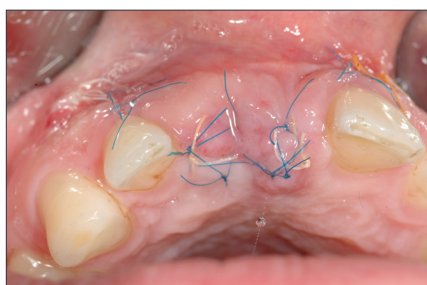
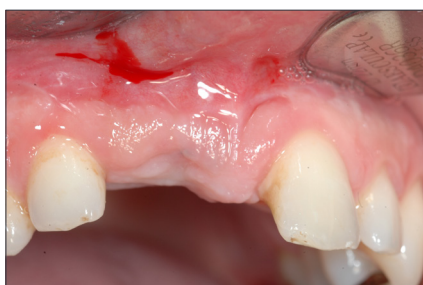
The soft tissue healing was uneventful (Figure 7-8).

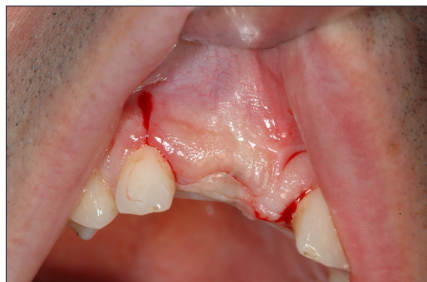
Figure 9

After 6 months, second stage surgery was performed. A mid-crestal incision with releasing incisions was used (Figure 9). The flap was lifted to expose the membrane (Figure 10). The soft tissue can easily be separated from the membrane after healing.

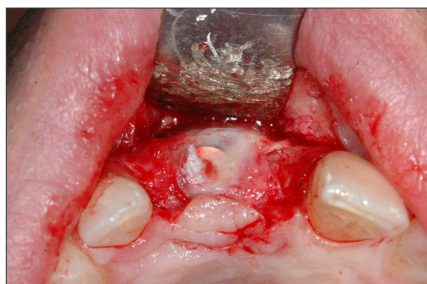
Figure 11

The membrane was removed. Newly formed bone fills the entire space created by the membrane (Figure 11). Excess bone on top of the cover screw was removed to get access to the implant (Figure 12).

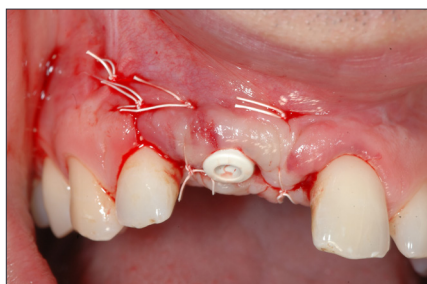
Figure 13

A PEEK healing abutment was connected to the implants and the flap was closed (Figure 13). Radiograph taken directly after abutment connection shows that bone has been successfully regenerated up to the level of the implant platform (Figure 14).
