South Australia Quarry

Decreases Maintenance Time, Increases Productivity With Flexco Solution

LOAD ZONE DAMAGE HALTS PRODUCTION

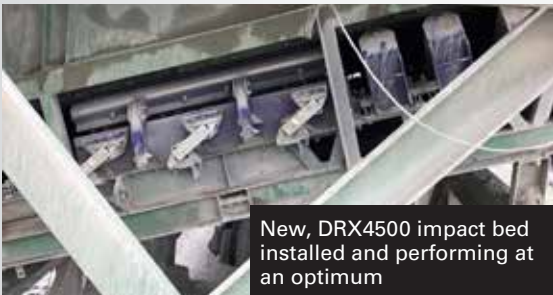
New, DRX4500 impact bed installed and performing at an optimum

However, for this application, the impact energy was far greater than the acceptable and safe standard of the largest, DRX 3000 bed, so a custom solution was made with extra support in the impact bars and impact energy absorber mounts. The custom solution offered the same benefits of the rest of the DRX line of beds, and was designed and manufactured in Australia.

After the custom DRX 4500 bed was installed, the site saw an outstanding amount of change. The biggest and most impressive difference in operation was that the belt could now run 24/7. Since the product was installed, the site has only performed planned maintenance and scheduled shutdowns. This results in not only higher output tonnages, but less need for maintenance, allowing maintenance crews to focus their time and knowledge on other areas of the site instead of reacting to the same issue repeatedly.

Due to the fact that the new impact bed is more than adequately supporting the tonnages seen by the belt – there is no need to replace the idler frames, impact bed support bars, or the belt.

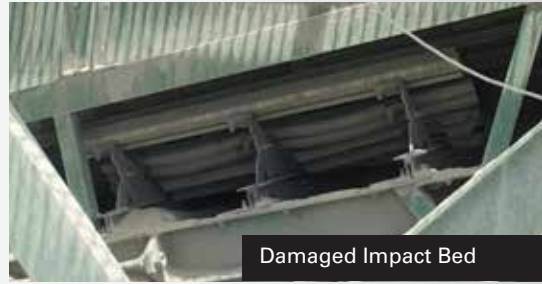
The impact bed that was originally installed was not strong enough to support the extreme tonnages the load point saw day in and day out. As a result, the idler frames would break every few weeks and the belt quickly became severely damaged – to the point of needing replacement. The idler frames would also have to be replaced every 4 to 6 weeks, with shutdowns occurring at the same rate, to replace the frames and repair or replace the belt. The belt itself was even replaced and upgraded multiple times to try and combat this issue.

Damaged Impact Bed
