Flexco Defeats Dust in Local Quarry Operation

Partners in Productivity

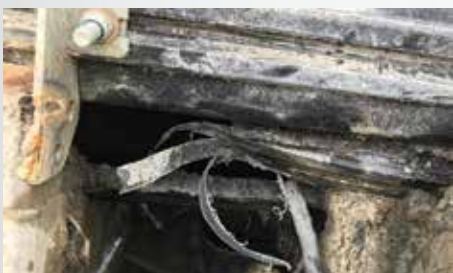
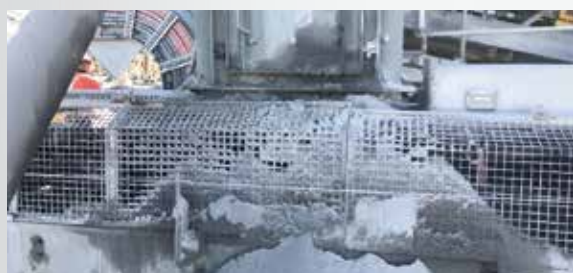
Skirt damage and spillage issues with previous system

Apart from maintenance issues, the previous system was also insufficient in protecting the belt conveyor system against serious safety and productivity issues such as spillage. The spillage on the current system was immense, making it difficult to conduct maintenance tasks safely. The severe levels of spillage also resulted in a loss of profit due to wasted and unsellable aggregate material. In addition to these issues, the spillage caused a material build up on one side of the conveyor belt, causing the belt to mistrack – damaging the soft skirt and also the conveyor structure.

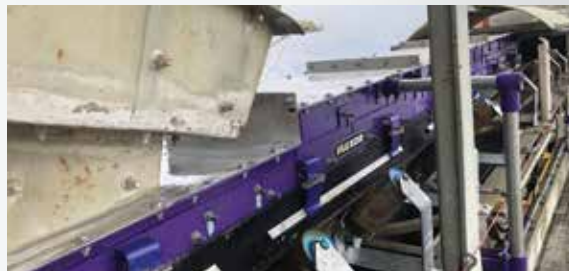
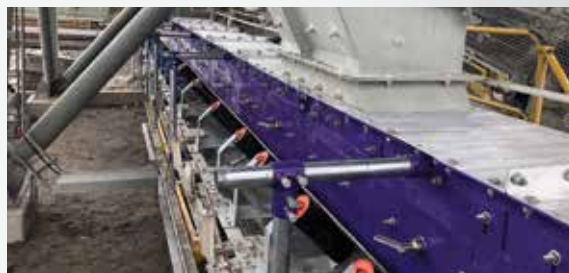
New Flexco Enclosed Skirt System

In addition to ease of installation, the simplicity of the design meant production time no longer had to be compromised to complete maintenance tasks such as soft skirt changes out and adjustments. The system also incorporates easily adjustable hardskirts for longer-wearing side panels.

Local distributor Fenner Dunlop installed a Flexco enclosed skirt system with great ease due to the simple, yet effective design of the product. Dean Callaway, Sales Manager for Fenner Dunlop Wollongong, oversaw the project and states that it took only two, 12-hour shifts to complete the installation of the 13-metre enclosed skirting system.
