CLIENT: **EasyTrim Reveals**
 4115 72 Ave SE
 Calgary, Alberta, Canada, T2C 2G5

Test Report No: RJ4491-REV 1 **Original Issue Date: May 3, 2016**
Revised issue Date: May 31, 2016

SAMPLE ID: EasyTrim wall cladding system with Alucoil LARSON ACM 4-mm thick Fire Rated (FR) and 4-mm thick Polyethylene (PE) core panels.

TEST REQUESTED: ASTM E330-14 *Standard Test Method for Structural Performance of Exterior Windows, Doors, Skylights and Curtain Walls by Uniform Static Air Pressure.*

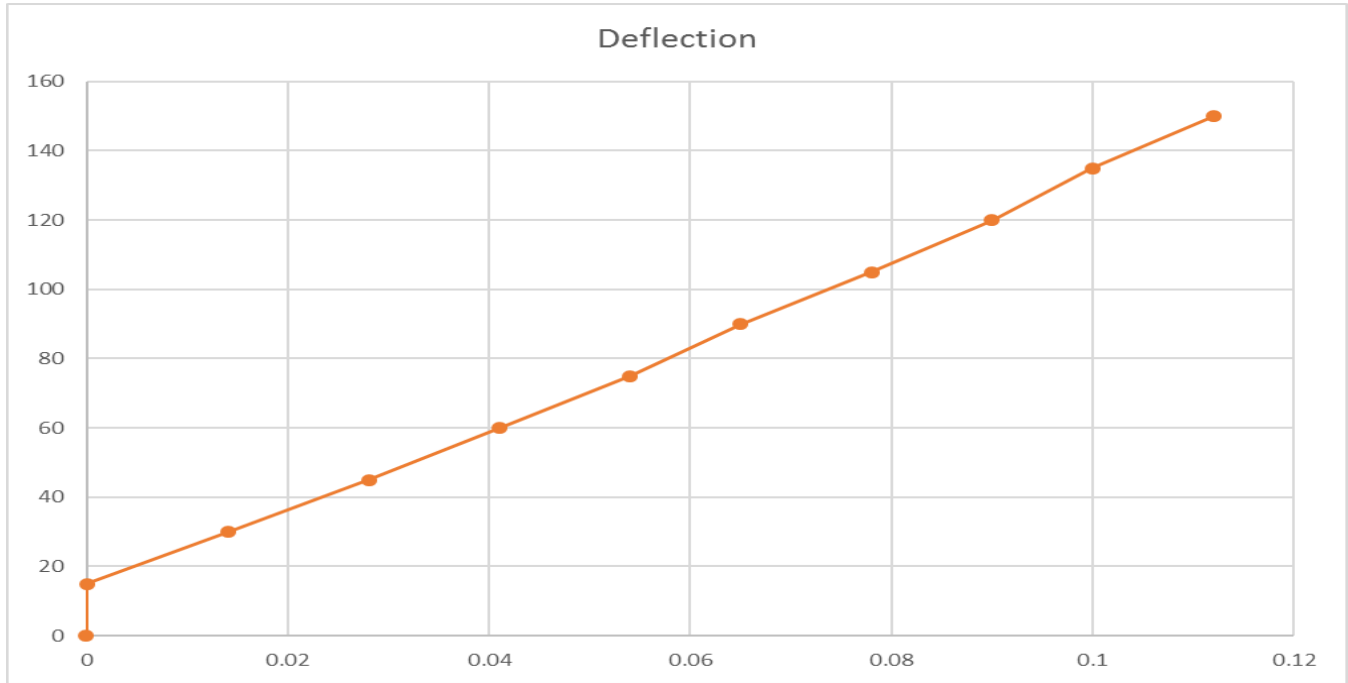
Assembly 1-Test 1 Load-Deflection Graph: 4' x 8' 4mm LARSON PE ACP with EASYTRIM ALUMINUM EXTRUSION in Positive Load Direction

Test Assembly & Test No.	Load Direction	Load L/60 Midspan (psf)	Ultimate Load (psf)	Allowable Load ⁽¹⁾ (psf)	Comments/Mode of Failure
Assembly 1-Test 1	Positive	Not Applicable	N/A	N/A	Assembly deflection limiter restricted further deflection of panel, failure of system could not be achieved.
Assembly 1-Test 2 ⁽²⁾	Negative	18	76	38	PE core panel pulled out of back plate / top cap trim assembly at one side of the panel. Back plate / top cap trim assembly remained intact. See photograph #5
Assembly 1-Test 3	Negative	18	97	49	PE core panel pulled out of back plate / top cap trim assembly at one side of the panel. Back plate / top cap trim assembly remained intact. See photograph #5
Assembly 1-Test 4	Negative	19	77	39	PE core panel pulled out of back plate / top cap trim assembly at one side of the panel. Back plate / top cap trim assembly remained intact. See photograph #5
Average		18	83	42	
Standard Deviation		1	12	6

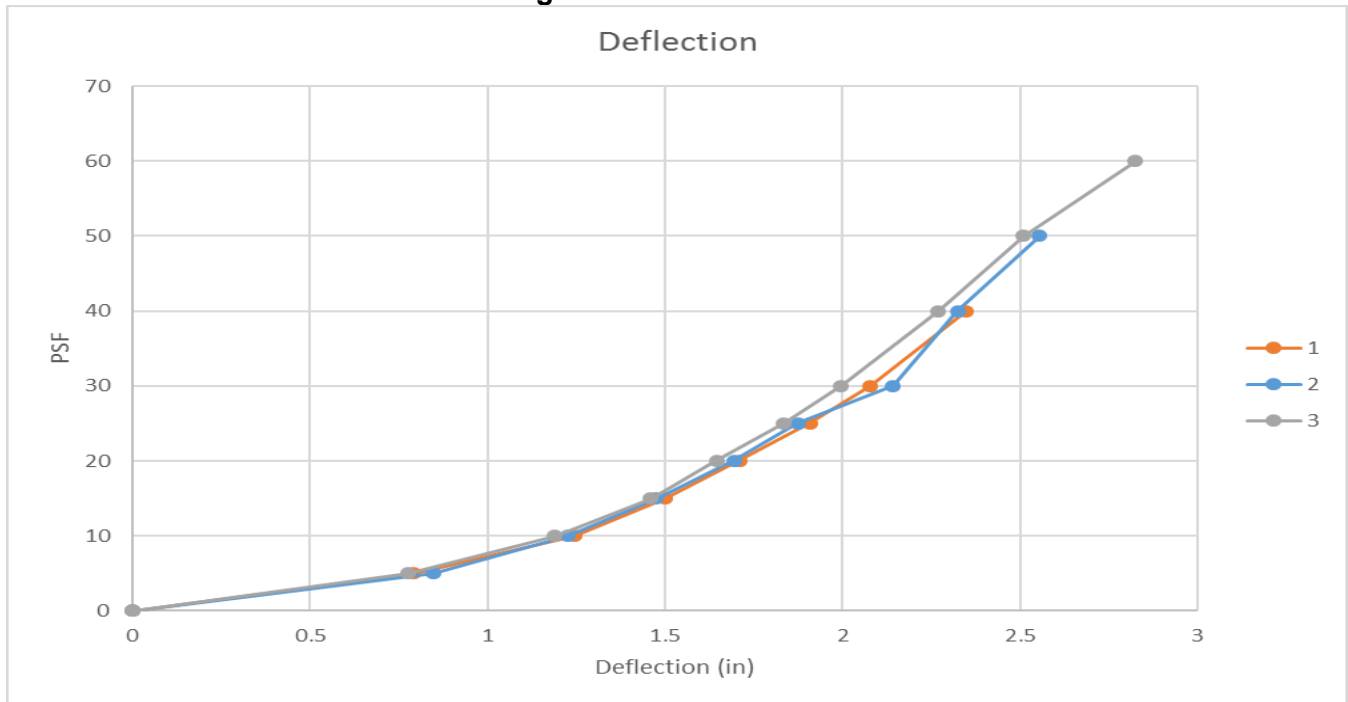
Assembly 1-Test Nos. 2 through 4 Load-Deflection Graph: 4' x 8' 4mm LARSON PE ACP with EASYTRIM ALUMINUM EXTRUSION in Negative Load Direction
