New Advances in Novel Polymeric Alloy Geocell-Reinforced Base Course for Paved Roads

Paper prepared for presentation

of the 2017 Conference of the  
Transportation Association of Canada  
St. John's, NL

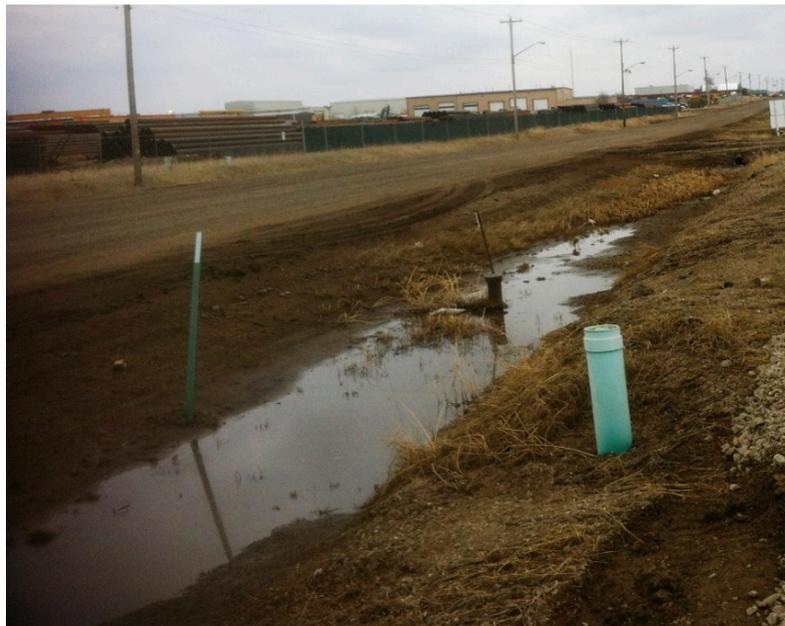
Figure 2: Condition of the seventh street before rehabilitation (picture taken in April 2012)

Although the entire length of the 7<sup>th</sup> street experiences very heavy traffic, the road on the north of the railway line where the granular base was reinforced with NPA geocell is exposed to some additional traffic load especially because of the traffic to a pipe yard and the County's water filling area. Figure 2 shows the condition of the road before the new pavement construction in 2012.

Construction of this project took place in July and August of 2012. The existing road was in very poor serviceability condition. The subgrade of the existing road was scarified and used as the subgrade of the rehabilitated road structure. NPA geocell was placed and infilled with new granular material to construct a reinforced base layer. A layer of woven geotextile was used under the NPA geocell as a separator between the base and subgrade. The GBC was 200mm thick and was reinforced with 150mm high NPA geocell. In the CTB side a minimum 16kg of Portland cement per square meter of the surface area was used to mix with soil to build the stabilized base course. In both the sections a 100mm thick asphalt concrete layer was recommended but the County decided to pave with 65 mm of asphalt concrete as the first paving stage and overlay the remaining in the future. The design recommendation was based on AASHTO (1993) method with a modulus improvement factor of 3.5 for the NPA geocell reinforced base course compared to the unreinforced granular base. Figures 3 shows the pavement cross sections of CTB and NPA geocell-reinforce GBC of the road and the photographs in Figures 4 shows the road at different stages of the construction that includes the stretching of NPA geocell, infilling of GBC material and compacted base course surface.

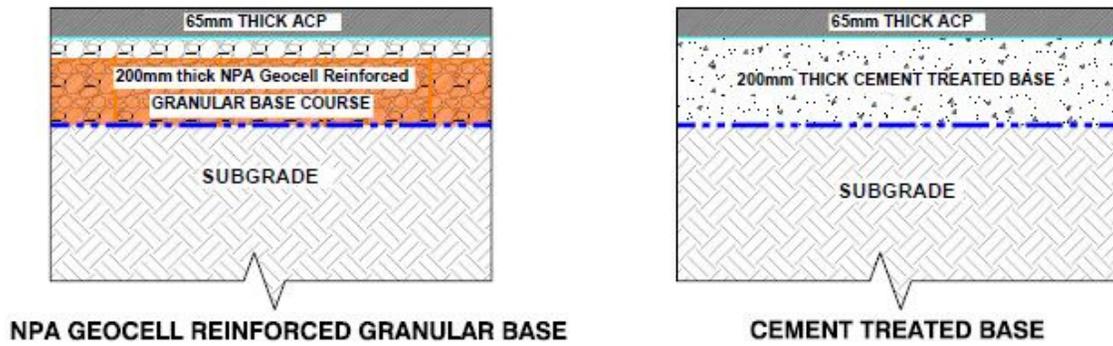
Figure 3: Cross sections of the Test sections

The CTB section was constructed by the County of Leduc as per their conventional construction practice. On the Geocell reinforced section the subgrade was rolled and graded before placing the woven geotextile separation. NPA geocell was then stretched on top of the separation layer and infilled with the granular material. The granular fill was compacted to 98% of the standard Proctor maximum dry density (SPMDD) within +/-2% of the optimum moisture content.

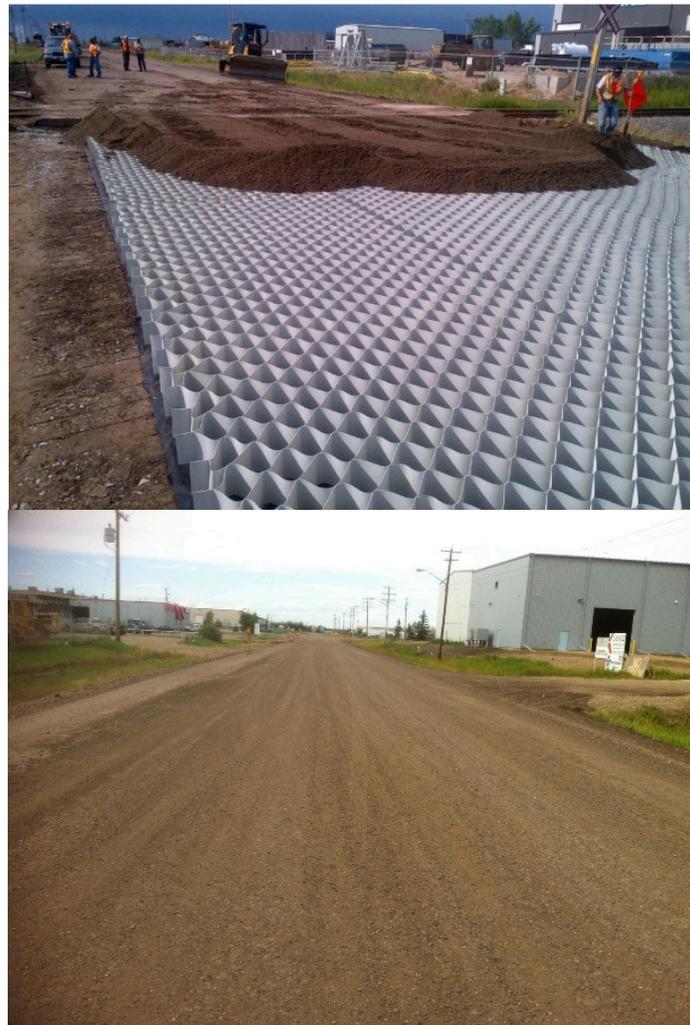
Figure 4: Fully stretched NPA geocell (top) and compacted NPA geocell-reinforced base (bottom) (picture taken in July 2012)

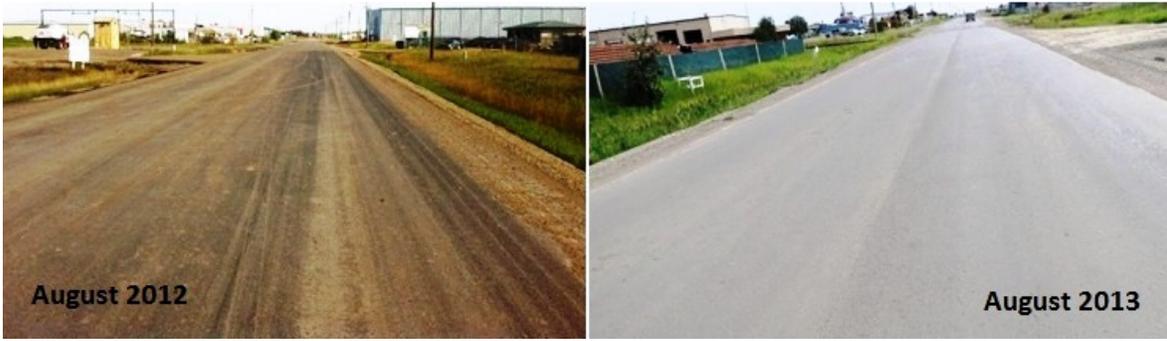
Figure 5: Paved road surface on NPA geocell-reinforced base (August 2012 and August 2013)

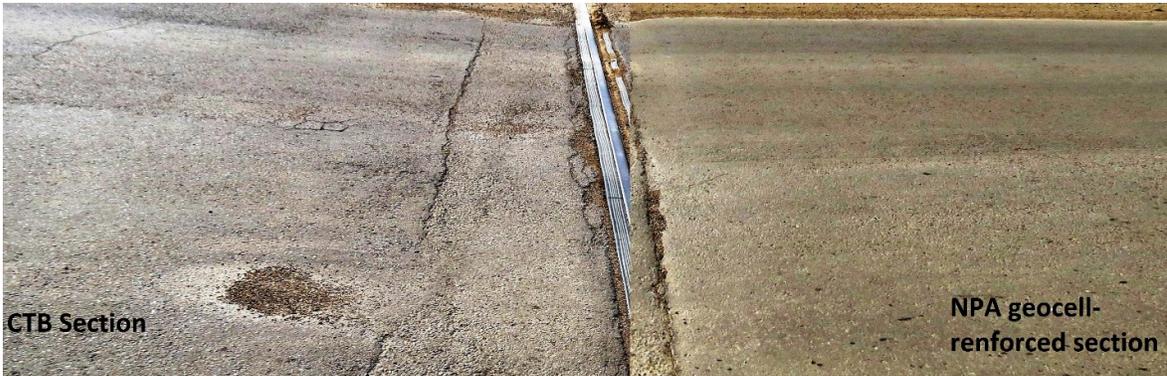
Figure 6: CTB section on left and NPA Geocell-reinforced on right side of rail track (Picture taken on August 2013)

The FWD results from different tests had so much variations that it was not possible to draw a clear conclusion regarding performance of these road sections solely based on these tests. Therefore, the authors decided to regularly monitor the performance of NPA geocell-reinforced section of the road until ACP overlay was done by the County in 2016. There were no signs of rutting or surface distresses on the NPA geocell-reinforced side and it was performing without any problem for first three years of operation until the overlay. Some pictures from the test sections in the Figures 5 through Figure 8 show conditions of these road sections. These pictures are self-explanatory of the road condition before, during construction and after the road was opened to traffic operation for three subsequent years. Figure 5 shows the condition of NPA geocell-reinforced side after construction in August 2012 and a year after in August 2013. The driving surface was smooth and the visual observation showed no sign of any pavement distress in the entire 500m length of this section. A comparison of the CTB and NPA geocell reinforced section one year after the construction in August 2013 either side of the railway track is shown in Figure 6. The pictures clearly show the deteriorated condition with surface distress on the CTB side and no issue on the NPA-Geocell

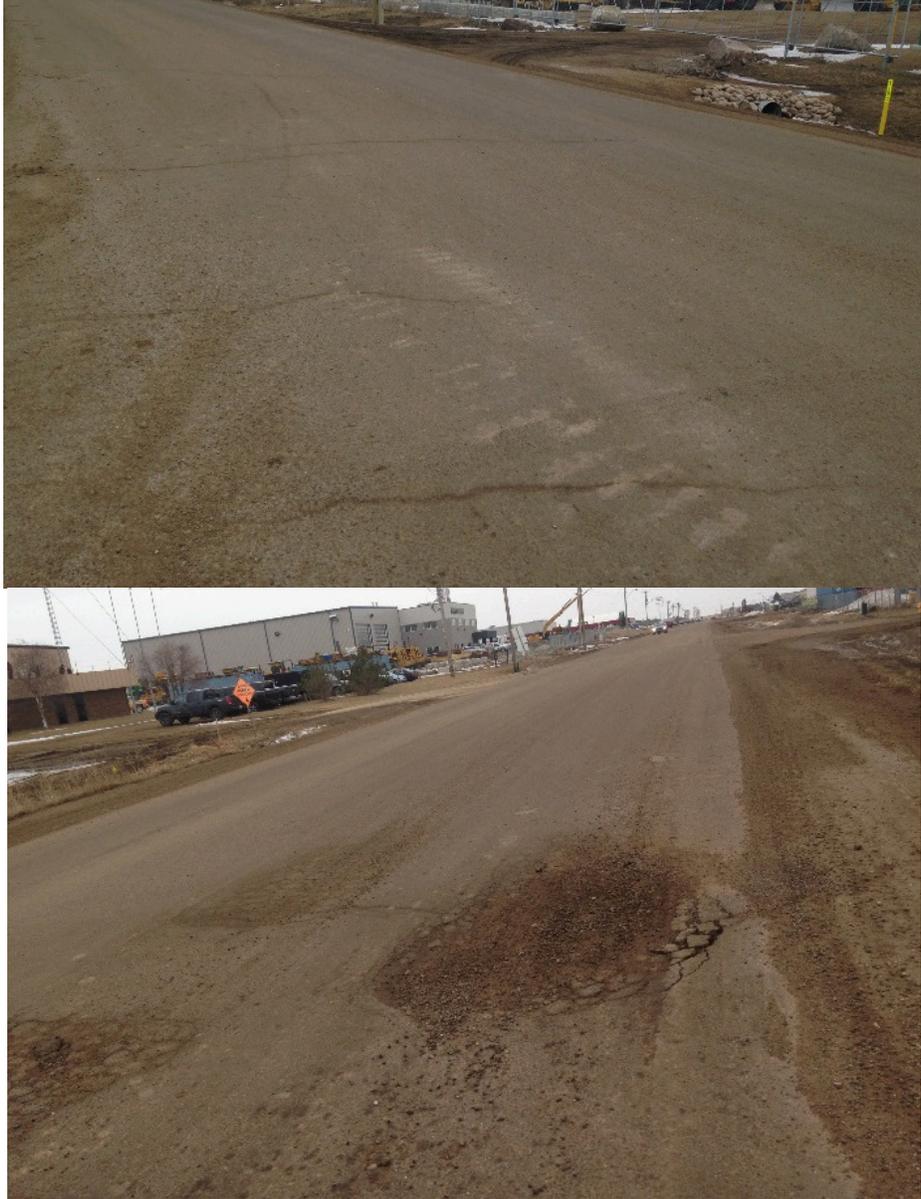
Figure 7: Pavement failures on CTB section in March 2015

reinforced side. Photographs in Figure 7 and Figure 8 were taken in March 2015. There were longitudinal and transverse cracks and a completely damaged pavement section on the CTB side but the NPA geocell reinforced did not have any visible rut or distress and the surface was smooth for driving.

Although, as expected, the results from the initial FWD tests showed the CTB section to be stronger than the test section with NPA geocell-reinforced GBC, the rate of deterioration of the pavement surface in the proceeding years was quicker in the CTB section. The pavement distresses in the CTB section had initiated even before completing a full year of service. By the end of the second year, there were a couple of areas with severe pavement distresses in the CTB side close to the railway track but nothing like that was observed on the NPA-geocell-reinforced side. CTB is usually expected to show higher stiffness values but the main problem with it is the shrinkage cracking. The failure of pavement on the CTB side that was observed on the CTB side was mainly the reflection of the shrinkage cracking. However, even in that condition after three years of operation the FWD test was showing similar strength values on both the test sections. In the absence of other tests the County, in this case, used the results from the FWD tests to decide on overlay requirements. Therefore, in the summer of 2015 the County placed ACP overlay in both of these test sections to meet the originally designed 100mm of ACP thickness. However, the authors based on the several field observations supported by the pictures in Figures 6, 7 and 8, believed that the road on the NPA geocell-reinforced side still was in good serviceability condition. As evidenced by the pictures and site observation the CTB side had some surface distress, longitudinal and transverse cracks and even pot holes in a couple of locations which needed rehabilitation.

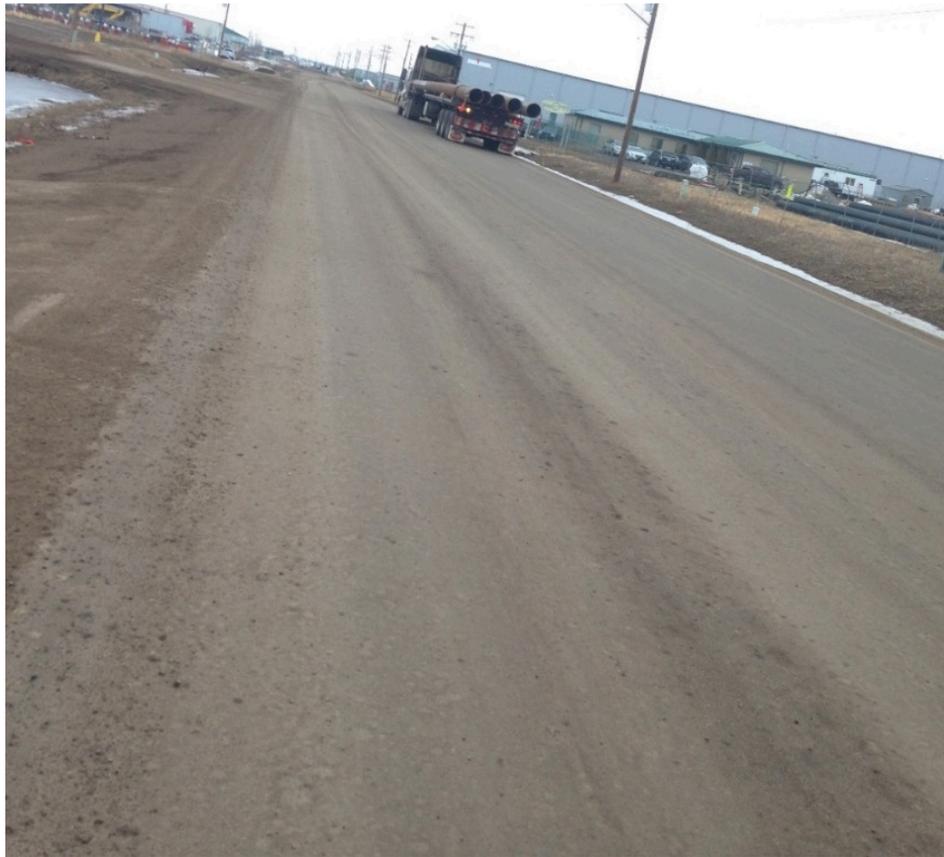
Figure 8: NPA Geocell-reinforced section in March 2015
