Delo® Testimonial: Golden Arrow Bus Services

**Achieves 630,000 kilometres in severe service in a
MAN Bus using Caltex Delo® family of products.**

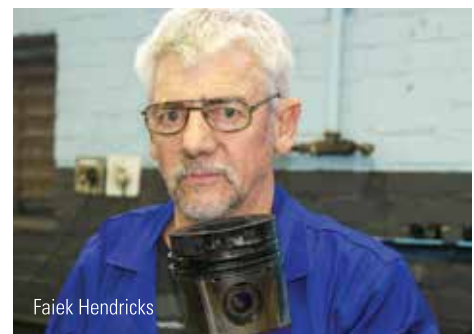
Piston Liners Exterior

Delo® XLC Extended Life Coolant also helps protect the engine cooling system on this bus. Inspection of the cooling system revealed that Delo® XLC prevented cavitation pitting on the liners and water pump impeller. The engine cooling system showed no signs of deposit build-up or corrosion on key metal parts. Additionally, the outsides of the piston liners are in very good condition with no visual sign of pitting or corrosion.

No visible pitting or corrosion showing the excellent protection provided by Delo® XLC.
