# Assessment of High-Temperature Hydrogen Attack Using Advanced Ultrasonic Array Techniques

by M.G. Lozev<sup>\*††</sup>, G.A. Neau<sup>†</sup>, L. Yu<sup>‡</sup>, T.J. Eason<sup>‡</sup>, S.E. Orwig<sup>††</sup>, R.C. Collins<sup>‡</sup>, P.K. Mammen<sup>††</sup>, F. Reverdy<sup>†</sup>, S. Lonne<sup>§</sup>, C. Wassink<sup>†</sup>, H. Cence<sup>¶</sup>, and J. Chew<sup>‡</sup>

## ABSTRACT

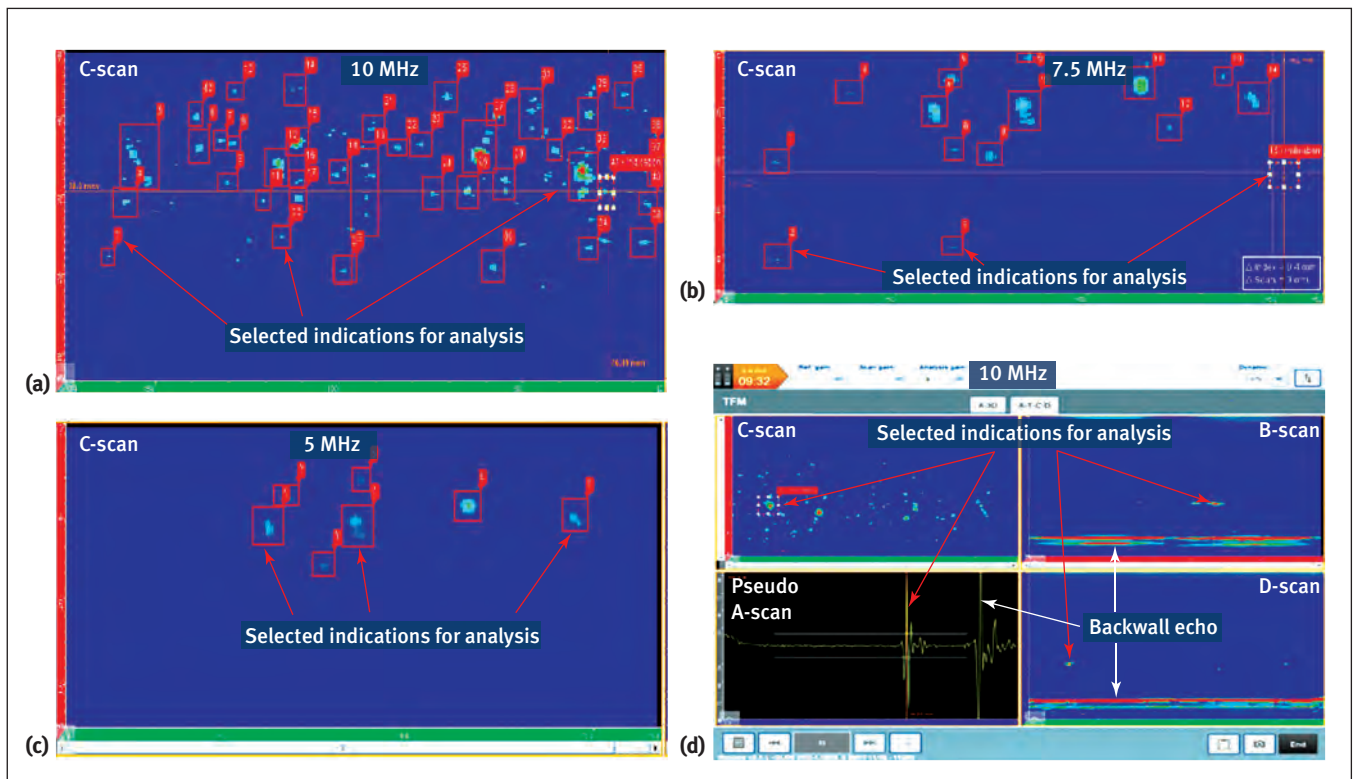
Figure 4. FMC/TFM LL imaging of damage block: (a) 10 MHz projected C-scan; (b) 7.5 MHz projected C-scan; (c) 5 MHz projected C-scan; (d) 10 MHz split screen imaging of selected indication showing projected C-scan, single-plane B-scan, single-plane D-scan, and pseudo A-scan.

The blocks were inspected using the array techniques before and after the synthetic HTHA damage was introduced. The best detection results were obtained using 10 MHz linear and matrix probes, and the FMC/TFM technique in LL path/mode. The 10 MHz FMC/TFM projected C-scan is shown in Figure 4a. More than 100 micro and macro indications were identified (shown in boxes). Only 30% of the indications were observed on the projected C-scan created by using a lower-frequency 7.5 MHz linear array probe (Figure 4b), and only 10% of the indications were detected when using a 5 MHz linear array probe (Figure 4c). These images demonstrated the decrease in detectability and resolution at a lower frequency and the potential increase of the sizing error.

Figure 4d illustrates a split screen analysis using a C-scan, a single-plane B- and D-scan, and a pseudo A-scan. One large indication of HTHA microdamage was selected for analysis and boxed in the projected top view image shown in the top-left corner of Figure 4d. The red color of the image indication is a sign of strong reflected and diffracted signals from the damage and was confirmed by pseudo A-scan (Figure 4d, bottom left). The same indication is marked with a crossing of X/Y measuring cursors in the single-plane side view (Figure 4d, top right) and front view (Figure 4d, bottom right). This indication is relatively near to the hot surface of the block,
