HEAD RUSH TECHNOLOGIES WHITE PAPER

PULLEY AND TROLLEY INSPECTION

JUNE 2020

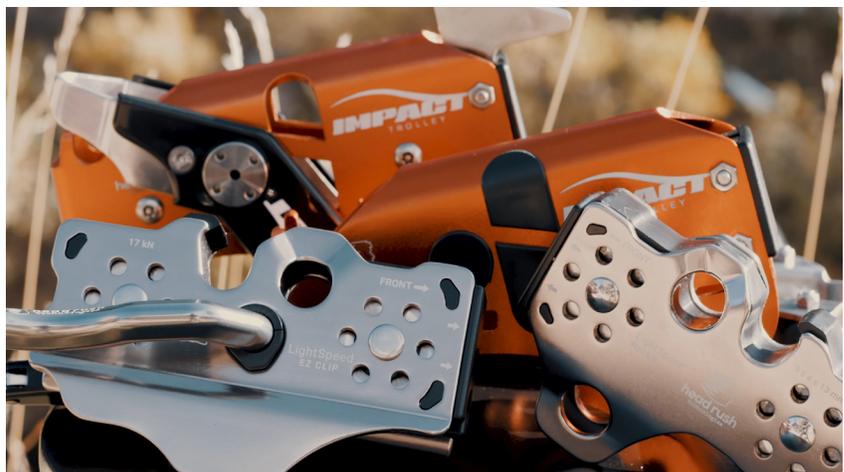
All Head Rush Technologies' zip line rider trolleys and redirection pulleys are built for maximum durability and minimal maintenance, and regular inspection is a critical step to ensure users get the maximum benefit of these products. This white paper is meant to supplement the user manuals for the LightSpeed Impact, EZ Clip, and Micro zip line trolleys and Head Rush Precision Redirection Pulley.
