NEW Water Infiltration and Inflow Program Workshop

I&I Overview

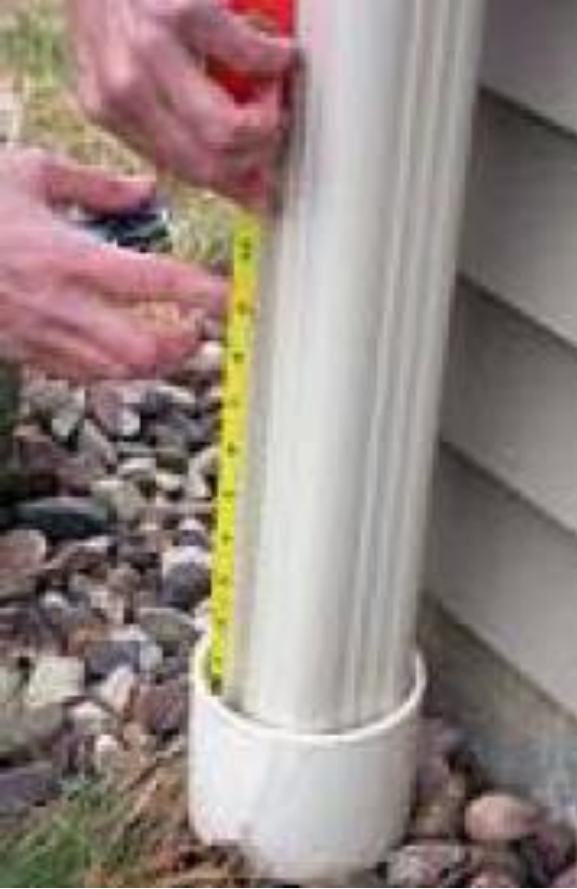
Connected downspout

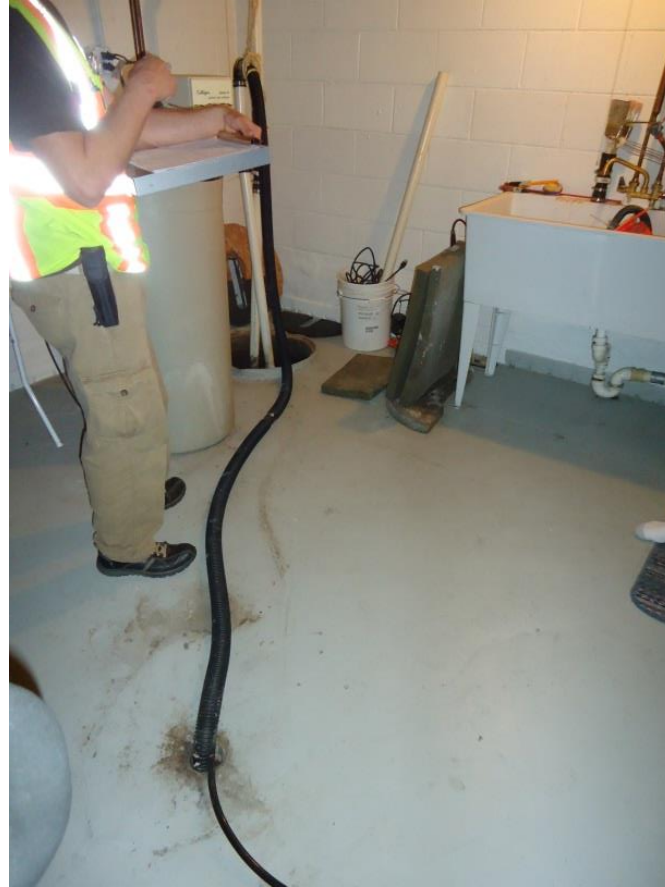
**Clear water sump discharge
Connected to sanitary sewer**

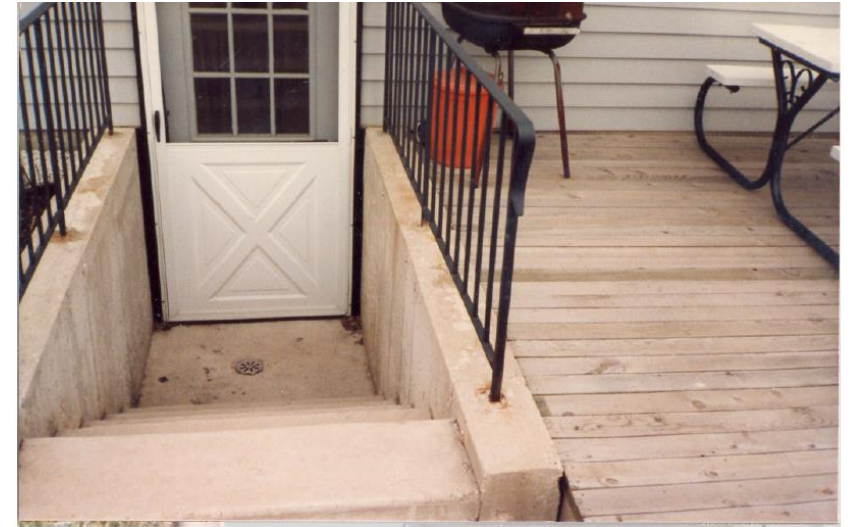
Stairwell with drain

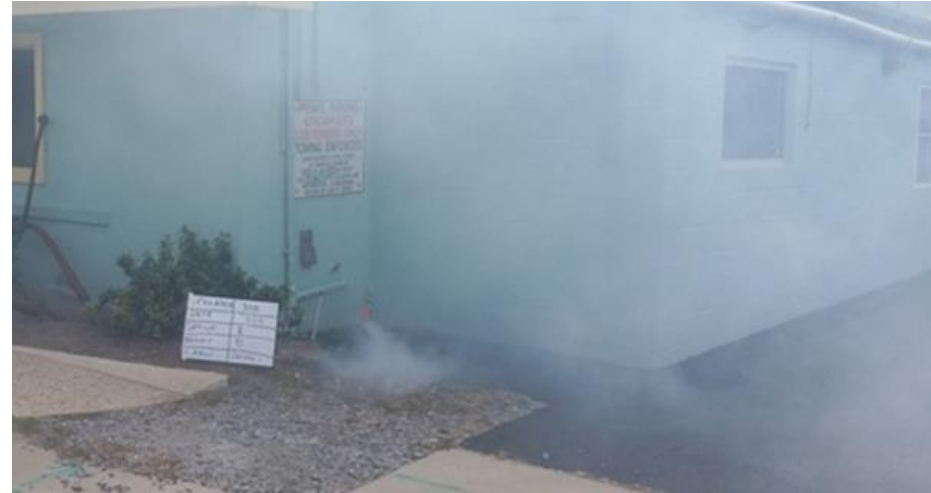
Smoke Testing

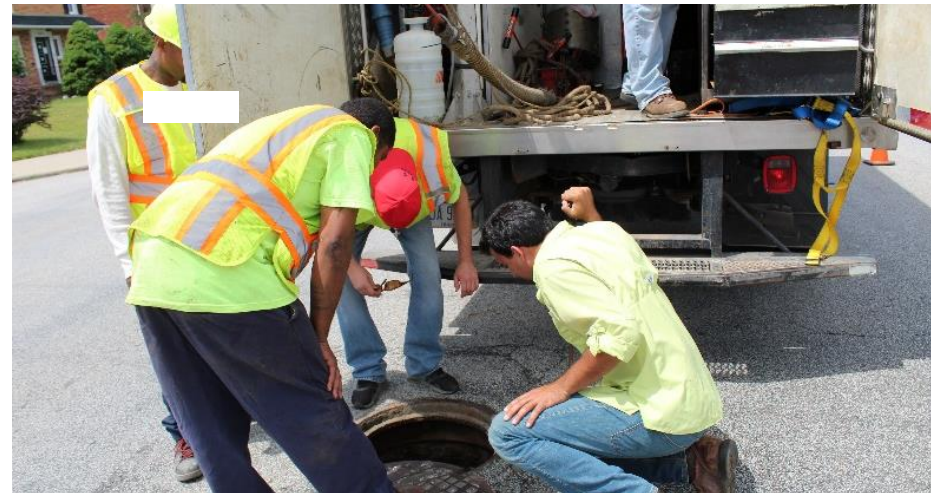
Manhole Inspection

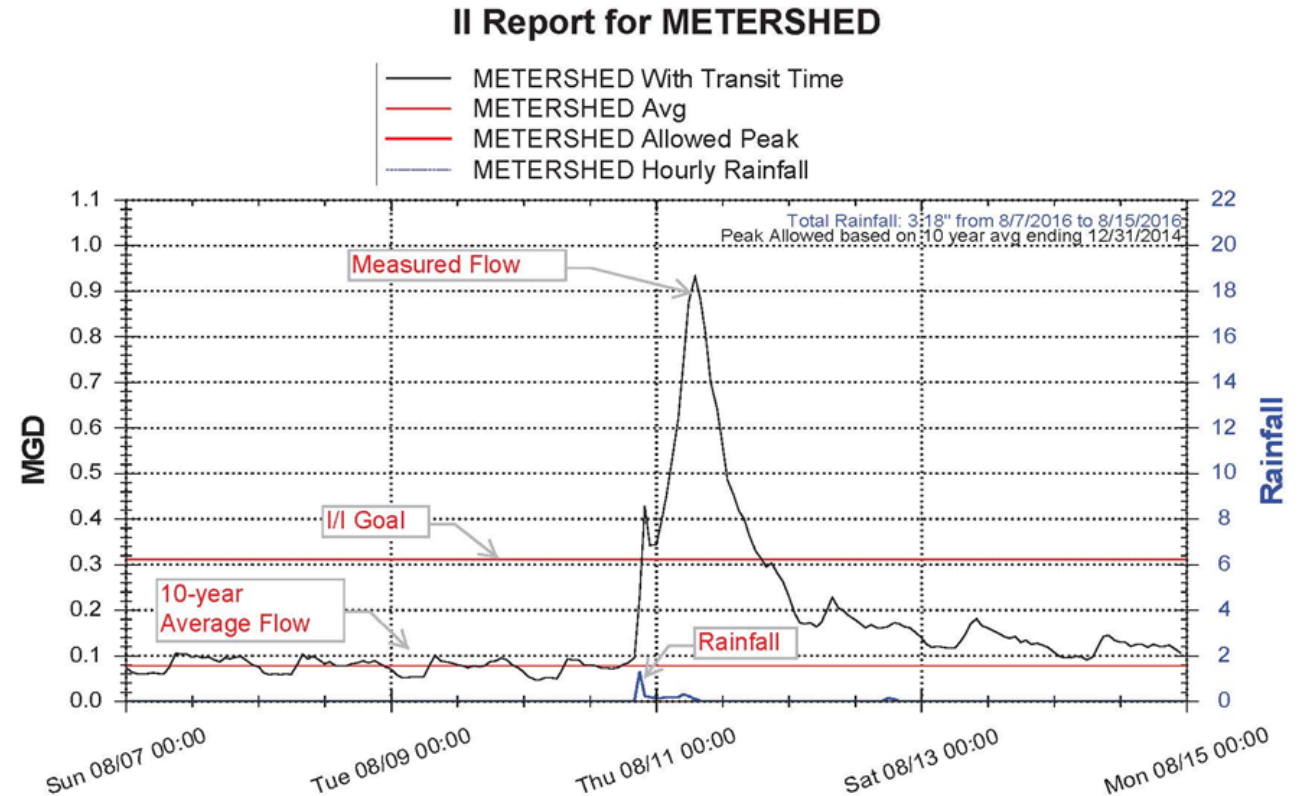
- Foundation of an effective I&I program
- Identifies where to investigate further
- Measures compliance with I&I standards
- Measures large areas at one time
- Relatively inexpensive investigation method

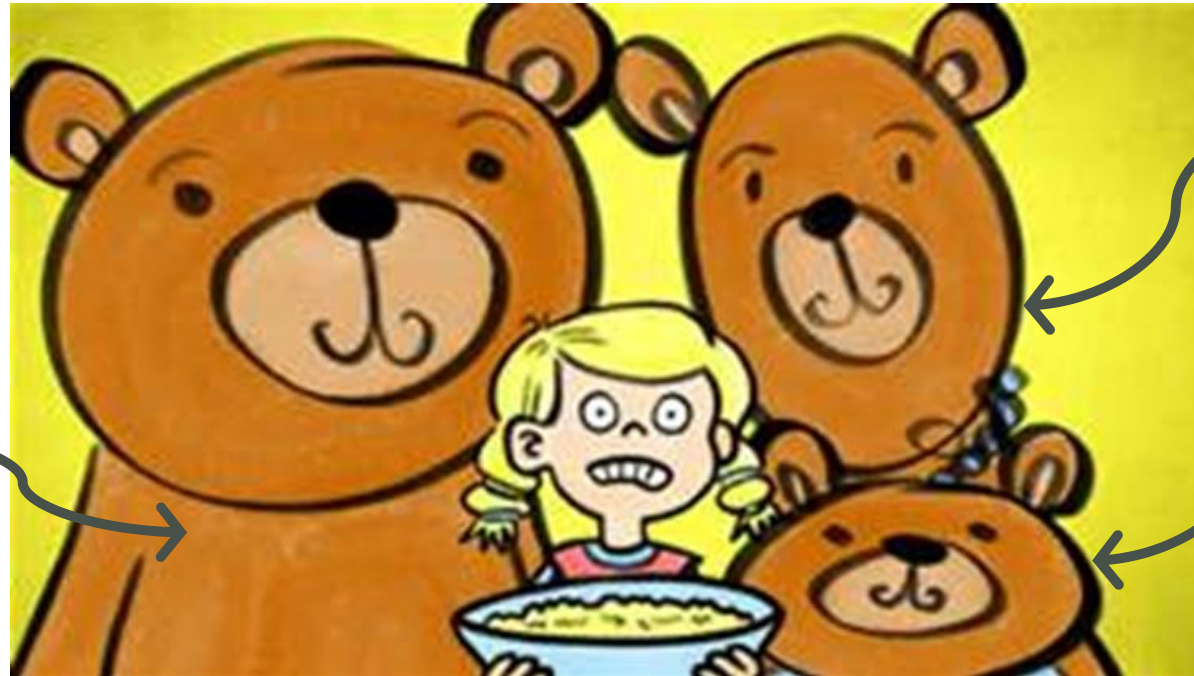
Flow Monitoring and Evaluation Considerations

I&I reduction
spread over too
large an area

Just right

Area too small
to reliably
measure

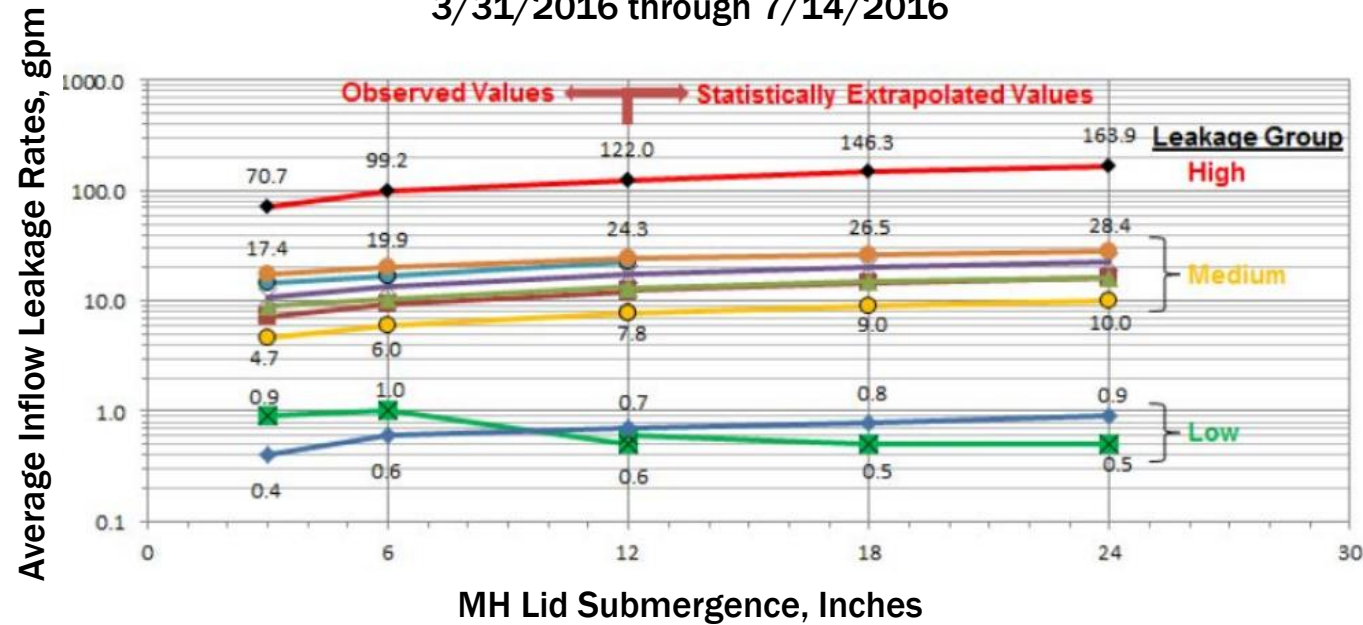
Manhole Frame & Lid Leakage Testing Summary
3/31/2016 through 7/14/2016

- Water System tested “in service” and new manhole structures
- Test box flooded manhole cover up to 24-inches
- Common issues in large leaks:
 - Corrosion at lid/frame interface
 - Poor/damaged gaskets
 - Lid vent holes and missing cover bolts
 - Hinges lacking no leak protection
 - Cam lock clamp malfunction
 - Structural damage to lids, frames, and riser rings

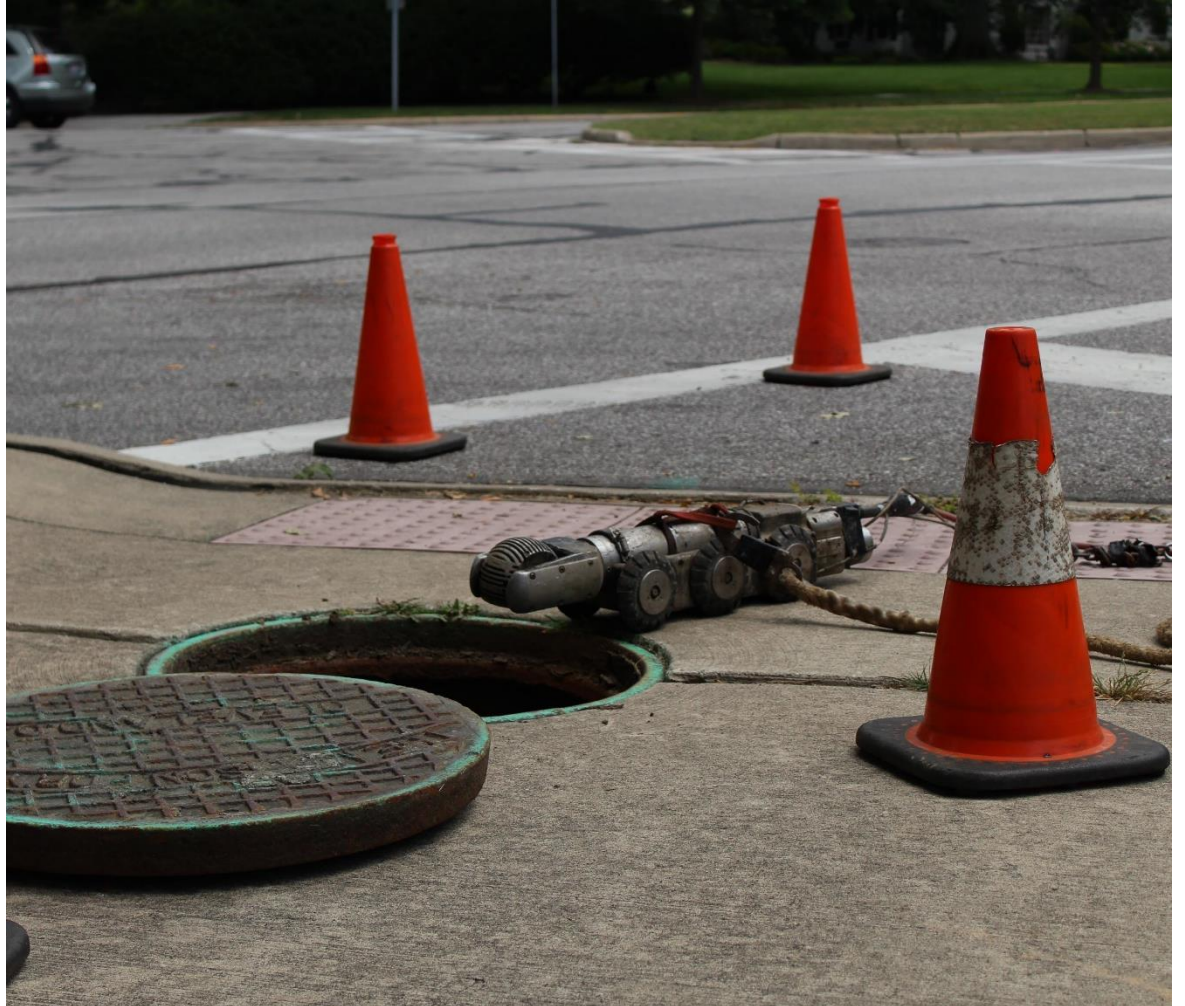
- Closed Circuit Televising (CCTV)
- Can inspect laterals with little interruption
- Can see major flaws in the pipe
- Standardized documentation processes (NASSCO)

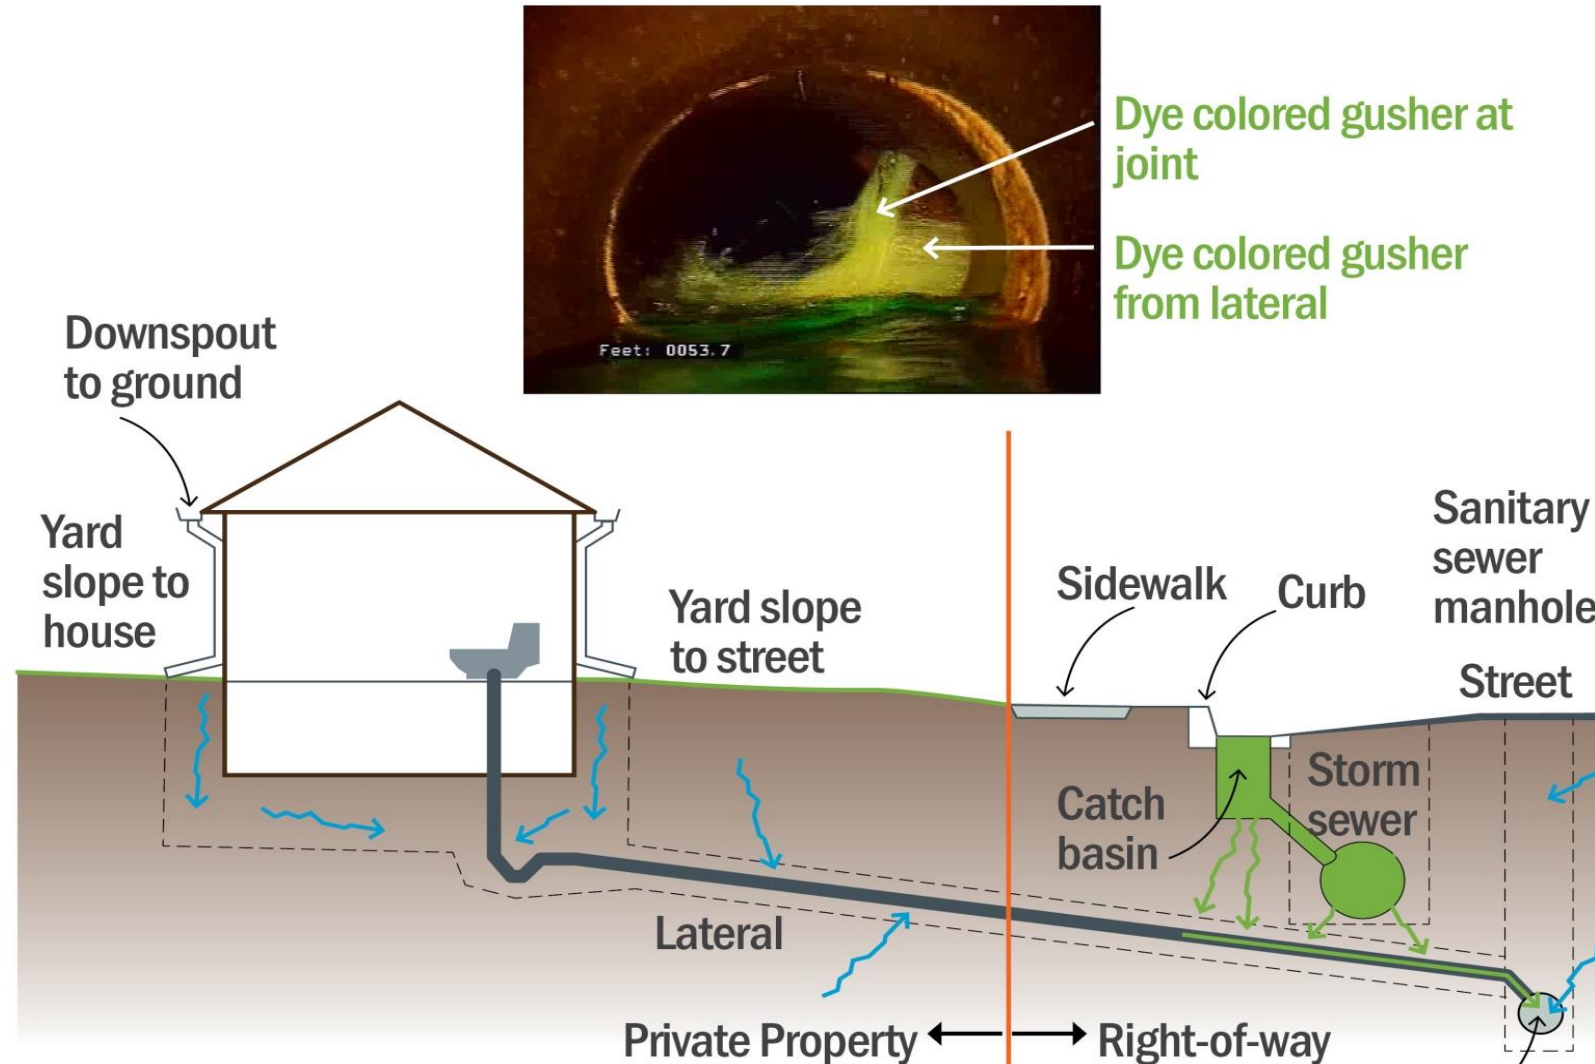
CCTV Plus Storm Sewer Dyed Water Test

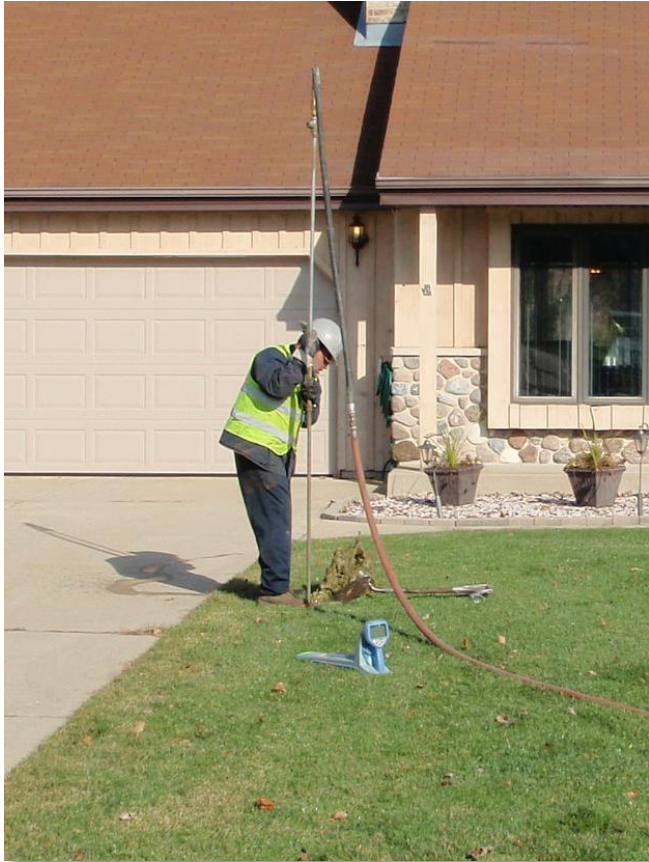
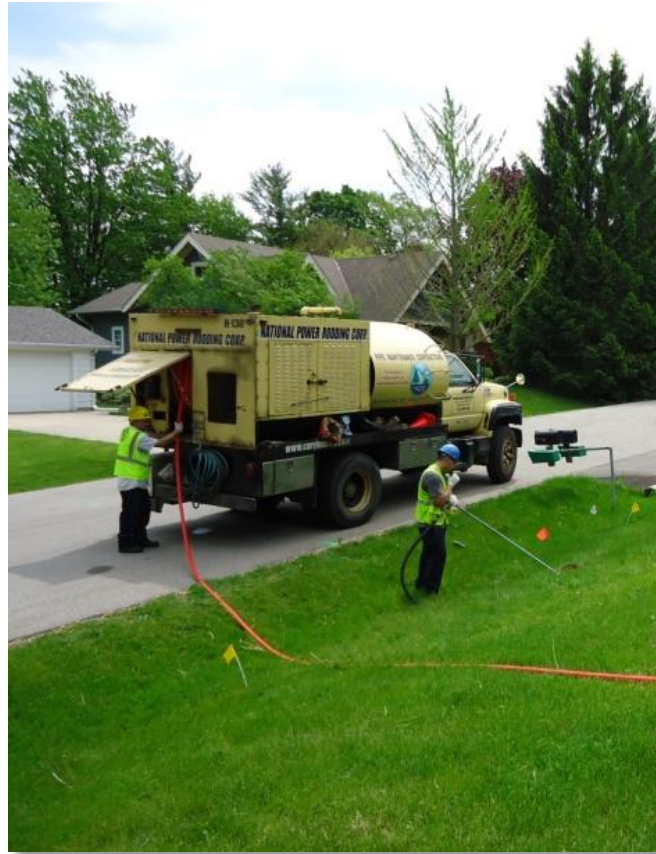
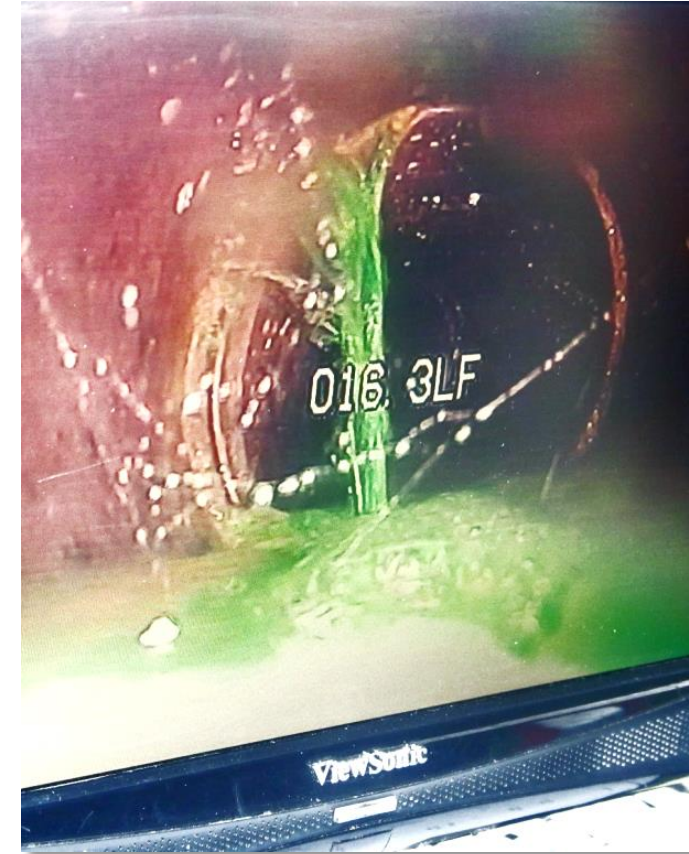
CCTV Plus Dye Injection Above Sewer Lateral

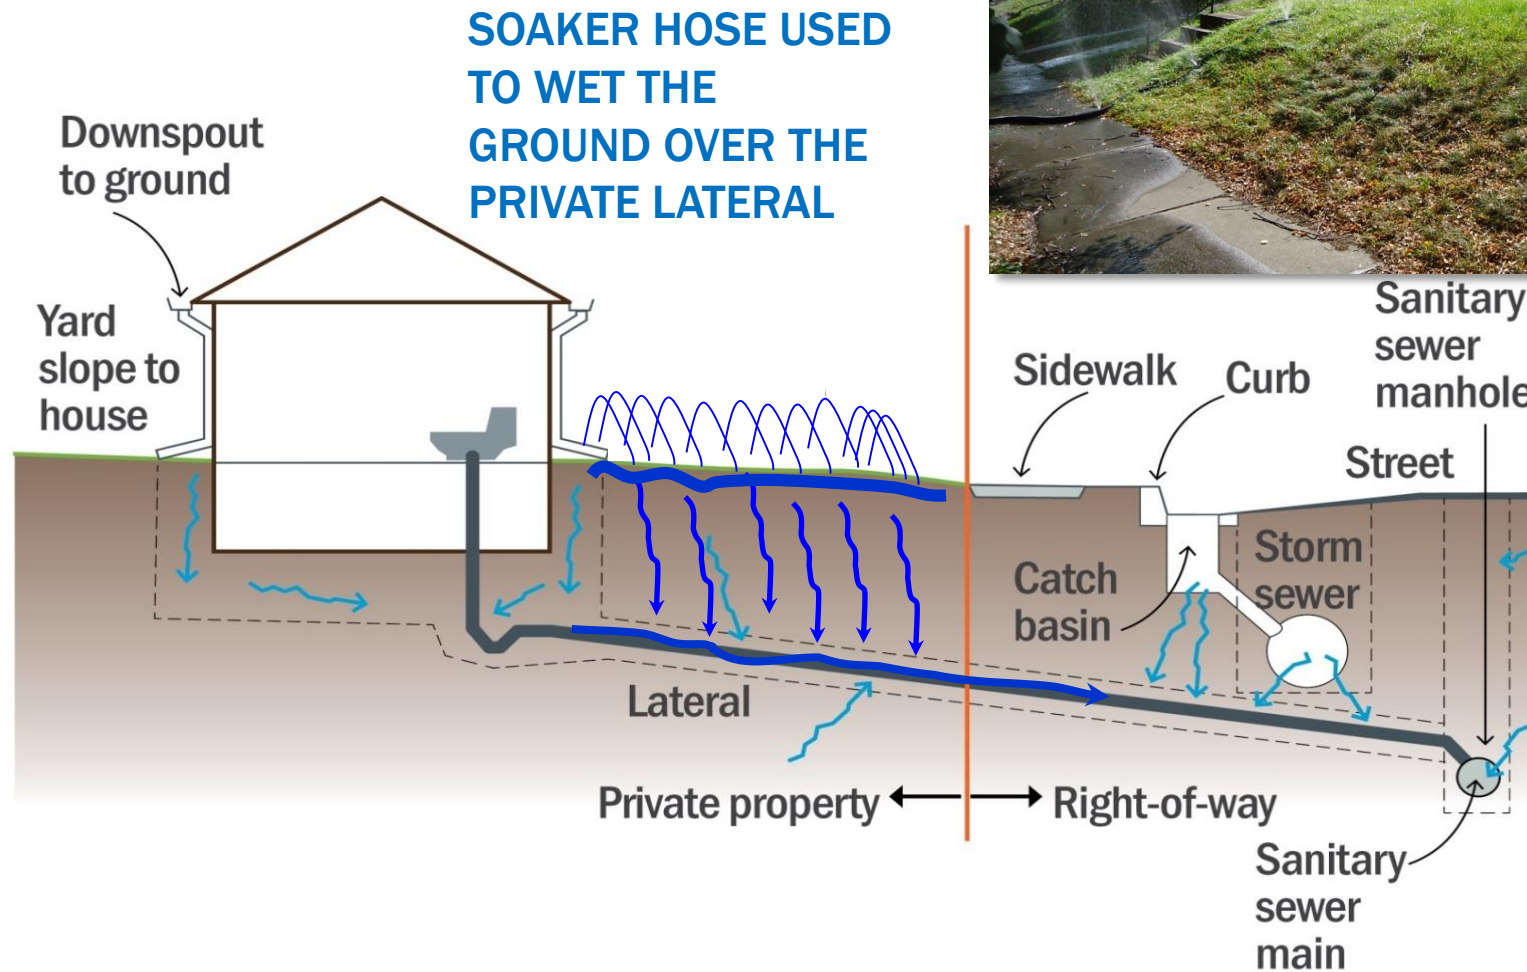
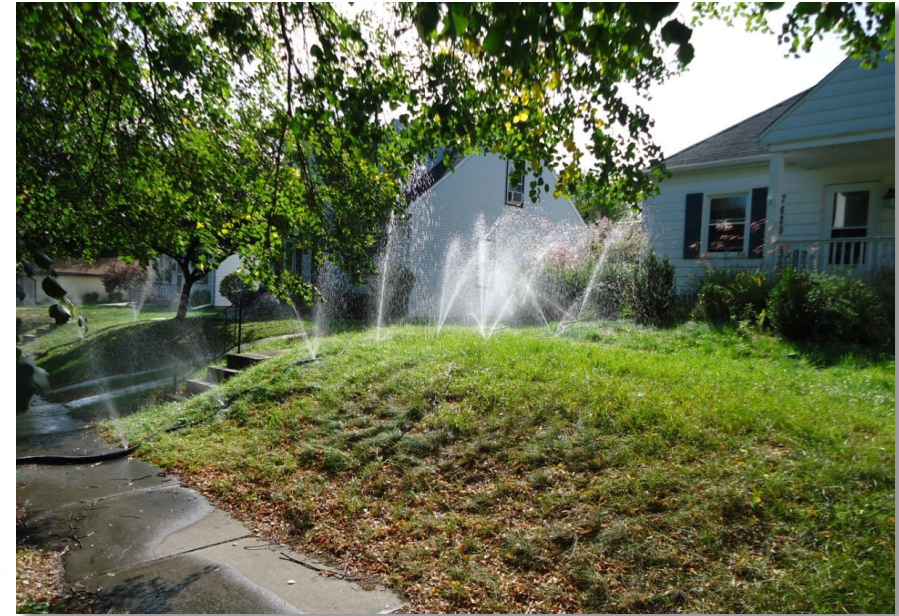
Soaker Hose Testing

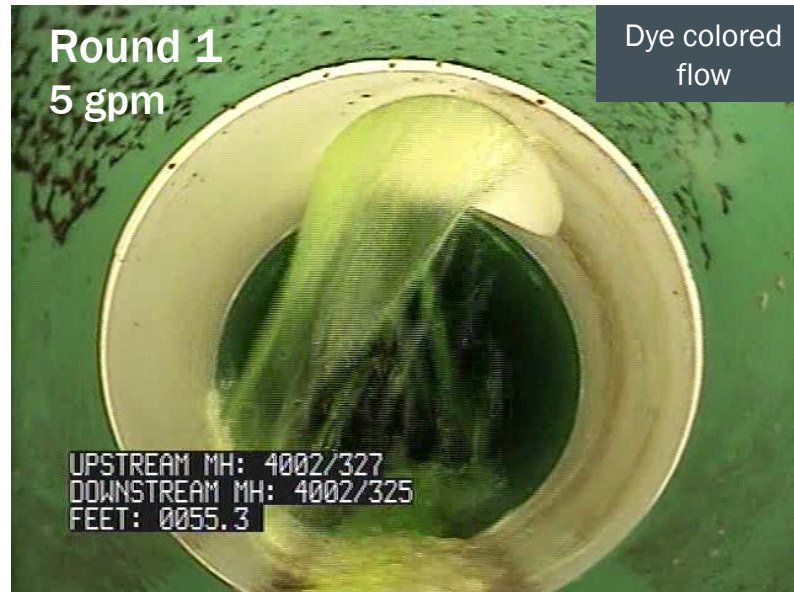
Round 1: New PVC sanitary main
and lateral connector stub

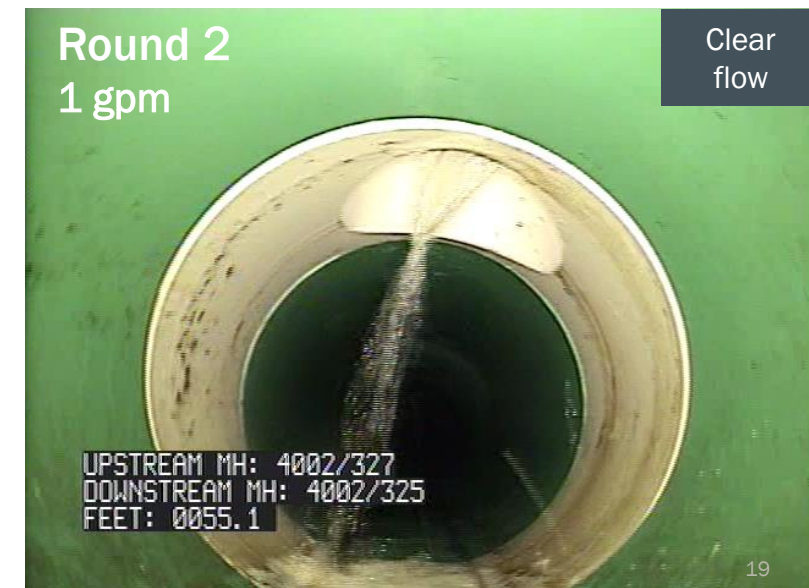
Round 2:
Priority Lateral After Targeted
Rehabilitation

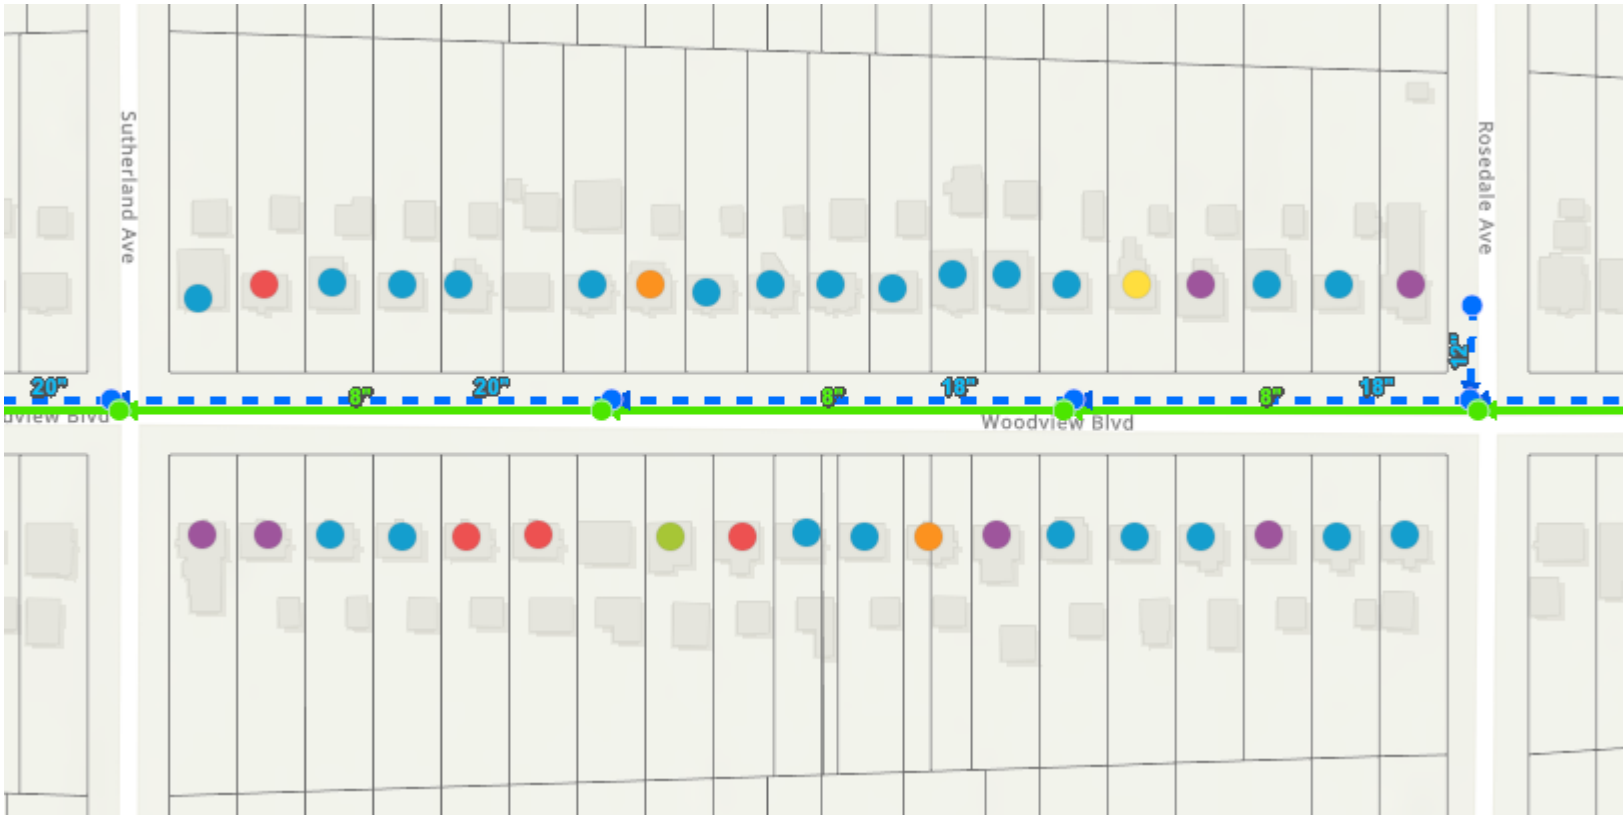
House Downspout Test Results

RESIDENTIAL DYE TEST

- All Positive Rapid
- All Positive Light
- Mixed Positive Rapid or Light
- Mixed Positive and Negative (Rapid)
- Mixed Positive and Negative (Light)
- All Negative
- Sanitary Manhole
- Storm Manhole
- Sanitary Sewer
- Storm Sewer

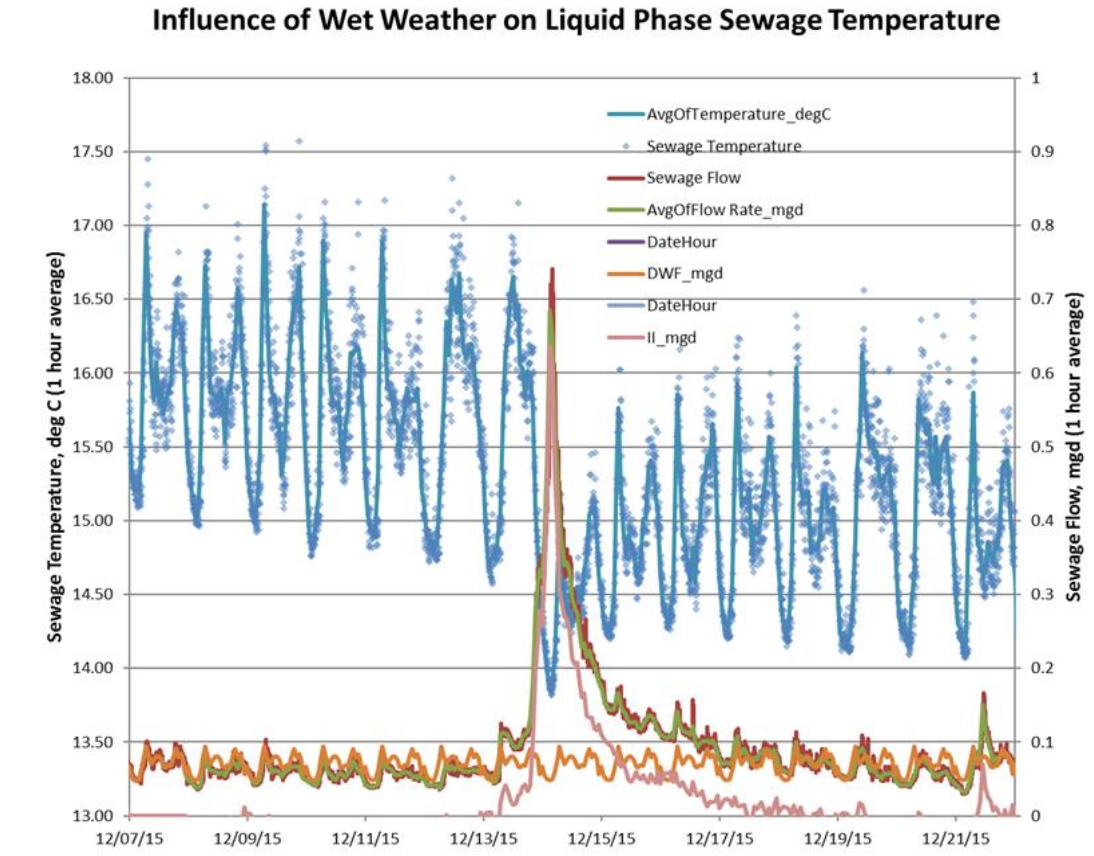
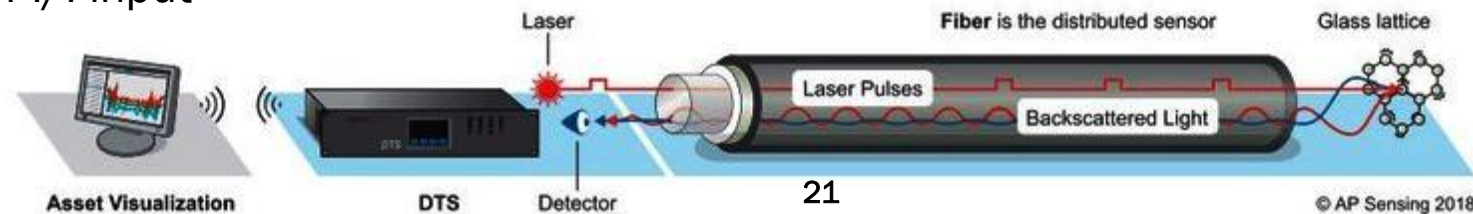
Changes in temperature along the cable indicate location of I/I input

Magnitude of temperature change will indicate quantity of I/I input

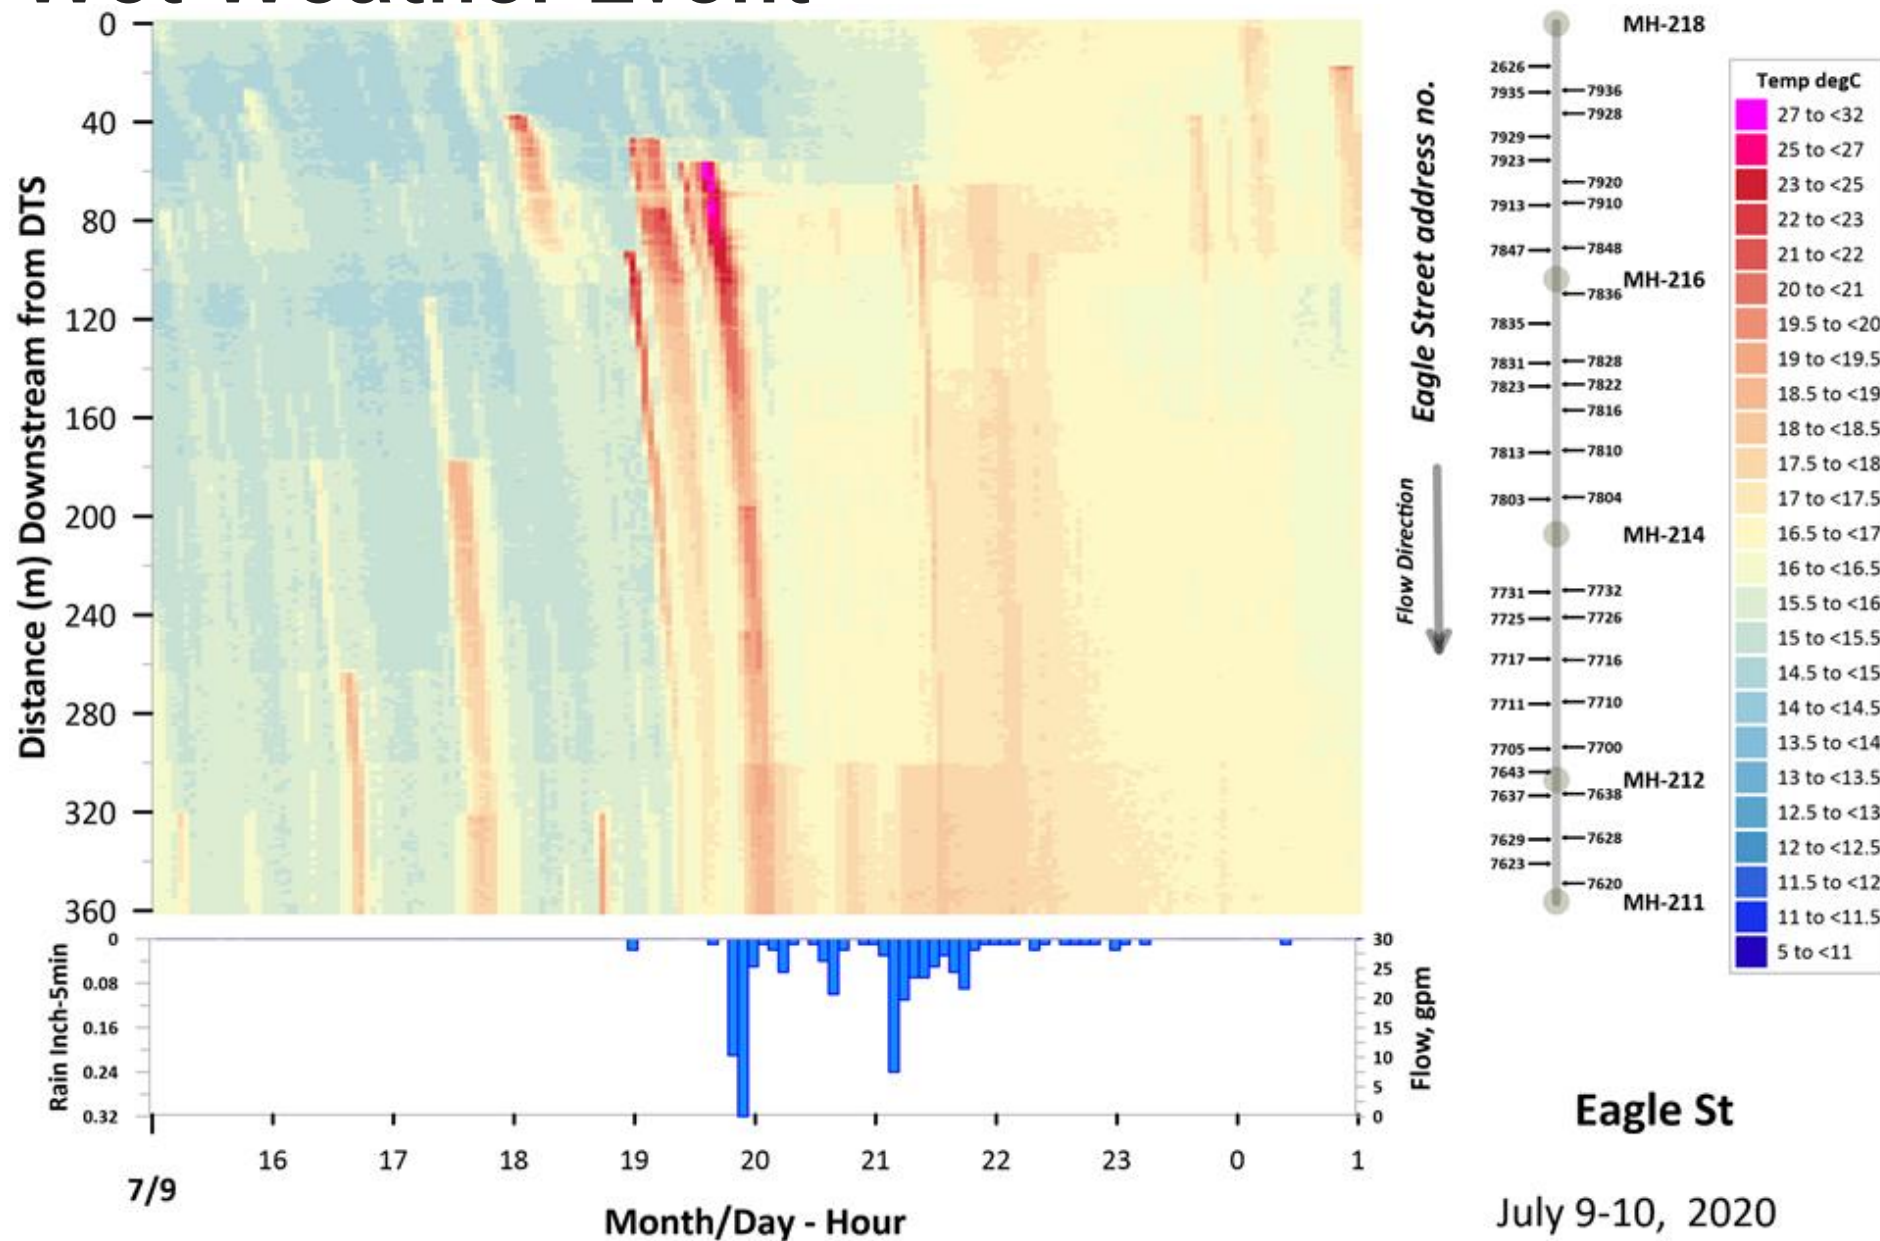
July 9 Wet Weather Event

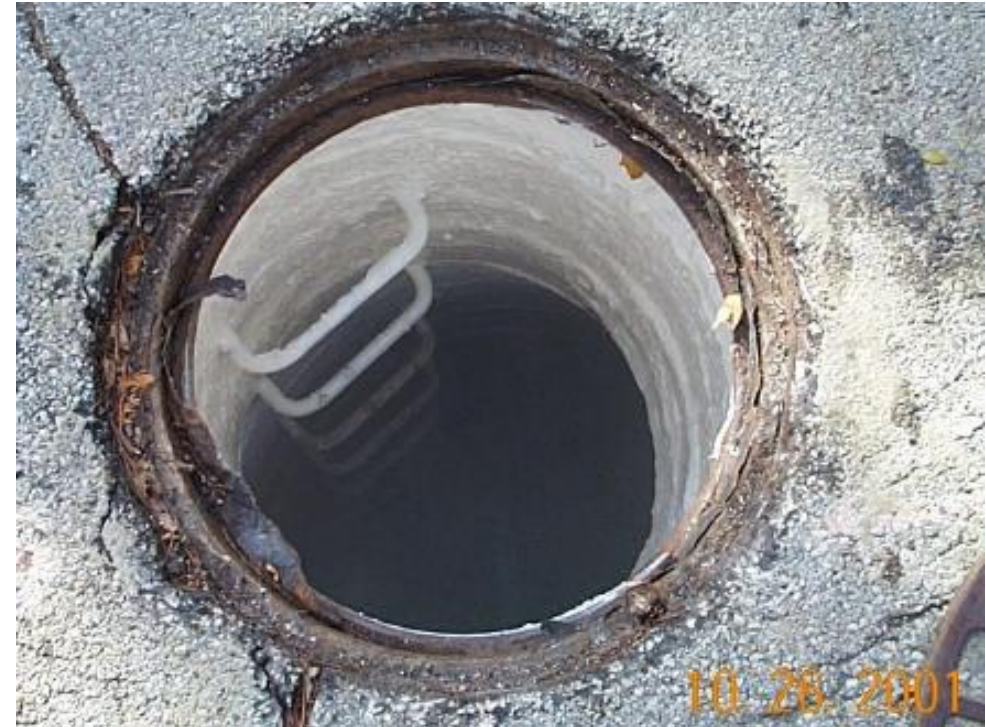
Manhole Rehabilitation

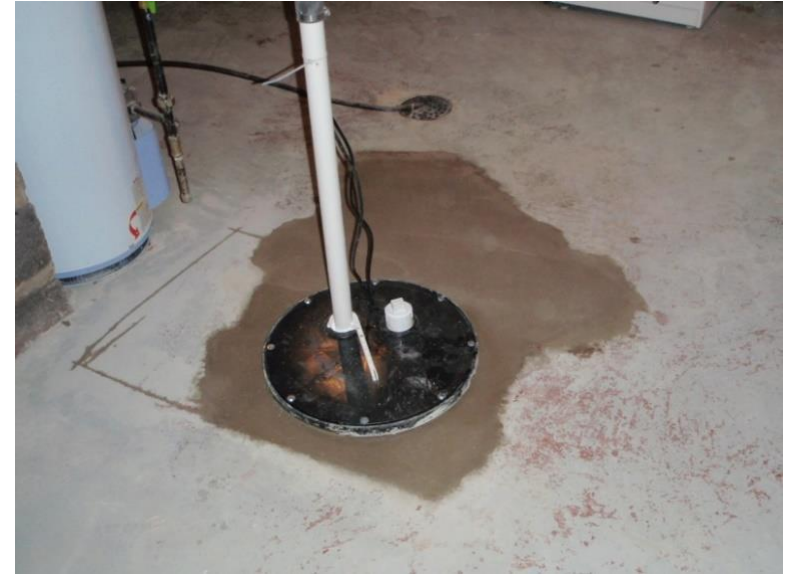
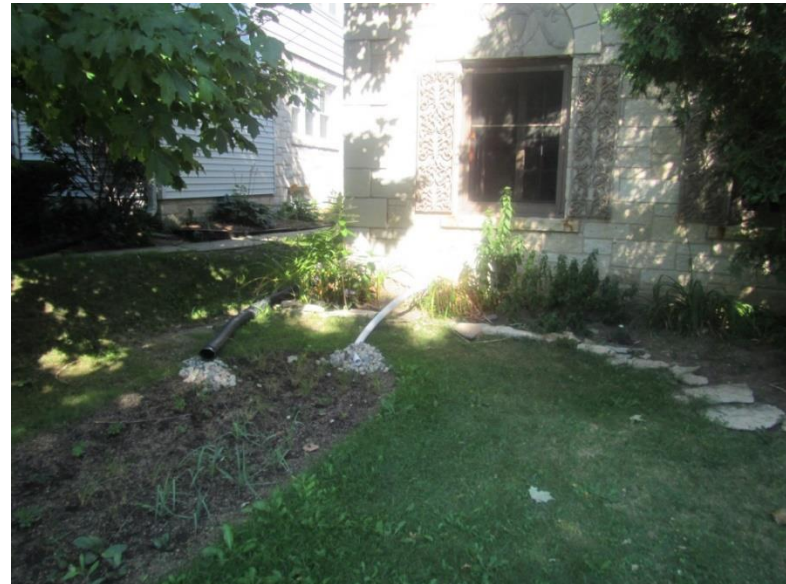
Foundation Drain Disconnection

- Install a sump pump to collect water from around the house foundation
- Replace Palmer Valve
- Sump pump discharge
 - To a storm pipe (lateral)
 - Over the yard
 - To a rain garden

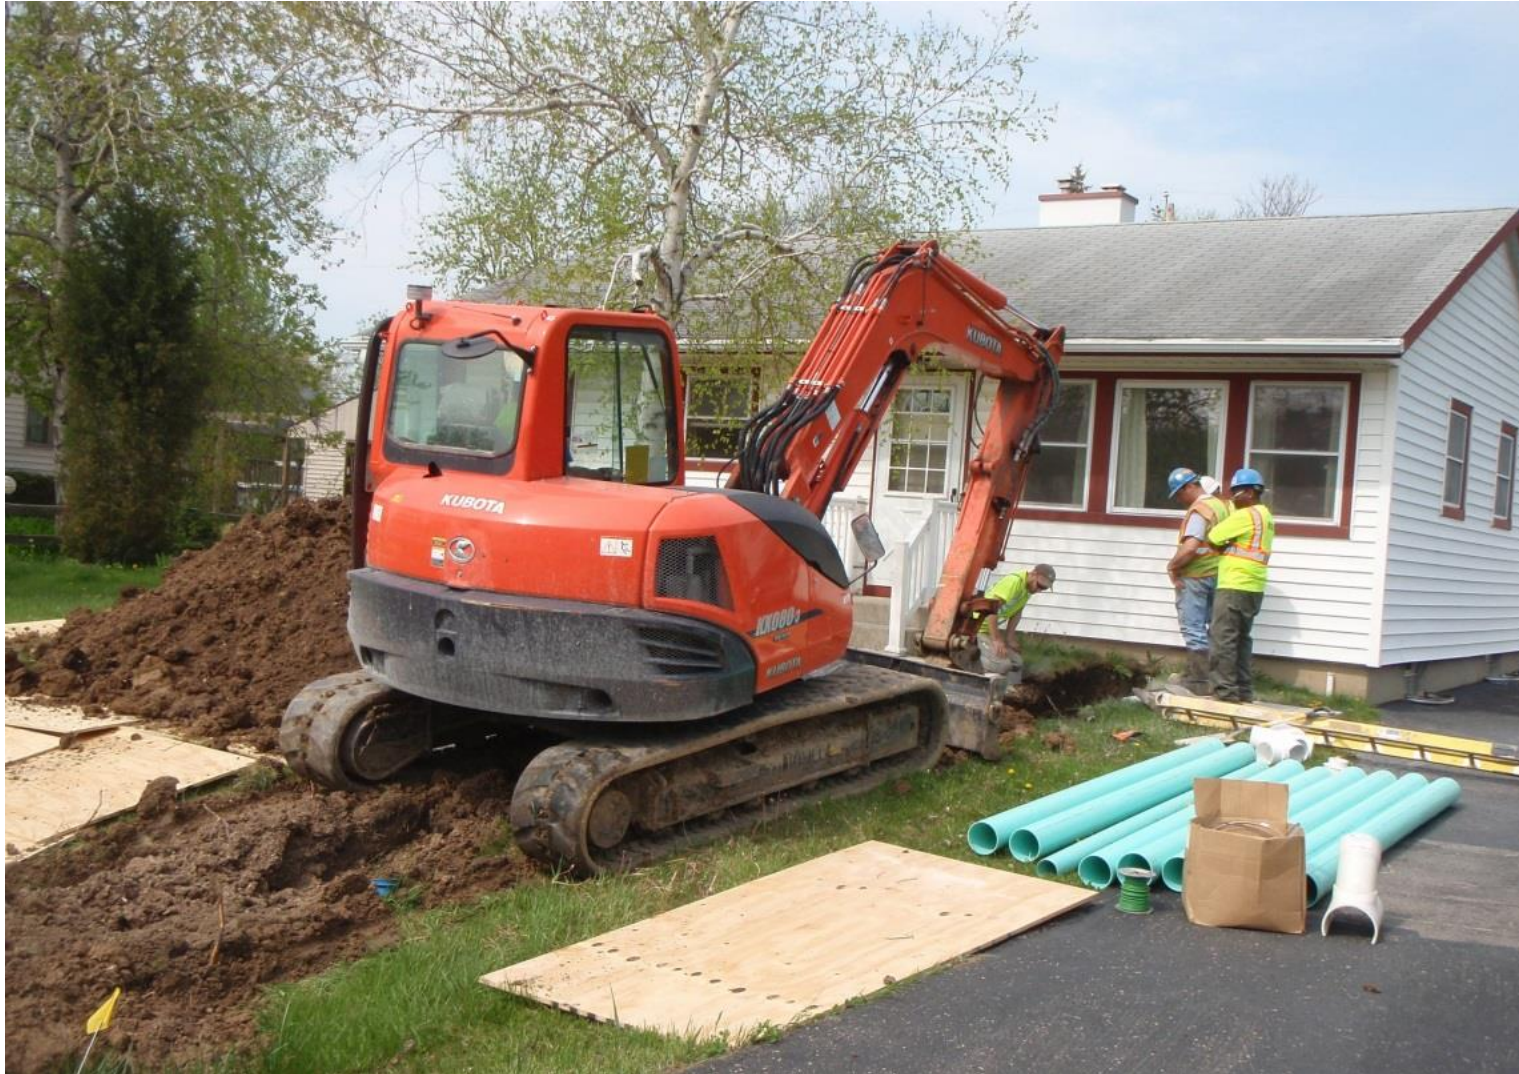
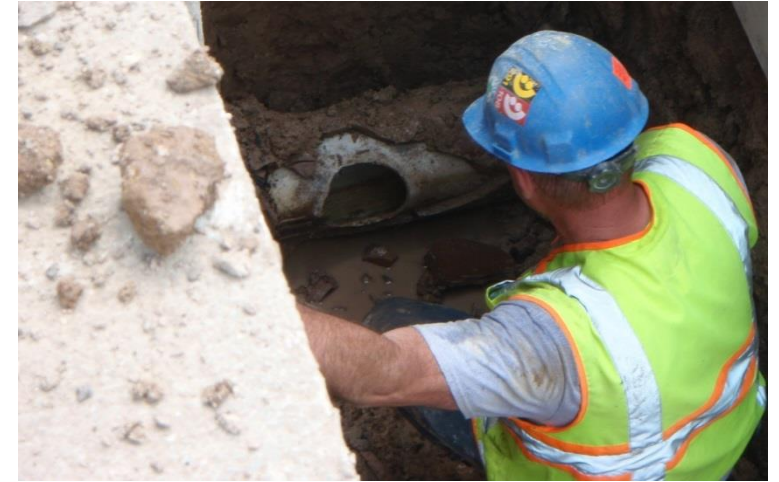
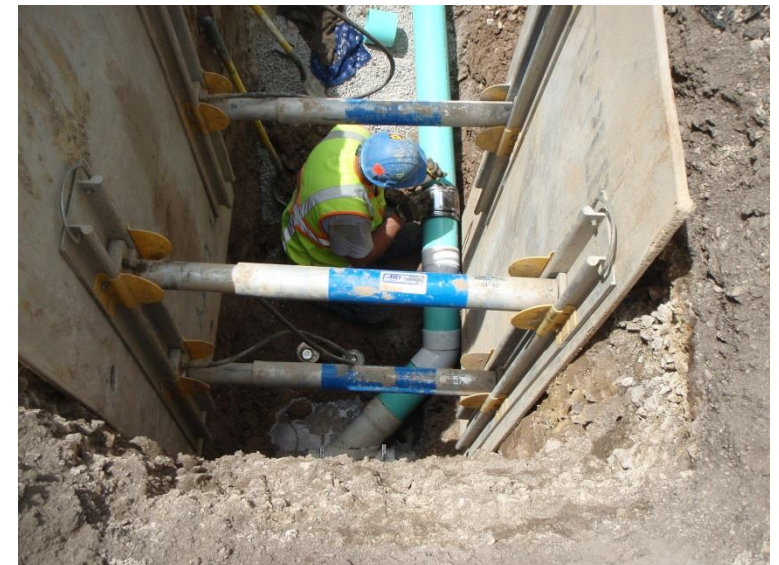
Lateral Open Cut Excavation
