NEW Water Infiltration and Inflow Program Workshop

I&I Overview

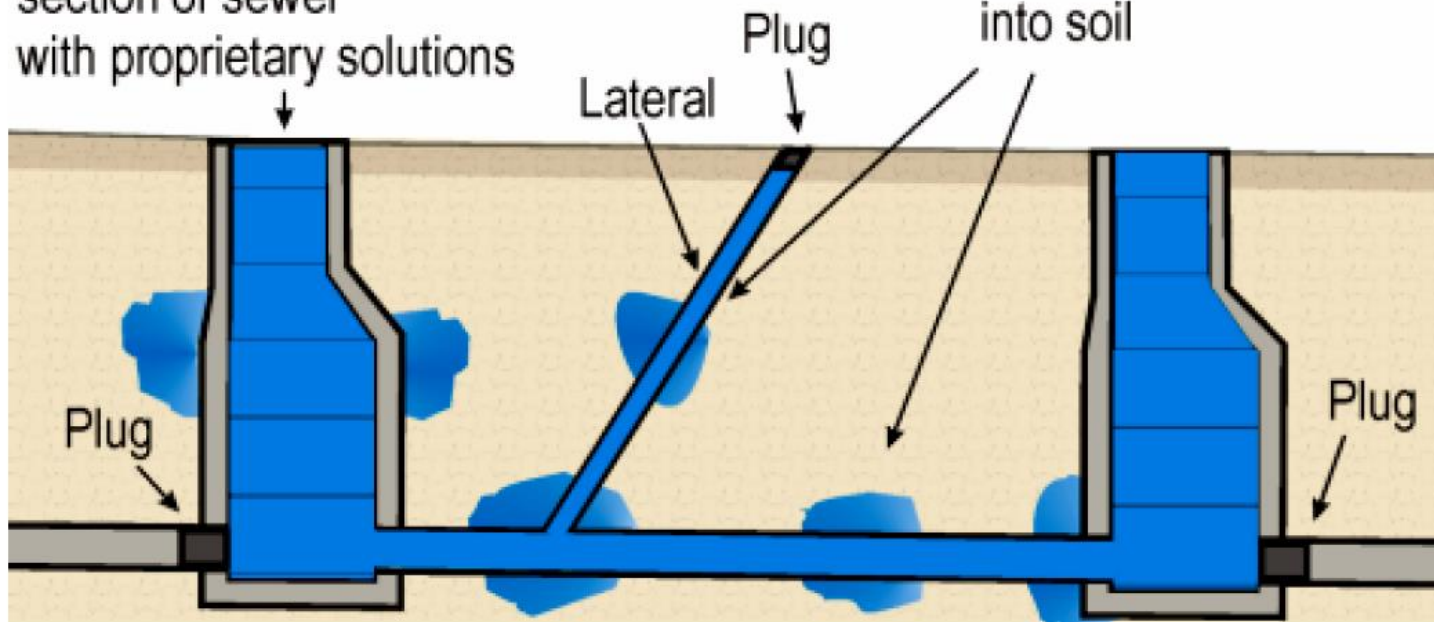
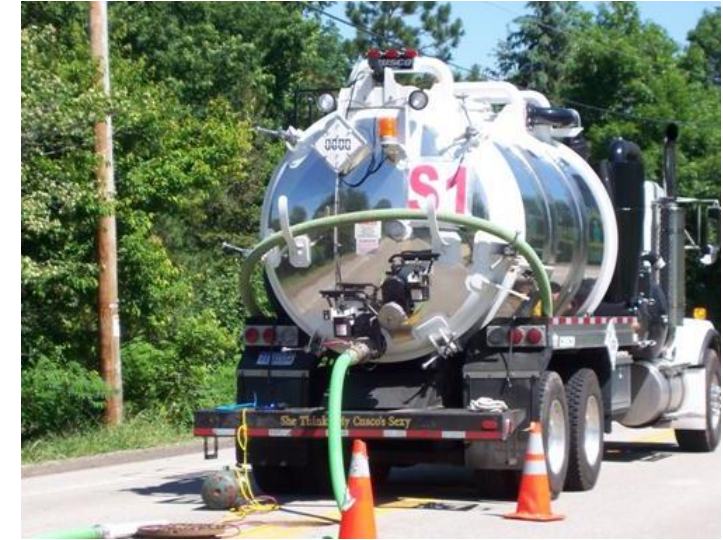
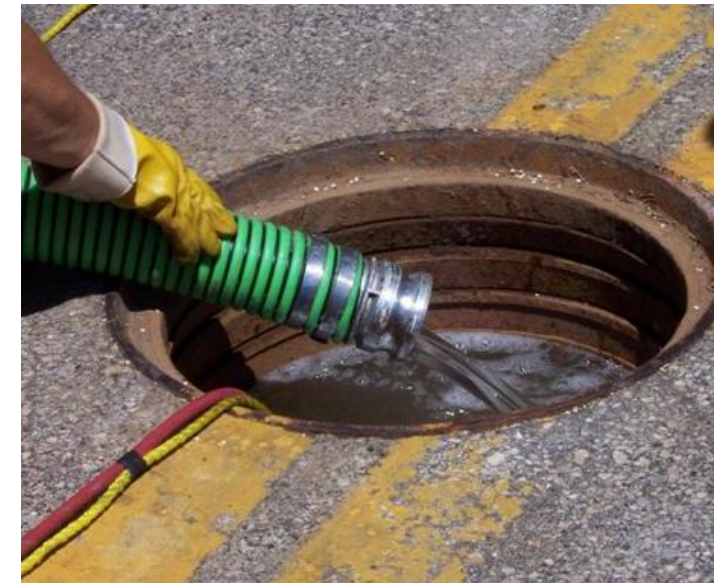
Flood Grouting

Flooding of an isolated section of sewer with proprietary solutions

Exfiltration into soil

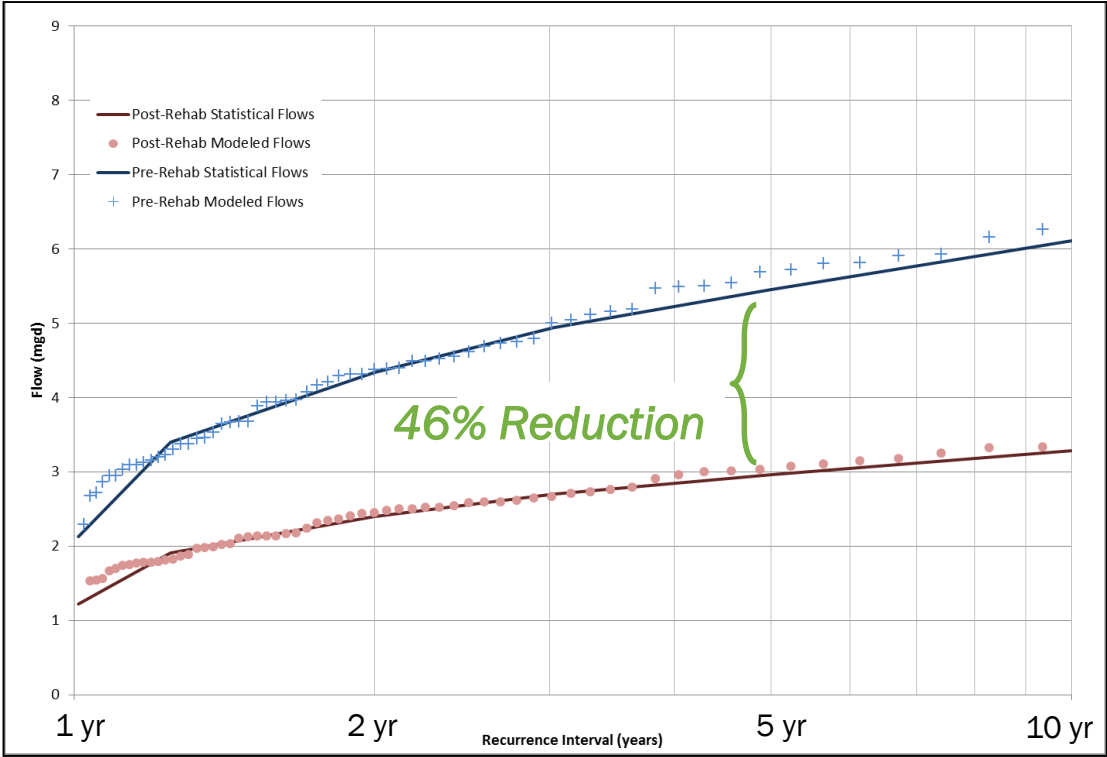
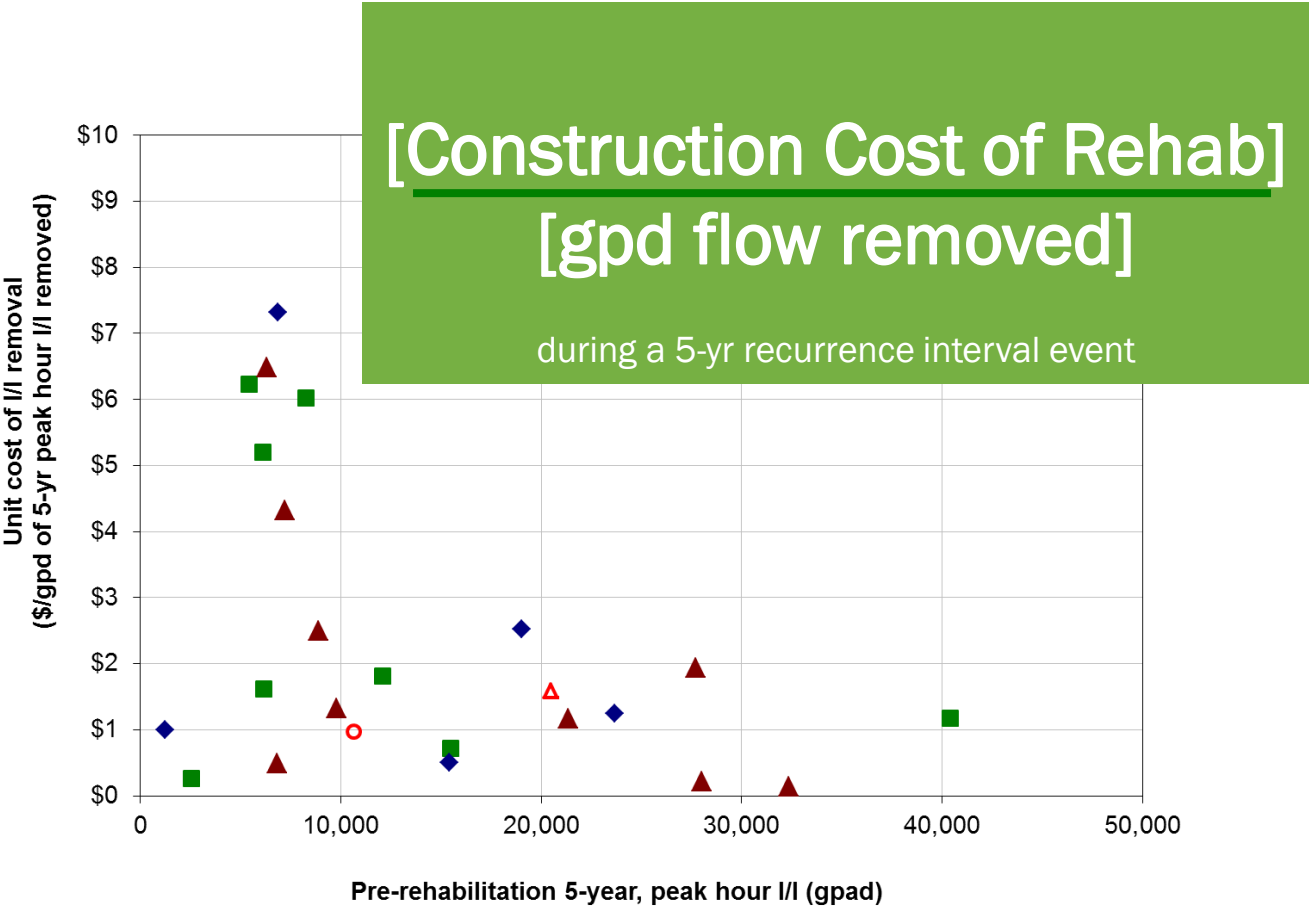
I&I Reduction Effectiveness Evaluation

1. Determine if I&I reduction is happening
2. Identify the cost per unit of I&I reduction
3. Identify the residual I&I
4. Identify I&I reduction by phase, for construction projects with multiple phases
5. Distinguish between infiltration and inflow removed
6. Identify whether the flows are in compliance

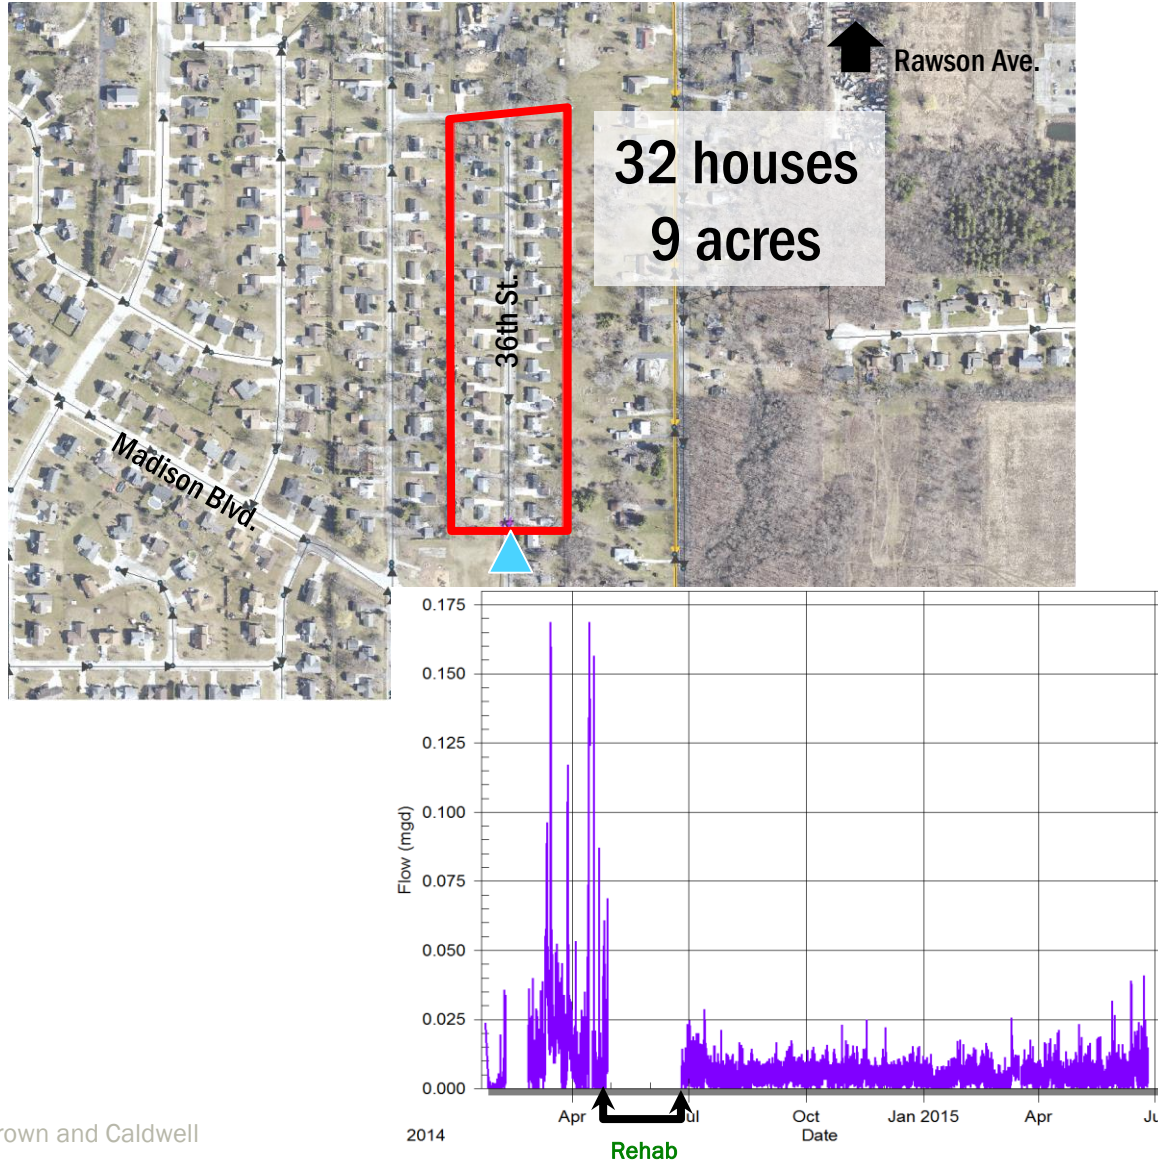
Case Study A

- Investigations
 - Flow monitoring
 - Lateral televising with dye injection
 - Internal and external house inspections
 - Cost of \$17,000
- Construction
 - 24 lateral CIPP (at least 50 feet)
 - 2 lateral excavated spot repairs
 - 6 lateral replacements
 - Removed sump pump connections to sanitary sewer
- \$240,000 total construction cost

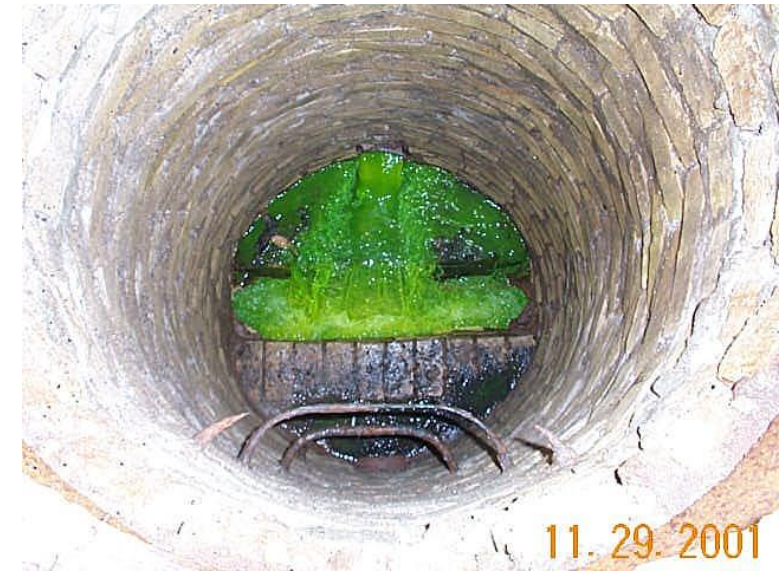
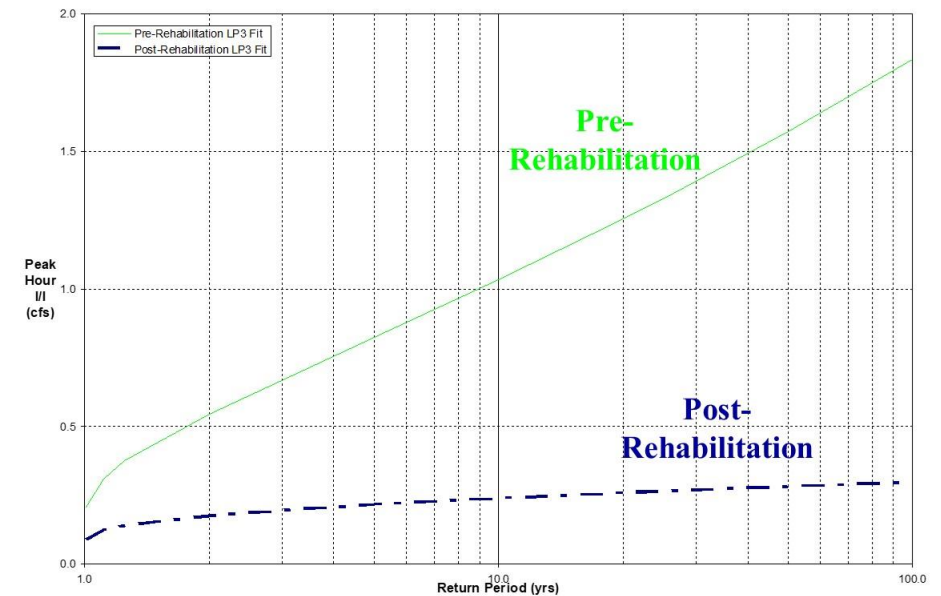
Case Study C

- Investigations
 - Flow monitoring
 - Televising with dye injection
- Construction
 - Lined 1,350 feet of 12-inch storm sewer
 - 231 LF of catch basins
 - 100% of the storm sewers and manholes in the basin
- \$59,000 total construction cost
- 74% reduction in 5-year peak hour I&I

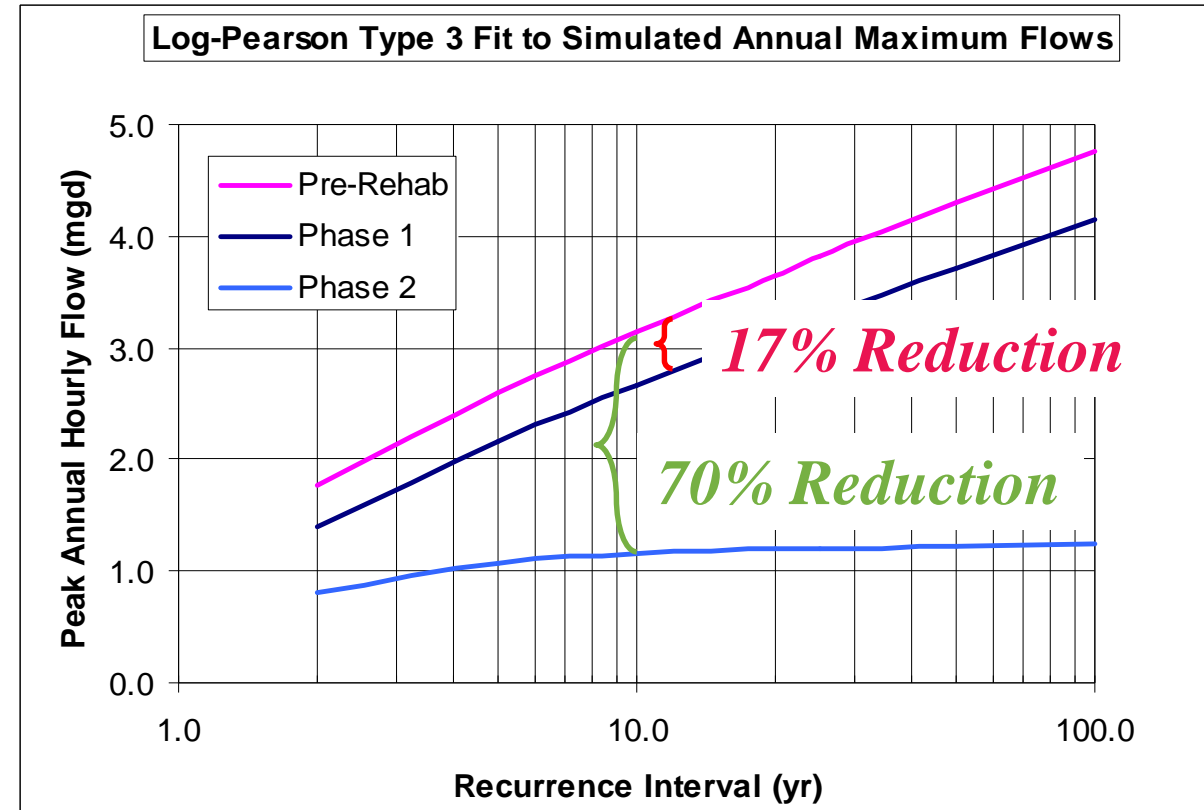
Case Study E

- Investigation
 - Flow monitoring and analysis before and after each phase of work
- Construction
 - Phase 1 – public system rehab plus lateral in right-of-way
 - Phase 2 – private system rehab of laterals and a few roof drains
- \$2.8 million total construction cost (2002)
- Public system rehab accomplished 17% peak flow reduction
- Private system rehab improved peak flow reduction to 70% from original

268 houses
130 acres
