Case Report

Regeneration of an extremely narrow ridge using NeoGen® Ti-Reinforced Membrane and simultaneously placed Neoss ProActive® implants

Dr. Norbert Hassfurther, Germany

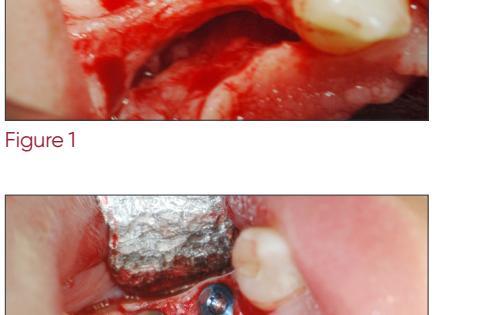
A 19 year old female presented with two congenitally missing teeth in the premolar area of the upper jaw, resulting in a very narrow atrophic ridge, with inadequate bone width to properly house implants (Figure 1).

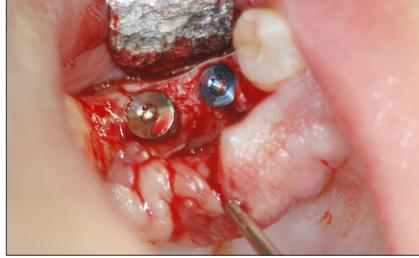
Figure 3

A full thickness flap was opened, osteotomies were prepared on the palatal aspect of the ridge, and two Neoss ProActive® Straight implants were placed. Both implant sites had fenestrations on the buccal side (Figure 2) and palatal dehiscences (Figure 3).

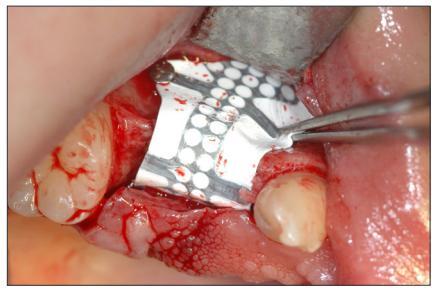
Figure 5

A Neogen® Ti-Reinforced Membrane Medium was trimmed, shaped, and fitted at the implant site. Autogenous bone chips collected during drilling of the implant osteotomies were used to fill the palatal dehiscence (Figure 4). No material was used to fill the buccal fenestration, the strength of the mesh created the space for bone regeneration. The membrane was secured with two tacks buccally (Figure 5). Flap closure was achieved, and the soft tissue healing was uneventful (Figure 6).

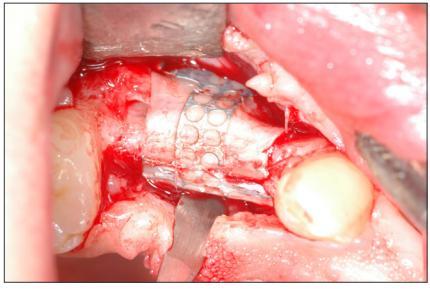
Figure 7

After 7 months, second stage surgery was performed. A mid-crestal incision with releasing incisions was used to lift a flap and expose the membrane (Figure 7). The titanium mesh kept the membrane shape stable for the entire healing period. Removal of the membrane revealed that the whole volume enclosed by the membrane had been regenerated with new bone and a new wide ridge had been created (Figure 8).

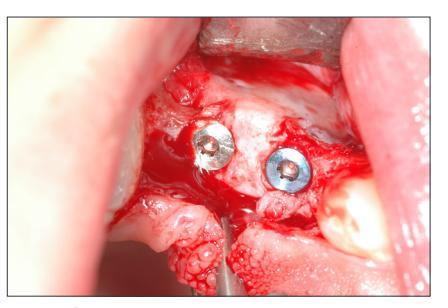
Figure 9

Excess bone on top of the cover screws was removed (Figure 9). PEEK healing abutments were connected to the implants and the flap was closed (Figure 10). Radiographic assessment confirmed bone regeneration around the implants (Figure 11).

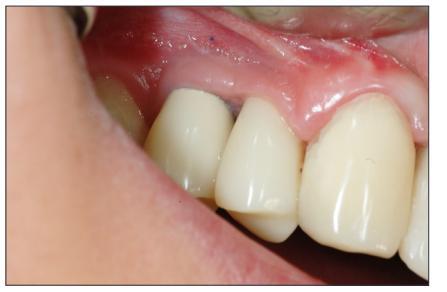
Figure 12

After 3 months of soft tissue healing (10 months after membrane placement) the implants were temporary restored (Figure 12).
