Case Report

Immediate loading of a Neoss ProActive® Tapered implant to correct upper right lateral incisor agenesis.

Dr. Roberto Romano, Italy

Treatment plan: Placement and immediate loading of a Neoss ProActive® Tapered implant restored with a screwretained zirconia crown.

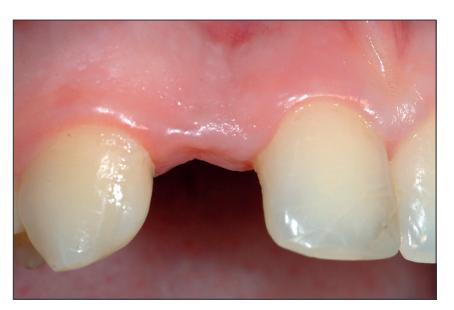
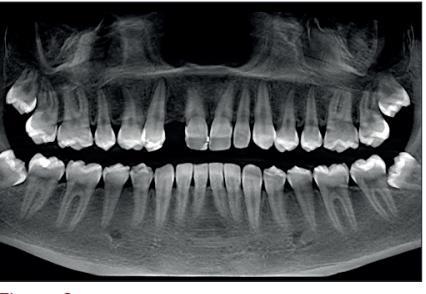
The patient needed an implant to replace the upper right lateral incisor missing due to

agenesis (Figure 1 and 2).

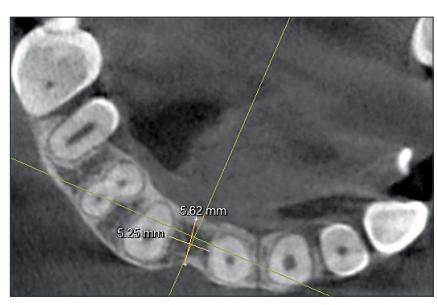
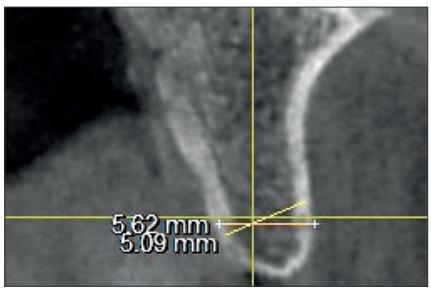
The CBCT scan showed a residual bone width of 5.6 mm in the palatal-buccal and 5.2 mm in the mesio-distal direction (Figure 3 and 4).

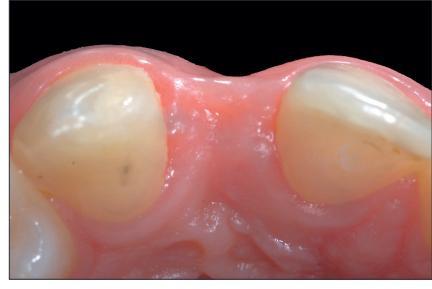
Figure 5

Although the amount of bone was sufficient for implant placement, the soft tissue on the buccal aspect showed a concave profile (Figure 5).

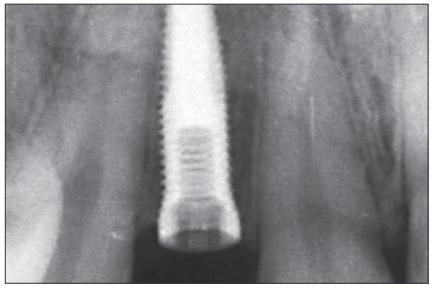
Figure 7

A Neoss ProActive® Tapered Implant 3.5 × 13 mm was placed with a final insertion torque of 50 Ncm and 65 ISQ (Figure 7).

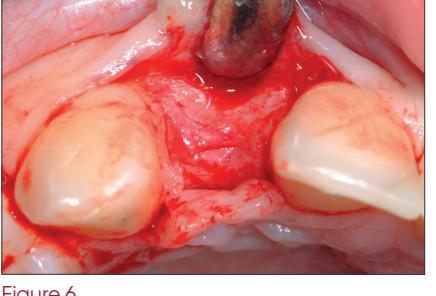
Figure 6

A full-thickness flap was raised on the buccal aspect in order to expose the surgical site (Figure 6).

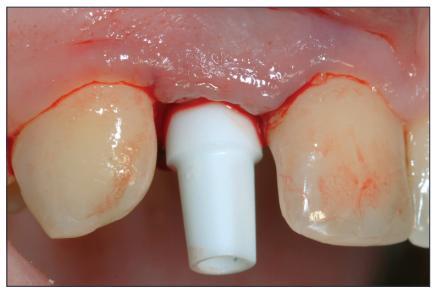
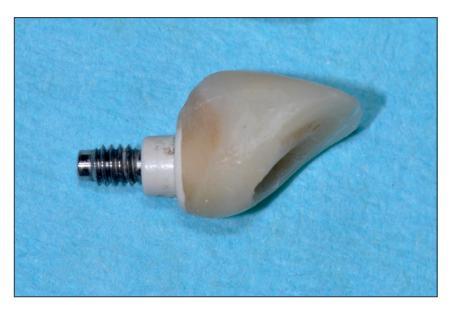
A screw-retained provisional crown previously manufactured by the lab was adapted to a Neoss Esthetic Tissue Former - Narrow Incisor (Figure 8 and 9).

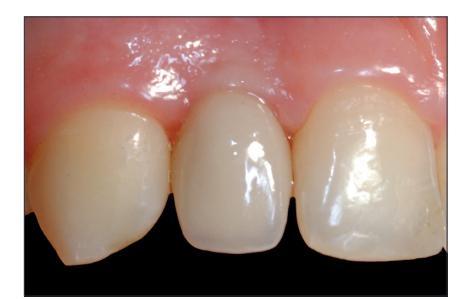
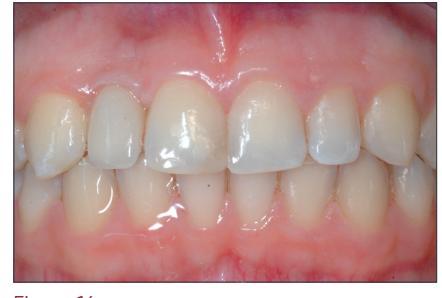
The final restoration was a zirconia abutment with ceramic layered on the buccal aspect (Figure 15 and 16).

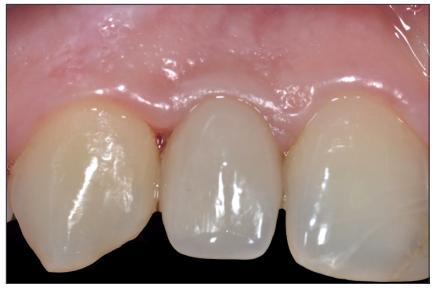
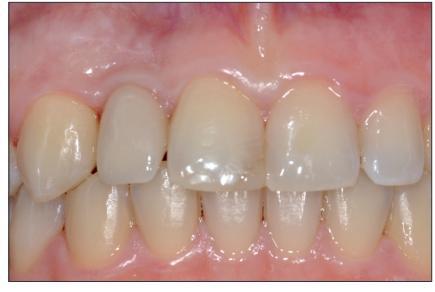
After 3.6 years from the definitive restoration delivery, soft and hard tissue levels were stable and the esthetic aspect was satisfactory (Figure 17 and 18).

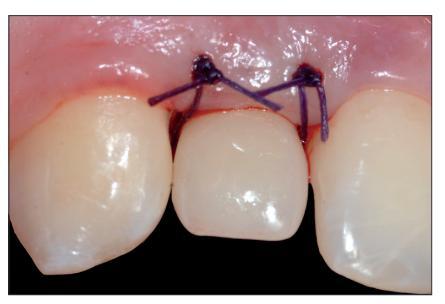
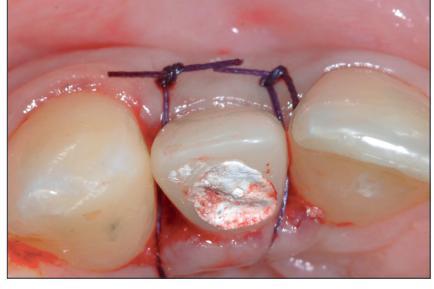
The crestal incision was slightly palatally displaced in order to correct the lack of soft tissue on the buccal aspect when the flap was sutured (Figure 10 and 11).

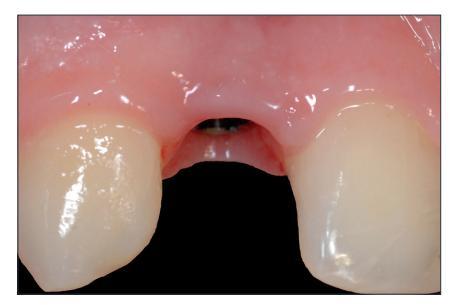
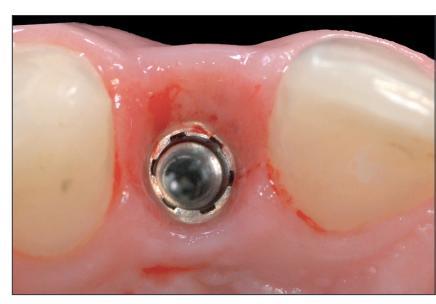
The concave aspect of the soft tissue on the buccal aspect appears corrected after 3 months of healing (Figure 12 and 13).

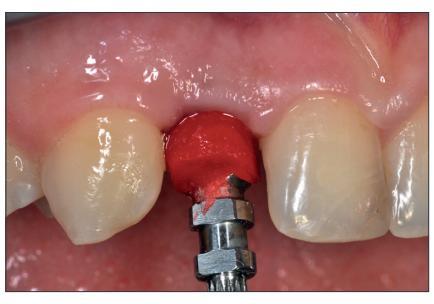
Figure 14

Final impression was taken with a customized impression coping aimed to replicate the trans-mucosal path shaped by the provisional crown (Figure 14).
