Flexco Washbox Says Goodbye to Carryback, Spillage, and Downtime

CUSTOM ENGINEERED SOLUTIONS

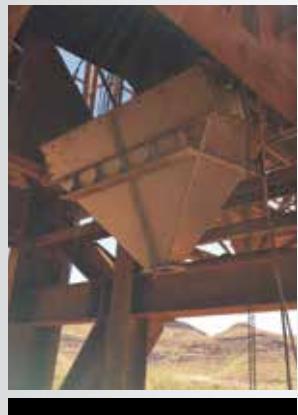
On site installation of the wash box for the operation was aided by extensive planning by the mine's construction team.

Washbox Being Installed

After discussions between the site's construction engineer and Flexco, it was decided that the best way to combat the excessive carryback was to install a wash box that was custom-engineered for the site by Flexco's in-house engineering team. The customisation allowed the wash box to be fitted seamlessly into the conveyor line without hindering existing construction.

Wash boxes will typically offer cleaning efficiency not found in usual primary and secondary cleaners alone. Using a wash box is advised in applications where the conveyor must be very clean or when head-end cleaning is not enough. Mounted on the return side of the belt, the stainless steel wash box is fitted with a combination of pressure rollers, spray bars, and a recovery system, depending on the application.

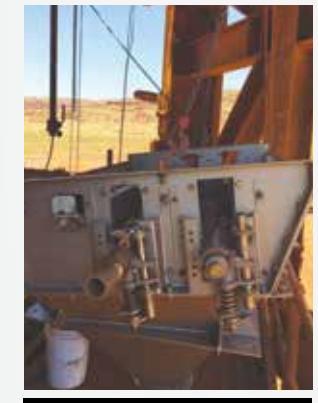
Washbox Being Installed

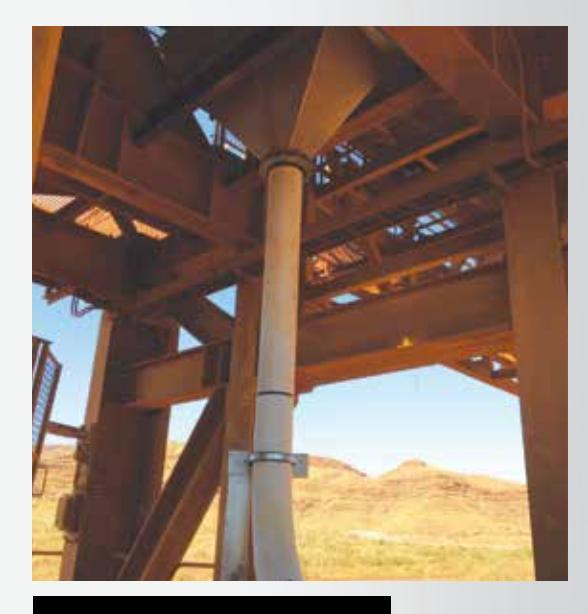
Charge Pipe Leading to Sump

Reducing carryback and inherent spillage has also had an overwhelmingly positive effect on the environment with all spillage redirected into a dedicated sump.
