**Wendy Yu, Christy Catalytics, USA,** emphasises the importance of checking quality control, logistics, packaging and job site storage before loading a process vessel.

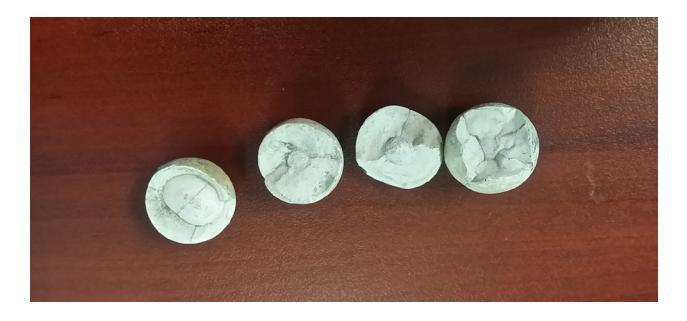
Figure 1. Examples of lamination.

Lamination can occur in both ceramic and alumina supports. This is a significant problem as it can lead to low impact resistance and can reduce the thermal shock resistance and lower crush strength. During start-up or unplanned interruptions, alumina balls or ceramic balls can undergo thermal shock or depressurisation. Inferior balls can delaminate and/or break, resulting in higher pressure drop across the bed and/or bed blockage, which ultimately results in a premature shutdown (Figure 1).

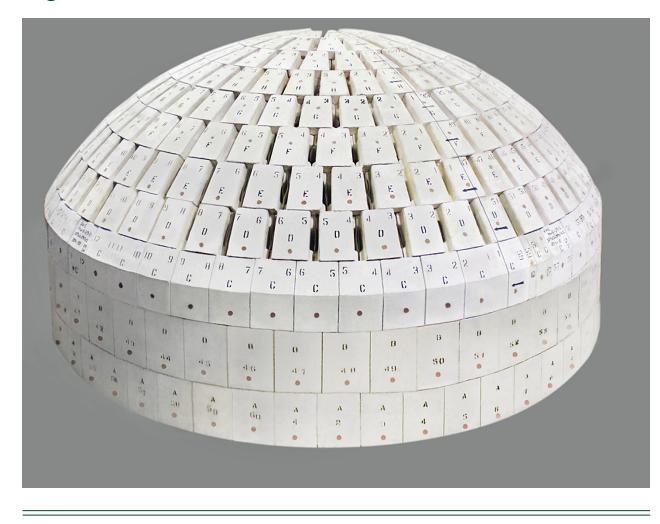
**Figure 2.** High alumina secondary reformers support dome.

When a plant's secondary reformer dome collapsed and needed to be replaced right away (Figure 2), the operator contracted Christy Catalytics to remedy the situation. However, it transpired that a replacement dome would take several months to manufacture since the company's emergency stock dome had been recently sold to another customer.

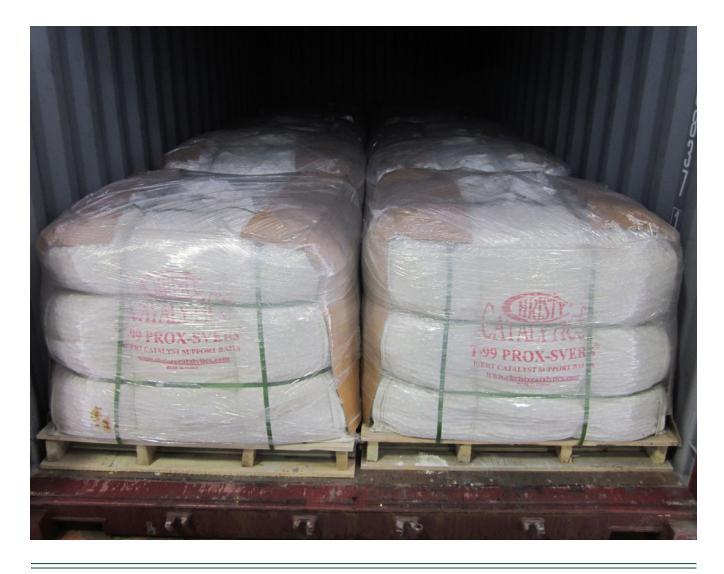
Figure 3. Proper packaging and loading of catalyst support media.

Common packaging issues include label damage and poor pallet design and quality. The label is frequently damaged due to weathering from dust, water, and wind. Therefore, the packages are usually prepared with plastic wrap on the outside to prevent damage to the label (Figure 3) and the packaged support balls should not be unwrapped until they are ready to be loaded into the vessel. Poor pallet quality could make the transit a challenge due to inadequate design or construction. The pallets could collapse, causing the entire stack to lean or even tumble to the ground, which would lead to safety and handling issues and potentially even contamination.

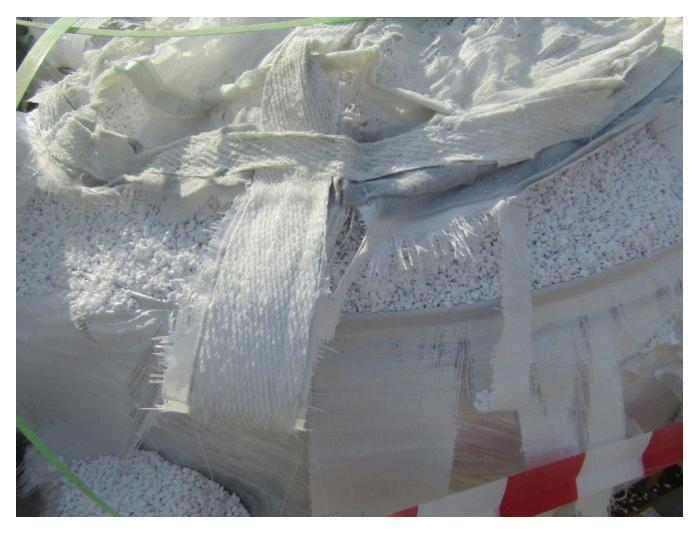
**Figure 4.** UV degradation to a flexible intermediate bulk container.

In one case, a customer had their materials stored outside while waiting for a turnaround. The bulk bags were covered with protective materials on top; however, the bags' sides were exposed to UV light. The UV light was found to have significantly degraded the polypropylene bags during the inspection, and the bags had become brittle (Figure 4). This outcome is not uncommon, even in cold climates, and it is therefore advised that UV warning labels are adhered to bulk bags to ensure proper storage and prevent UV damage.
