M1 Concrete Slab Replacement:

62% Cost Saved, 70% Time Saved

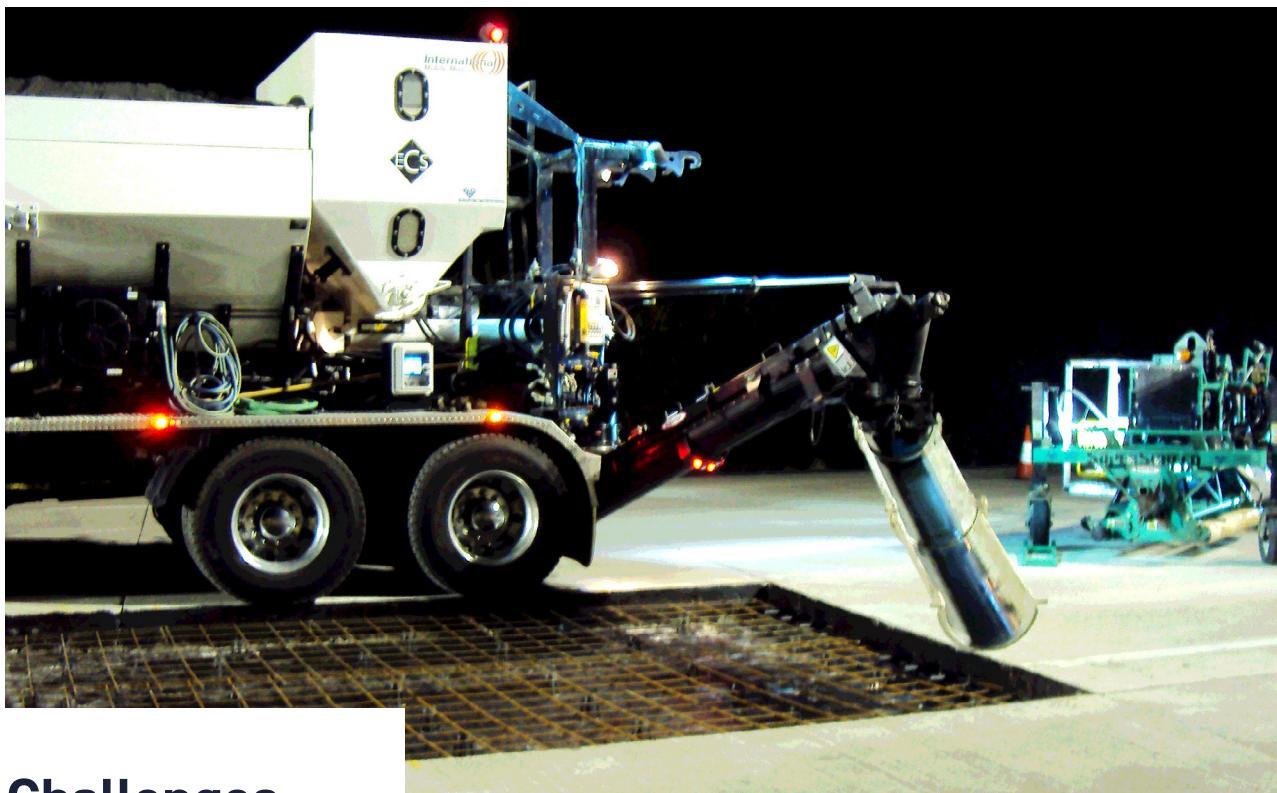
To ensure road safety, the M1 motorway was in desperate need of repair. There were serious damages to the concrete pavement such as cracking, spalling, settlement, and faulting. Roadtek directly engaged Antoun, to rehabilitate these sections of pavement and to be ready for trafficking at 04:00 EST.

Step 1	Saw cutting was done after seeing the need for it the previous night. Antoun had to then demolish and replace up to a maximum of 3 slab sections within an 8-hour time frame, including all establishment and demobilisation.
Step 2	Concrete sections were demolished and slab sections were placed into steel bodied trucks for carting and disposal. The existing lean mix was then swept free of any remaining debris. The demolition took place using the efficient, clean method of lifting plates with concrete screws for each sawn panel section. Slabs were drilled post demolition and lifted. The existing adjacent slab faces parallel to the flow of traffic were then to be drilled using a 16mm diameter drill bit, 300mm deep. The slabs perpendicular to the flow of traffic had to receive a 38mm diameter hole 225mm deep into the existing adjacent slab faces.
Step 3	Dowel pins & tie bars were drilled and an SL82 Mesh was placed, in which all adjacent slabs received a coat of emulsion. Each hole had to be doweled using a 900mm long, R12 bar, a chemset at a depth of 300mm, and a 450-mm long galvanised N32 dowel chemset at a depth of 225mm. Reinforcement mesh (SL82) was then placed, lapped and tied at 250mm with a clear cover of minimum 50mm from all adjoining faces. A plastic bond breaker was then installed spanning the full length and width of the slab to be replaced. Any additional plastic was cut away with all additional plastic lapped. Reinforcement mesh (SL82) was then placed, lapped, and tied at 250mm with a clear cover of a minimum of 50mm from all adjoining faces, N36 dowels etc. This was required as the aforementioned slabs are classified as a 'repair' as opposed to a 'new pavement'.

Step 4	CTS Rapid Set Cement production, placement & finishing was done and the concrete was then installed as per best practice, with no radius on the adjoining edges and a tine finish across the carriage way. Post saw cutting then commenced as soon as possible, with all joints saw cut as needed. Finally, all teams scheduled to clean up the site were brought up and the lanes were finally opened at 03:30EST.
