## Neoss ProActive® Straight implants for the complete oral rehabilitation of a cancer patient.

Dr. AJ Ray-Chaudhuri, United Kingdom

**Treatment plan:** A complete obturator for the maxilla and complete denture for the mandible, both retained by four Neoss ProActive® Straight implants.

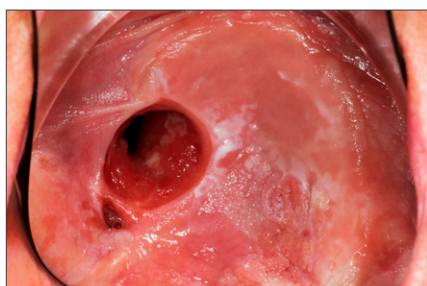
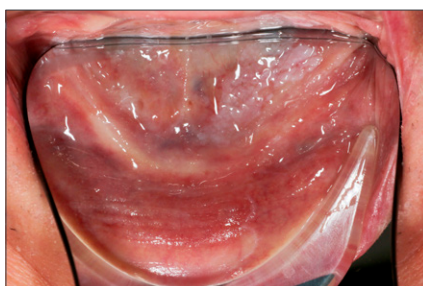
An 85-year old man, non-smoker with ischaemic heart disease was presented after surgical excision of a squamous cancer of the palate. The patient also had oral field change and suffered multiple recurrent oral cancers requiring surgical excisions during implant treatment. This resulted in multiple oro-antral communications requiring a maxillary obturator and an implant supported denture for the mandible. The patient required no chemotherapy or radiotherapy. (Figure 1 and 2).

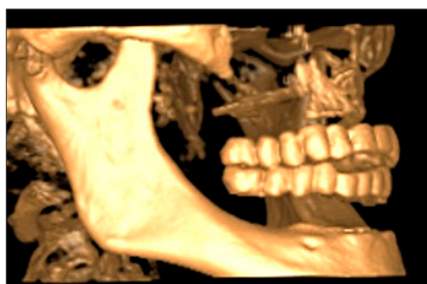
Figure 3

Cone-beam CT scan illustrating limited height and width of bone in the anterior maxilla. (Figure 3).

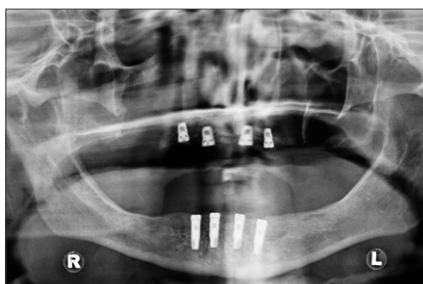
Figure 4

Panoramic radiograph showing four Neoss ProActive® Straight implants placed in the maxilla and mandible, on separate surgical appointments, with simultaneous xenograft augmentation. (Figure 4).

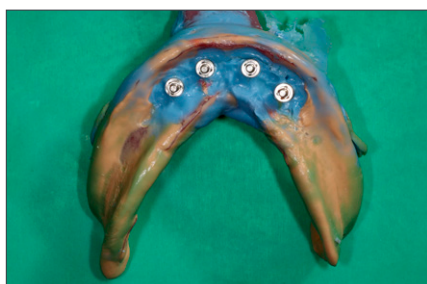
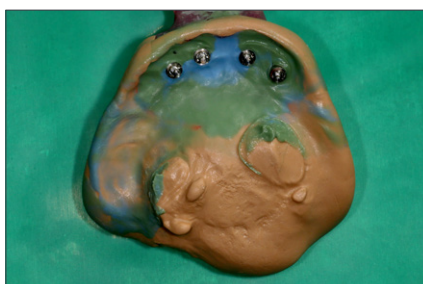
Upper and lower open tray fixture head impressions were taken with 13 mm copings using silicone and custom made trays. (Figure 5 and 6).

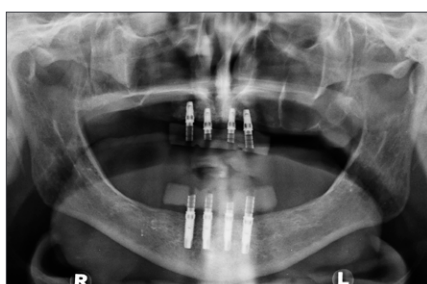
Figure 7

The casts were confirmed using acrylic jigs attached to Neoss Provisional Ti Abutment Multi. The accuracy of the cast was verified clinically and radiographically. (Figure 7).

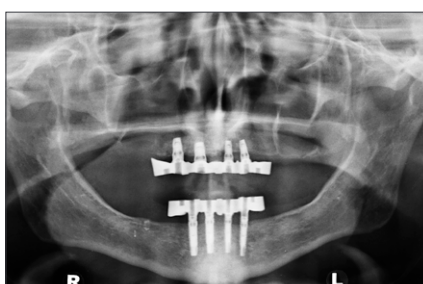
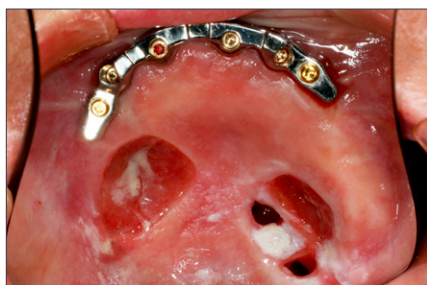
Upper and lower screw-retained wax registrations and wax provisional dentures were created on the same provisional abutments to verify the vertical dimension, occlusion and tooth position. Upper and lower CAD/CAM titanium bars with attachments were designed and placed on the implants. (Figure 8 and 9).

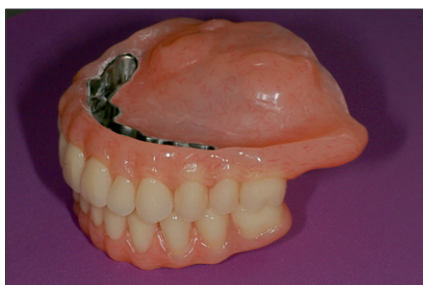
Figure 10

The patient was provided with upper and lower removable prostheses 18 months from implant placement (due to cancer recurrence), dedicated oral hygiene advice and reviewed for 3 years. (Figure 10).

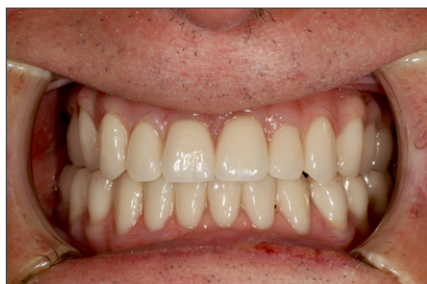
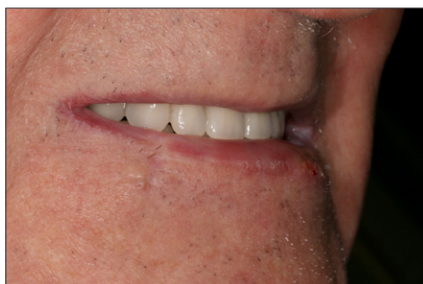
The oral rehabilitation significantly improved the patient's ability to eat, drink and speak as well as his facial and dental cosmetics. (Figure 11 and 12).
