# Belt Damage

**Problem:** Belt damage

**Solution:** Frequent and proper maintenance of belts and conveyor systems

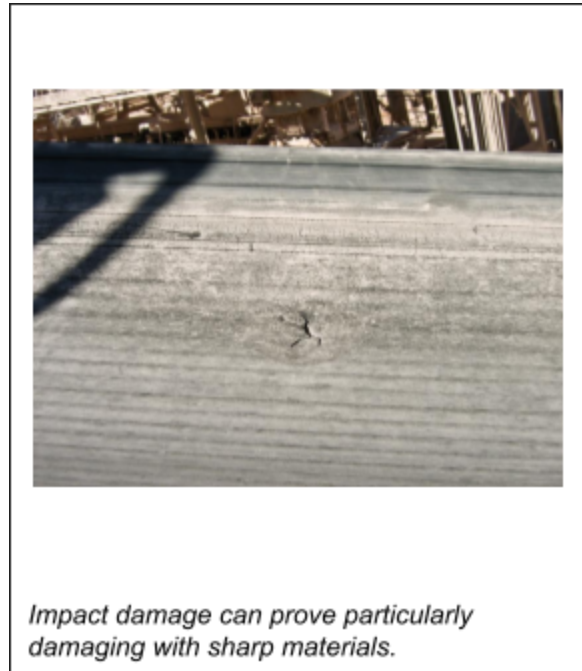
Strong impact by large or sharp materials can lead to significant damage to the top cover of a conveyor belt. These materials can nick, scratch or gouge the top cover, potentially tearing through the belt entirely with enough force.

A large, frozen lump of coal is a good example of materials that could cause significant impact damage. Often this problem is seen most under crushers or in mines on conveyors handling run-of-mine (ROM) materials. Long drops can also lead to significant impact damage, however, especially without any systems to absorb some of the energy from falling materials.

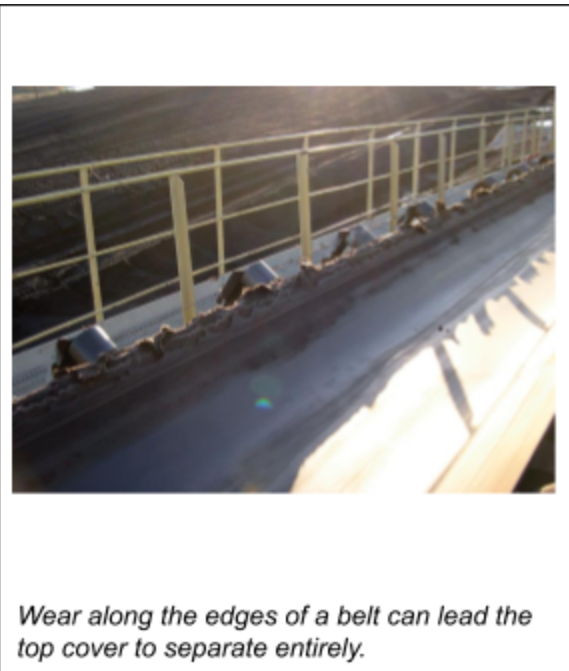
Delamination is a condition where the plies in the carcass of a conveyor belt separate or the carcass as a whole separates from the top cover. This problem can be caused either by excessive tension in the belt or by foreign materials finding their way into the belt. The entry of moisture, chemicals, or other foreign materials into the edge of the belt can contribute to this problem.

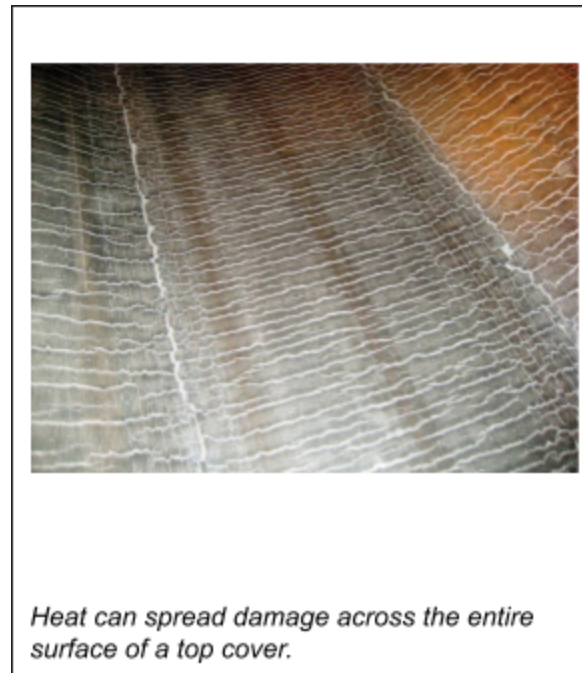
Conveying hot materials may also cause the top cover to crack or the plies to separate. These cracks can travel in either direction along the belt based on the type of material and the manner of loading. If a material's temperature sufficiently exceeds a belt's specifications, holes may burn entirely through the belt. Some belts

are specifically designed to handle higher temperatures, but ultimately the only complete solution is to allow materials to cool before loading or to use other methods to move hot materials.

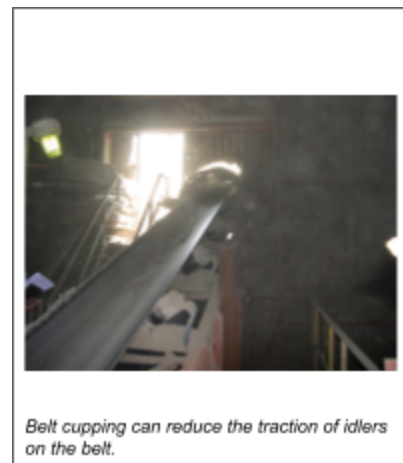
Belt cupping refers to a permanent curvature across the face of a conveyor belt, perpendicular to the line of travel.

Belt cupping can be caused by heat, by transition distances not matched to the belt, or by too severe a trough angle for the type of belt being used. Another cause of cupping is over-tensioning the belt. The

presence of chemicals such as deicers or dust surfactants can also cause a belt to cup up or down, depending on whether the chemical shrinks or swells the elastomer in the belt's top cover. Aspect ratios that are too great (where the top cover is too thick for the bottom cover) can also cause a belt to cup.
