Delo® Testimonial: Freestate Petroleum Distributors

Achieves 1,000,000+ kilometres in a Freightliner® Truck using Delo® family of products.

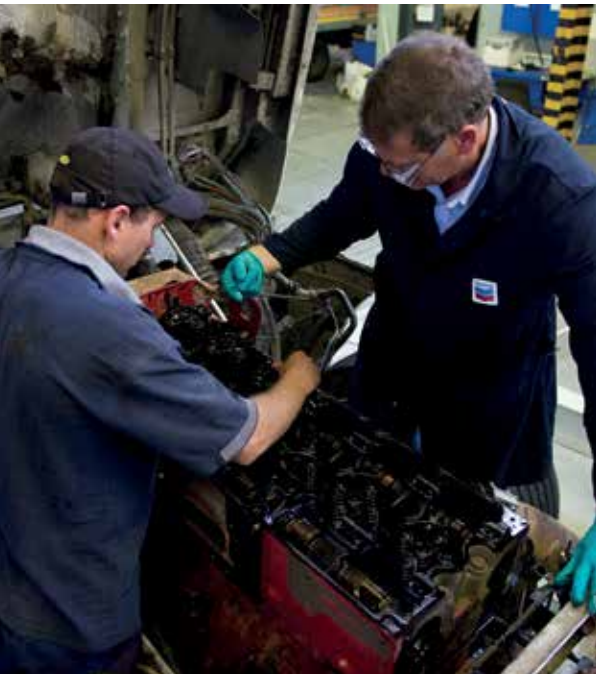
Camshafts are in very good condition with no evidence of micro-pitting or adhesive wear visible.
